# Smithsonian Castle Cornerstone Survey Report

## **1.0 Introduction**

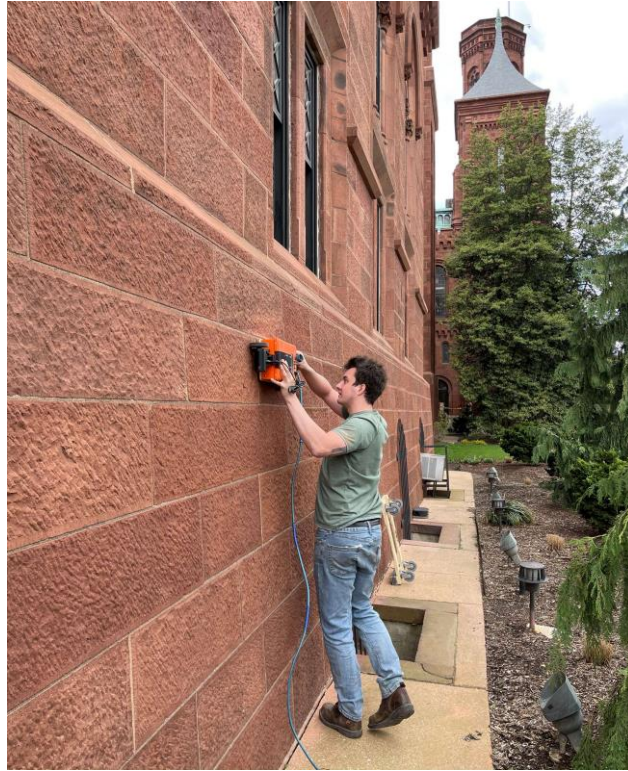
Figure 3. Typical SPR scan collected with the 900 MHz antenna at the northeast corner of the East Wing.

While on site, approximately one hundred and eighty (180) SPR scans were collected in both horizontal and vertical orientations, collected from interior and exterior sides of the wall. All interior scans were collected at the basement level for the full height of the wall at that level, typically spaced 6" on center. All exterior scans were collected at the first floor from exterior grade level up to approximately 7'-6" above grade, with scans typically spaced 6" to 12" on center. Figure 1 and Figure 2 show the scan areas overlaid on plan views of the basement and 1<sup>st</sup> floor levels. The background drawings are provided by others. Figure 3 shows a typical SPR scan being collected with the 900 MHz antenna at the northeast corner of the East Wing.

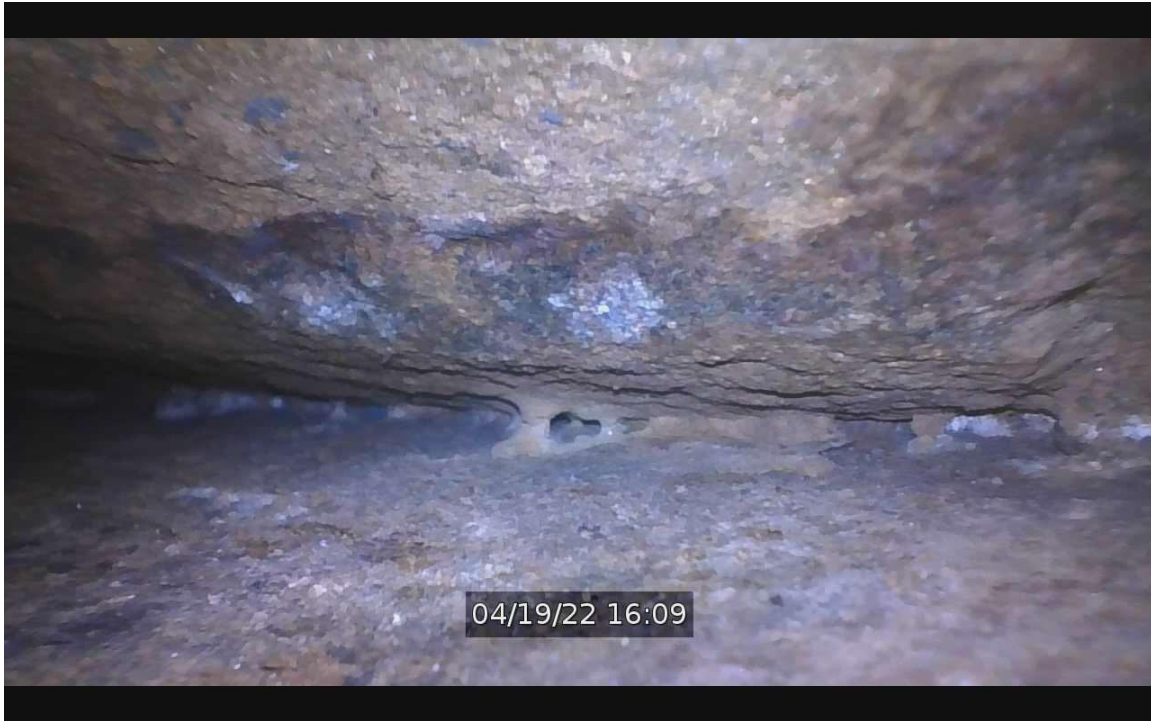
One hole was drilled from the interior at the east wall near the southeast corner of the East Wing. This was drilled at the most significant anomaly detected throughout the 180+ SPR scans. The anomaly is shown in Figure 5 above as highlighted by the green rectangle. The anomaly was at an appropriate depth into the wall (~14") where a time capsule could reside, and the shape and general dimensions were in line with expectations. The anomaly was approximately 24" wide by 12" tall when looking at the wall in elevation – also in line with expectations for a time capsule. The videoscope hole was drilled at the middle of the anomaly to a depth of approximately 14", when the drill jumped slightly. Drilling was stopped and the videoscope was inserted into the hole to reveal a significant void between stone units, void of mortar – not a time capsule. Looking up, down, left, and right, the void appears in line with the SPR signature as approximately 24" wide by 12" tall and approximately 1/2" thick. No other anomalies were deemed significant enough to drill into. Figure 6 and Figure 7 show videoscope images from within the internal void at a depth approximately 14" into the east wall.

Figure 6. Videoscope image looking up inside the internal void initially suspected of being a time capsule.

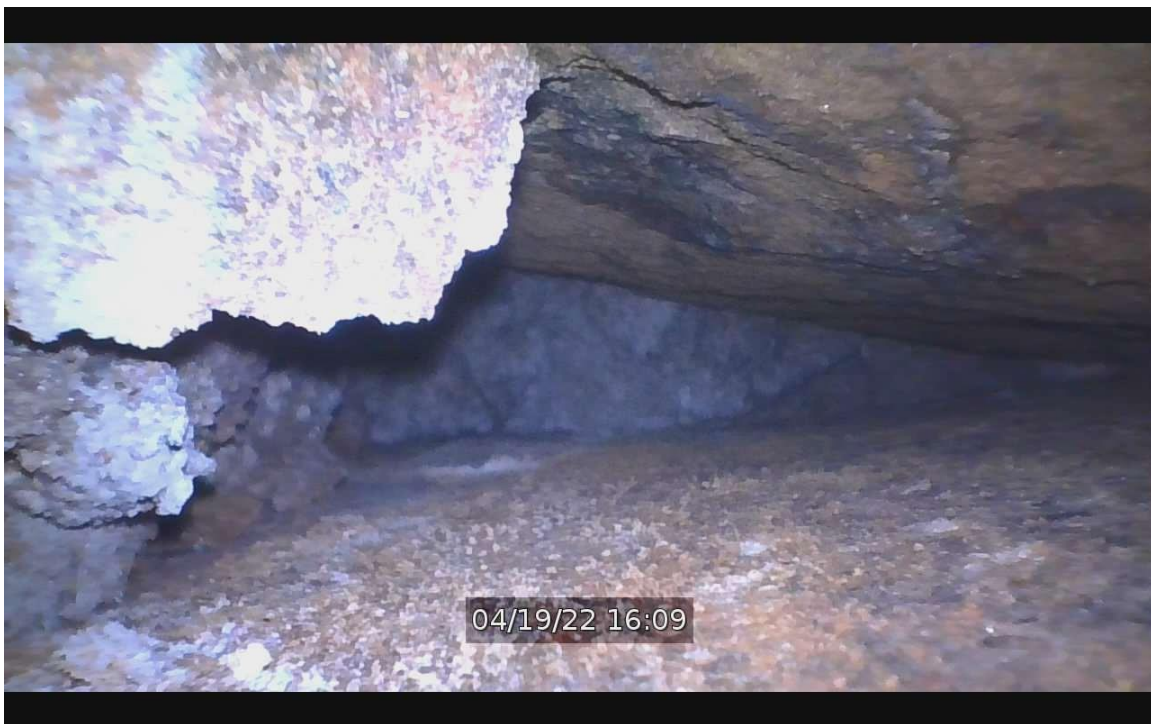
Figure 7. Videoscope image looking down inside the internal void initially suspected of being a time capsule.
