Analysis of Mechanical Strategies

This document provides an overview analysis of schemes considered for mechanical systems for the Hirshhorn Revitalize Building and Plaza project. All schemes were considered through Section 106 consultation pursuant to the National Historic Preservation Act. This document is intended to assist Section 106 consulting parties to understand the preferred alternative selected to advance into design and consultation in 2025.

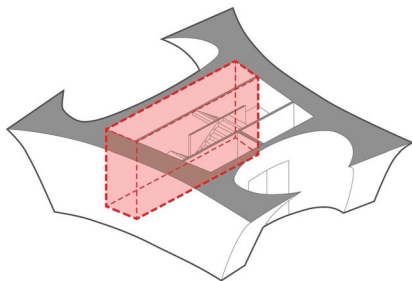
Available Shaft Space 285 SF, cumulative for three piers

The majority of available pier space is dedicated to required egress stairs and elevators

AXONOMETRIC OF PIER: LIMITED AVAILABLE SHAFT AREA

The drum piers are the only points through which the upper levels are connected to the Plaza for egress and to the Lower Level through which air and services are conveyed. The southeast pier is dedicated to elevators. Space within the remaining three historic piers is limited. It will not be possible to serve the upper levels entirely from below without major alterations to the historic piers.

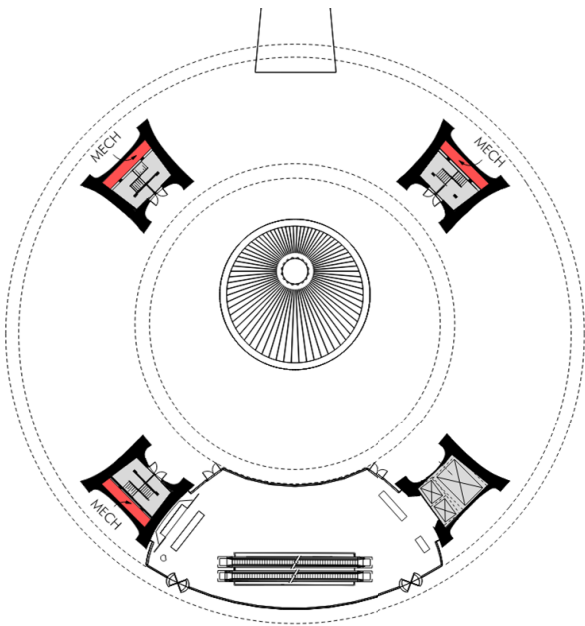
PLAZA LEVEL: LIMITED AVAILABLE SHAFT AREA

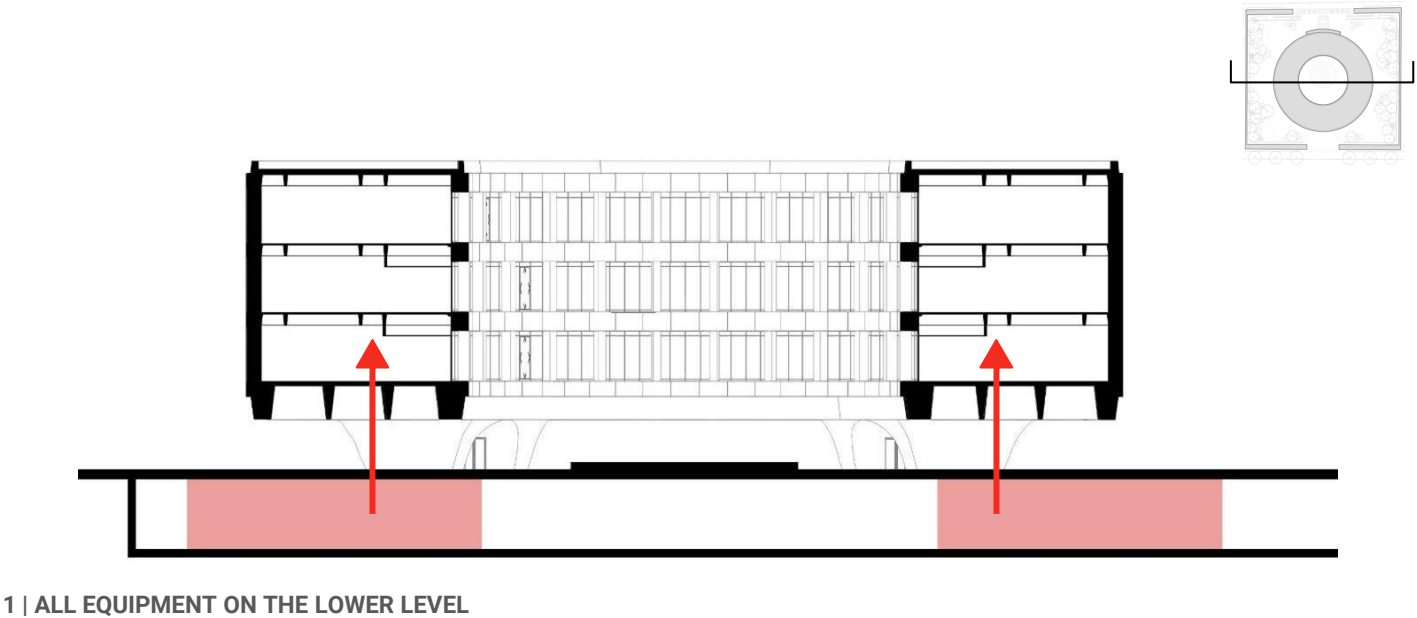
1 | All Equipment on the Lower Level

Scheme 1 evaluates locating all the mechanical equipment on the Lower Level at the request of the consulting parties. It is not feasible due to code requirements and physical constraints.

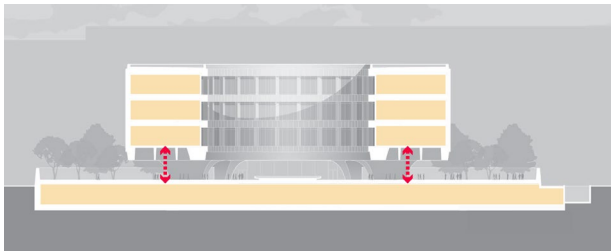
Shaft space required if all MEP equipment remained at the Lower Level: **~1,100 SF**

Shaft space available: **285 SF**  
(cumulative for three piers)

THE HISTORIC PIERS PLACE A PHYSICAL CONSTRAINT ON THE AMOUNT OF DUCTWORK THAT CAN COMMUNICATE UP FROM THE LOWER LEVEL

**Pinch Point at Piers:** The historic piers place a physical constraint on the amount of ductwork that can communicate up from the Lower Level.

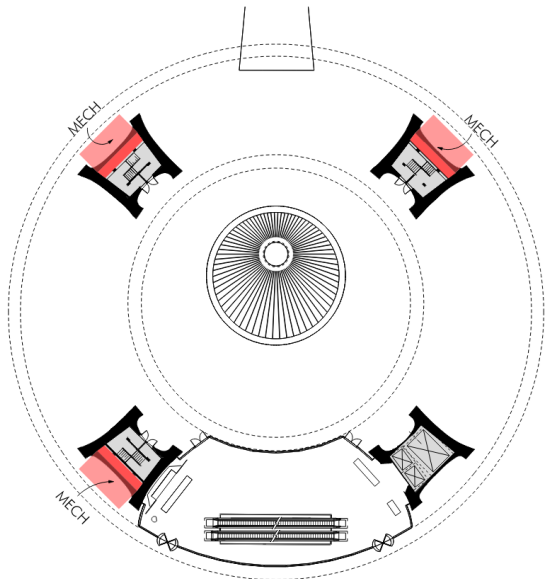
PLAZA LEVEL SHAFT PLAN SHOWING REQUIRED SHAFT AREA IF ALL MECHANICAL EQUIPMENT IS LOCATED ON THE LOWER LEVEL

**Historic Fabric:** If all equipment is located on the Lower Level, the required shaft space will increase more than three-fold and require heavy modifications to the historic piers. The sculptural piers support the elevated drum. This alteration will adversely affect the building form.

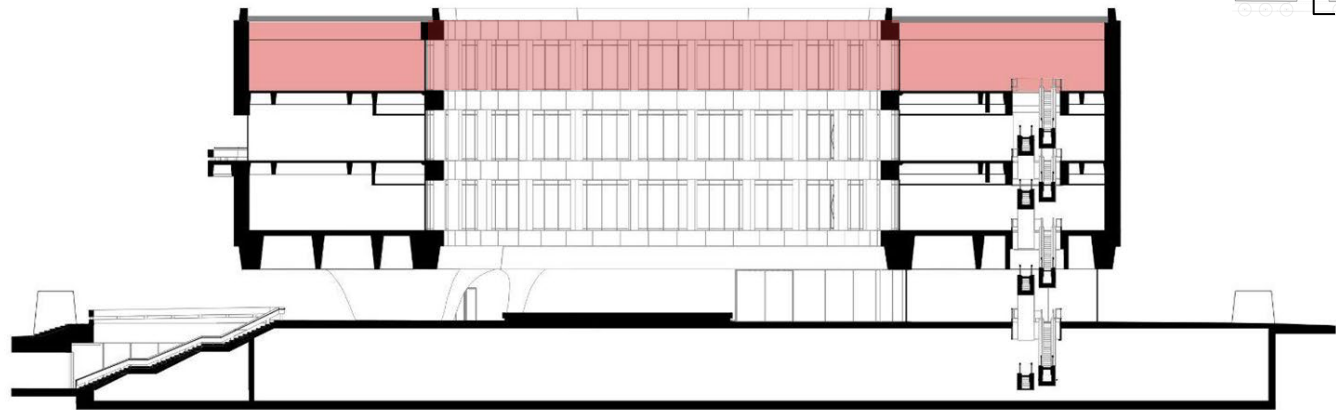
2 | ALL EQUIPMENT ON LEVEL 4

Scheme 2 evaluates locating all mechanical equipment on Level 4. The layout, due to the limiting cylindrical floor plan, takes up the entire 25,000 square feet floor plate of the drum and removes 40% of the new public space planned in the building revitalization. This precludes the relocation of staff and collections from Level 4 to allow for public access to a full-depth ring gallery with visible historic coffered ceilings. It is also not desirable due to access limitations, risks associated with exposure to water infiltration, and compromises to gallery and visitor experience at the galleries on Level 3. This scheme has the least impact on visible exterior alterations but does not meet the project’s goal of increasing public space inside the Museum. This scheme is not recommended.

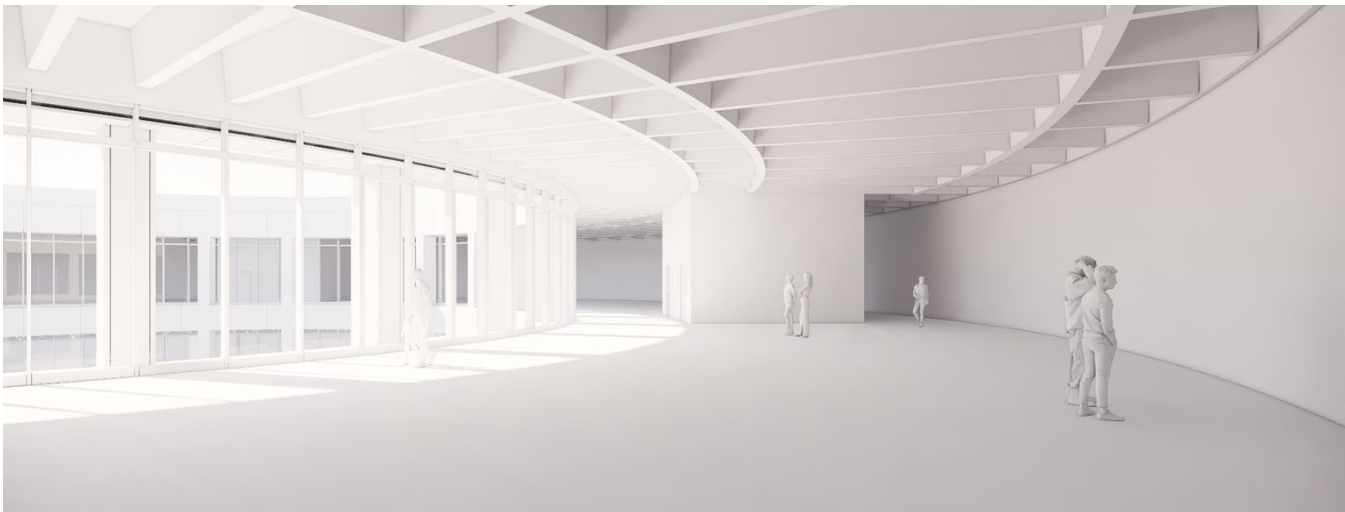
LEVEL 4 FULL-DEPTH RING GALLERY PROPOSED FOR PUBLIC SPACE: USING LEVEL 4 AS A MECHANICAL LEVEL RATHER THAN A NEW GALLERY LEVEL REMOVES 40% OF THE NEW PUBLIC SPACE PLANNED BY THE BUILDING REVITALIZATION

**Visitor Experience:** Dedicating Level 4 to mechanical space will drastically reduce the amount of public space available to the Museum for exhibition and public programming.

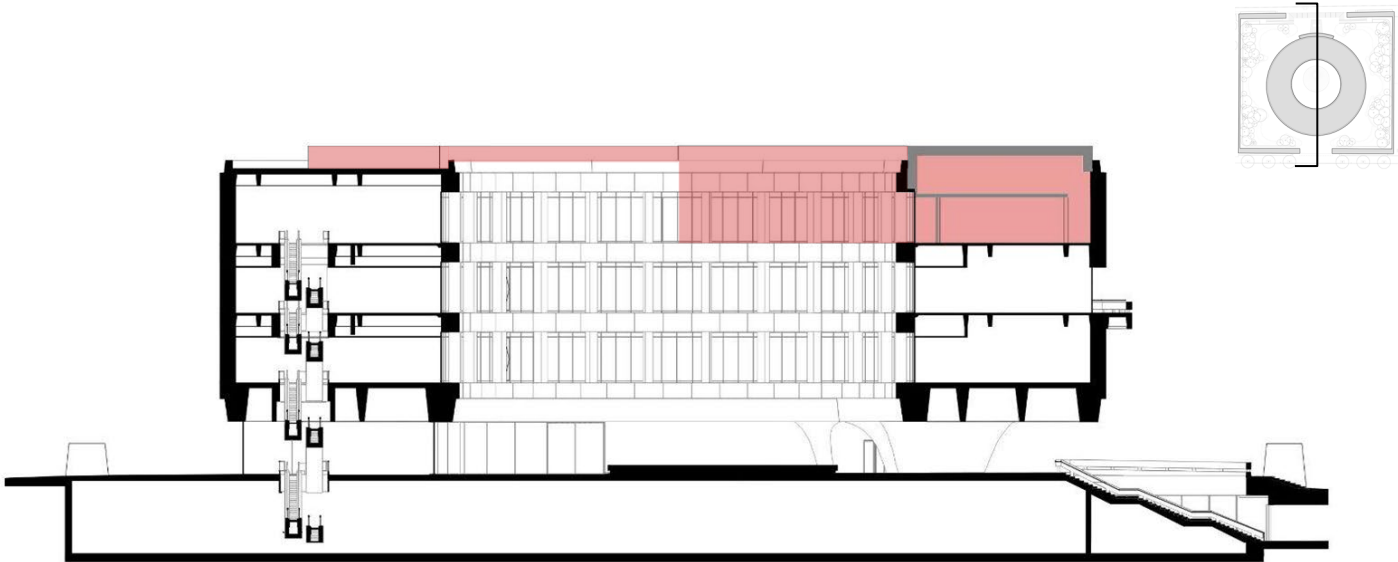
3 | EQUIPMENT PARTIALLY ON LEVEL 4

Scheme 3 evaluates using part of Level 4 for mechanical equipment. It consolidates the equipment to the north side of the Level 4 floor plate with a mezzanine. Only half of Level 4 will be available for public use, and an addition to the roof will still be necessary to accommodate the stacked equipment and ductwork. Due to access limitations, risks associated with exposure to water infiltration, visible exterior rooftop alterations, and compromises to gallery and visitor experience, this scheme is not recommended.

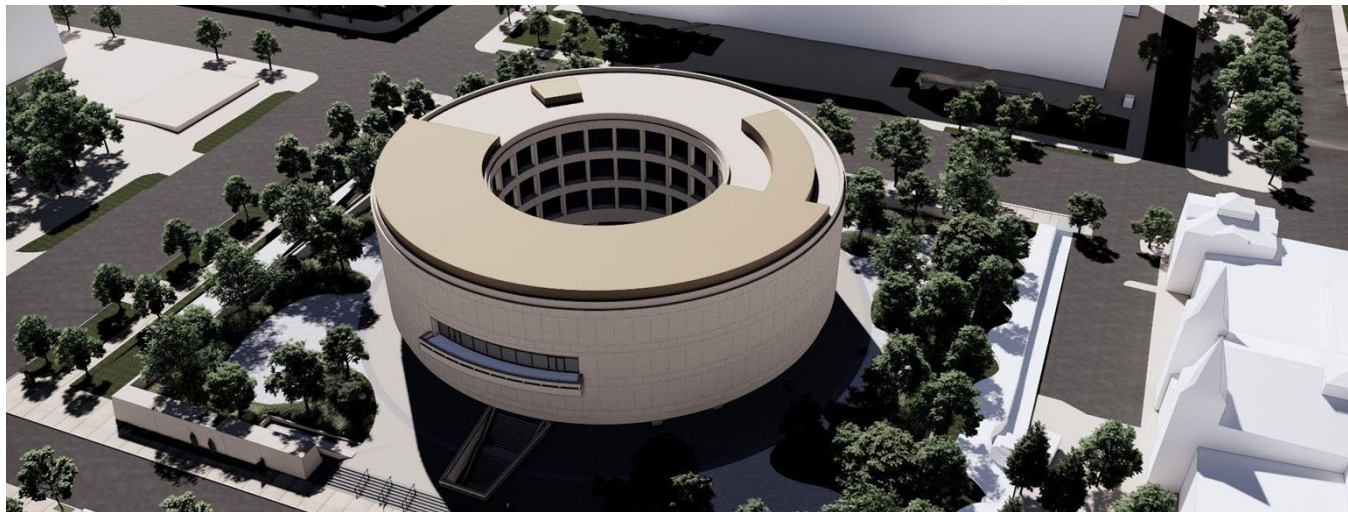
ROOFTOP EQUIPMENT AND ENCLOSURE WILL BE VISIBLE FROM PUBLIC THOROUGHFARES AND THE NATIONAL MALL

**Visible Exterior Alterations:** This scheme requires visible rooftop mechanical equipment and/or enclosure, visible from multiple public thoroughfares and the National Mall.

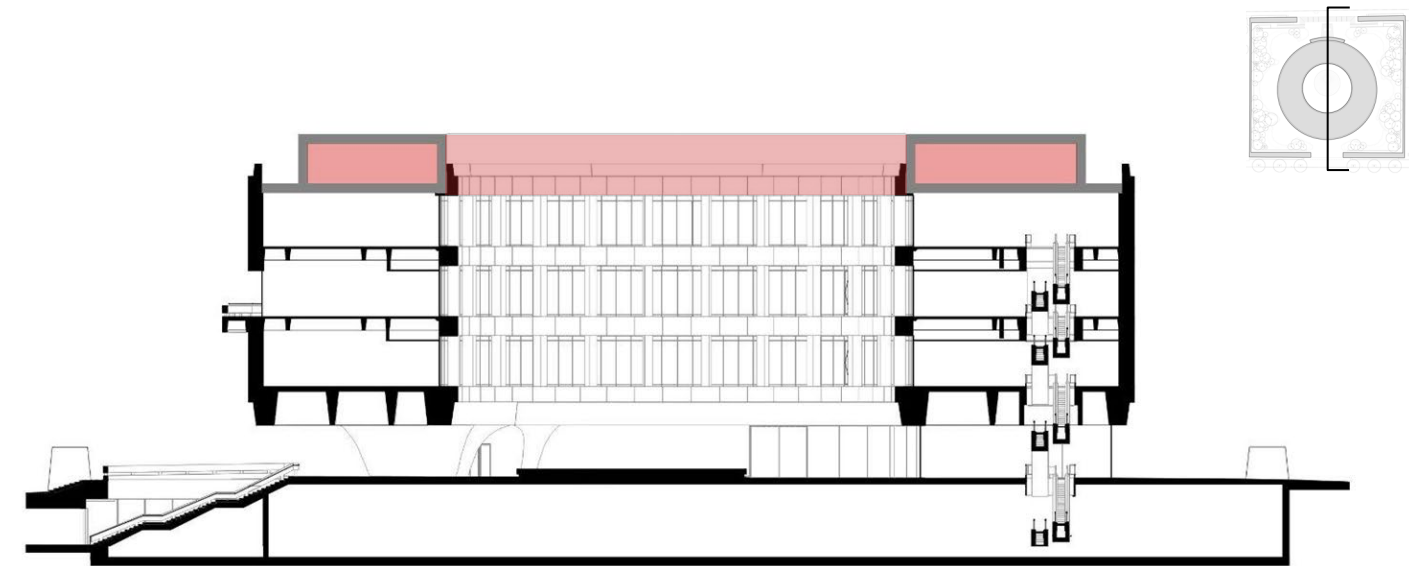
4 | ALL EQUIPMENT ON A LOWERED ROOF STRUCTURE

Scheme 4 evaluates a new lowered roof structure to minimize the visibility of the rooftop mechanical addition. This strategy removes the historic coffered roof structure. It reduces 1 to 2 feet of height from an addition but significantly alters the building's interior historic character and creates a risk to structural integrity. This scheme is not recommended.

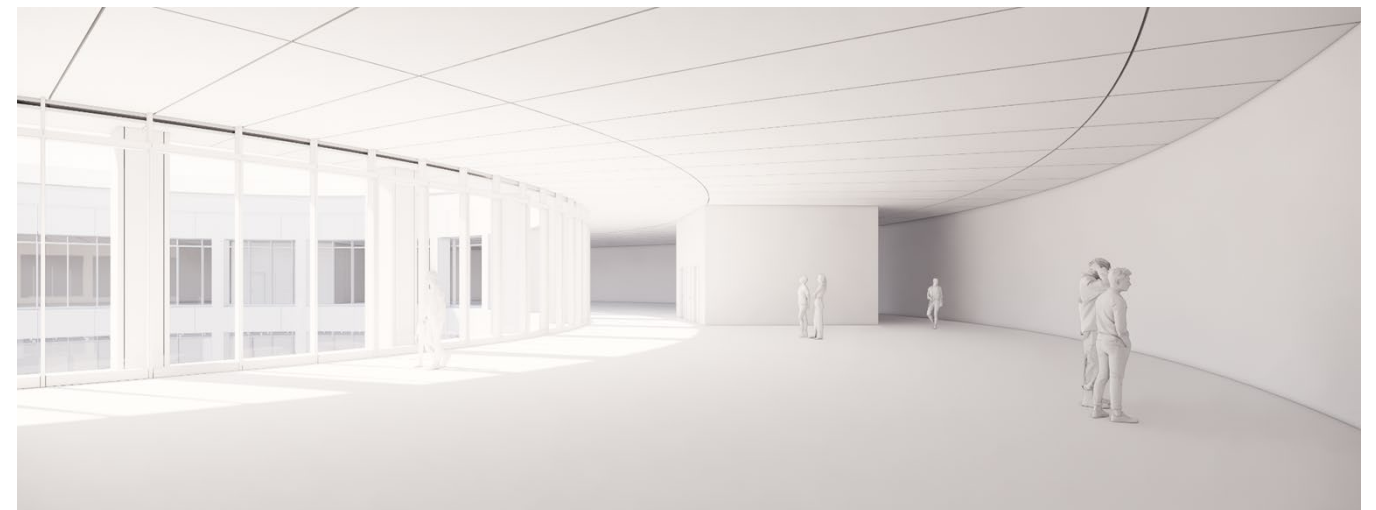
HISTORIC STRUCTURAL COFFER CEILING WILL BE PERMANENTLY REMOVED AND BE REPLACED WITH A FLAT CEILING

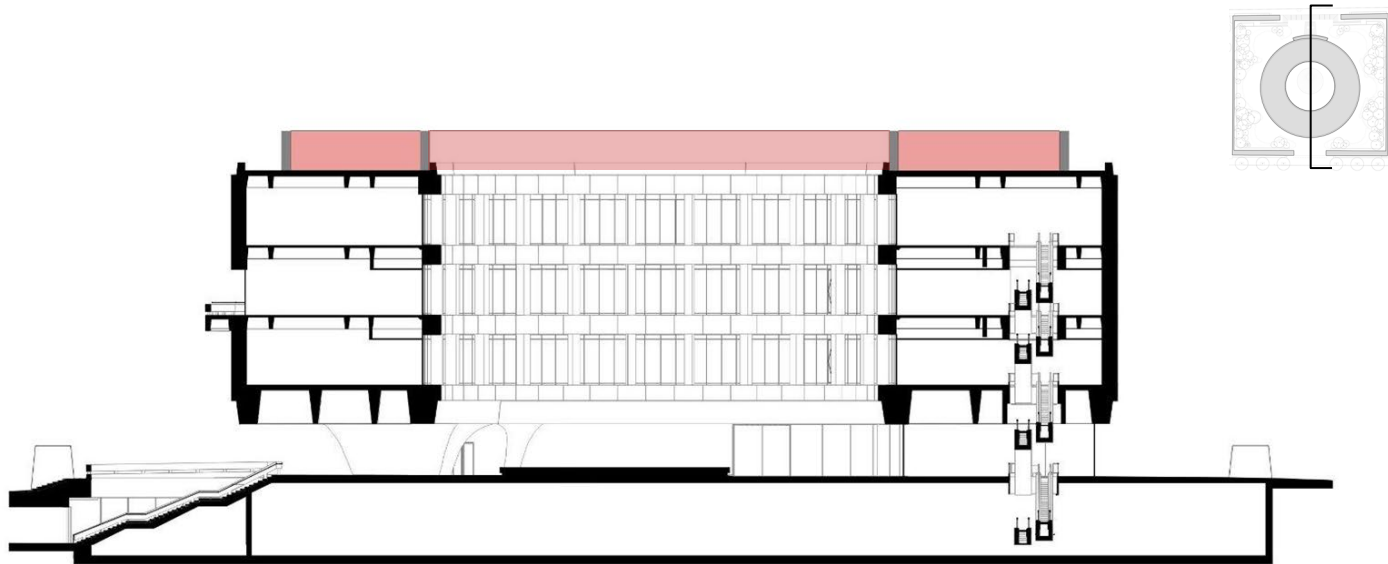
5 | EQUIPMENT ON OPEN ROOF STRUCTURE

Scheme 5 evaluates removing the enclosure over the equipment to minimize the visibility of the rooftop addition. This scheme creates associated water infiltration risks, adds complexities to insulate individual equipment and ductwork, and results in visibility of unsightly equipment from above and from public thoroughfares. This scheme is not recommended.

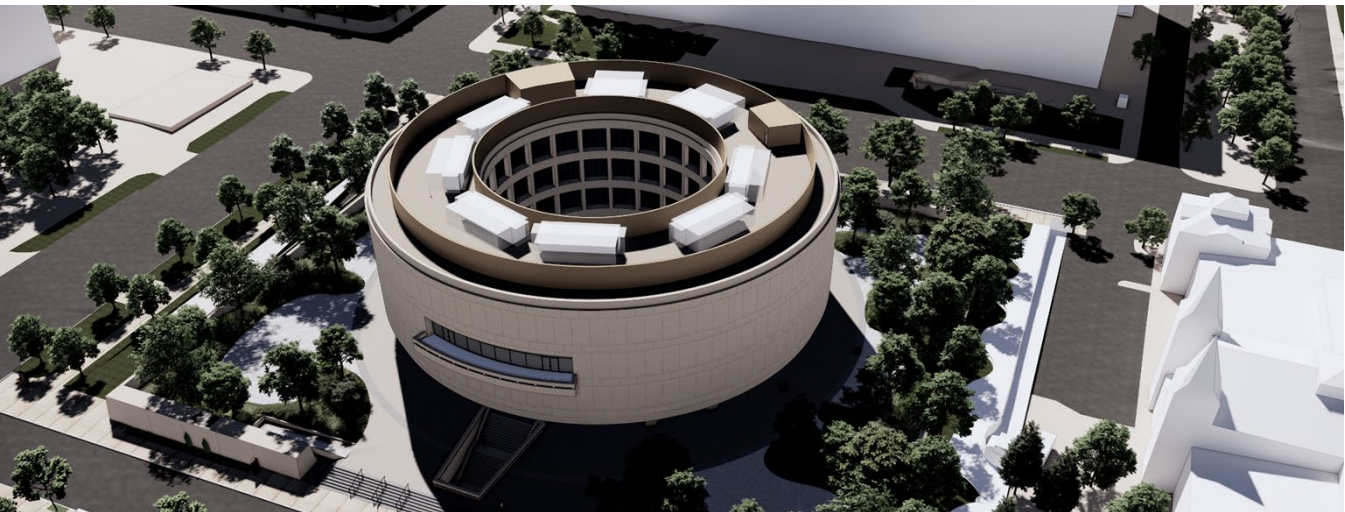
REMOVING THE ENCLOSURE OVER THE EQUIPMENT EXPOSES UNSIGHTLY EQUIPMENT FROM ABOVE

**Visibility of Equipment:** An open roof does not obscure equipment from all vantage points and neighboring buildings. In particular, the view from the sky (planes, etc.) will be unattractive and highly visible in contrast to the simple building drum. The equipment and enclosure will be visible from above, multiple public thoroughfares, and the National Mall.

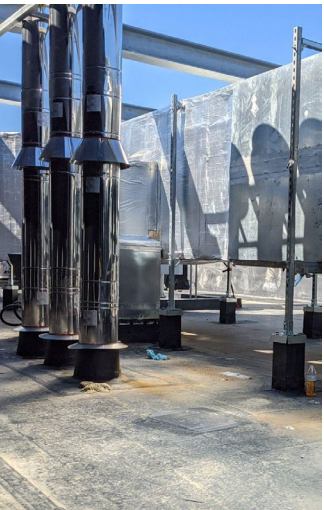
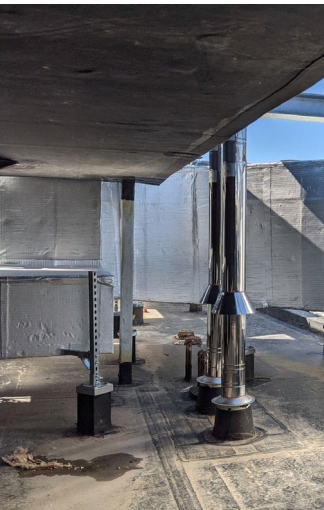
HVAC EQUIPMENT ON OPEN ROOF STRUCTURE REQUIRE OVERHEAD STRUCTURE TO SUPPORT DUCTWORK AND PIPING

**Infrastructure:** Mechanical equipment on an open roof requires additional weatherproofing and structure that take up additional area on an already limited footprint. Supports for hanging ductwork and piping will need to be installed to provide adequate pathways for maintenance. This is made more difficult by the circular geometry of the roof.

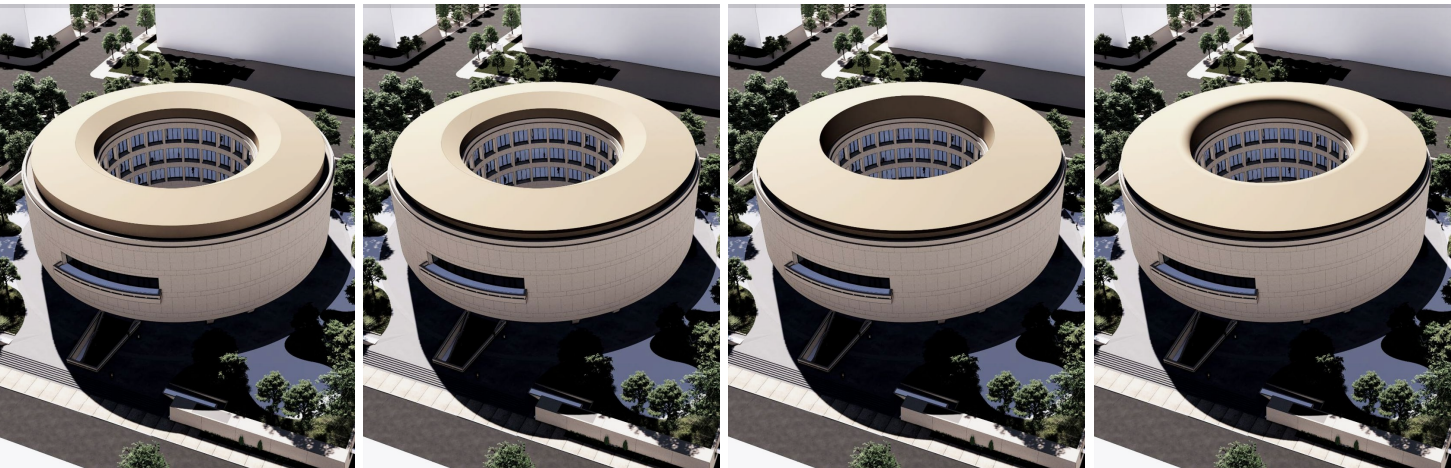
OPTIONS OF FORM, SHAPE, AND MATERIALITY TO BE STUDIED WITH PUBLIC CONSULTATION

This scheme is recommended, with future design and consultation required on the shaping of the massing and materials. As this proposes an addition to the roof, rigorous study of the form is needed. Careful consideration of sightlines and evaluation of the visible size of the enclosure relative to the drum is required. Analyses will prioritize visibility from the National Mall and public thoroughfares. The design of the envelope and materials will be carefully examined alongside the development of the mechanical systems.

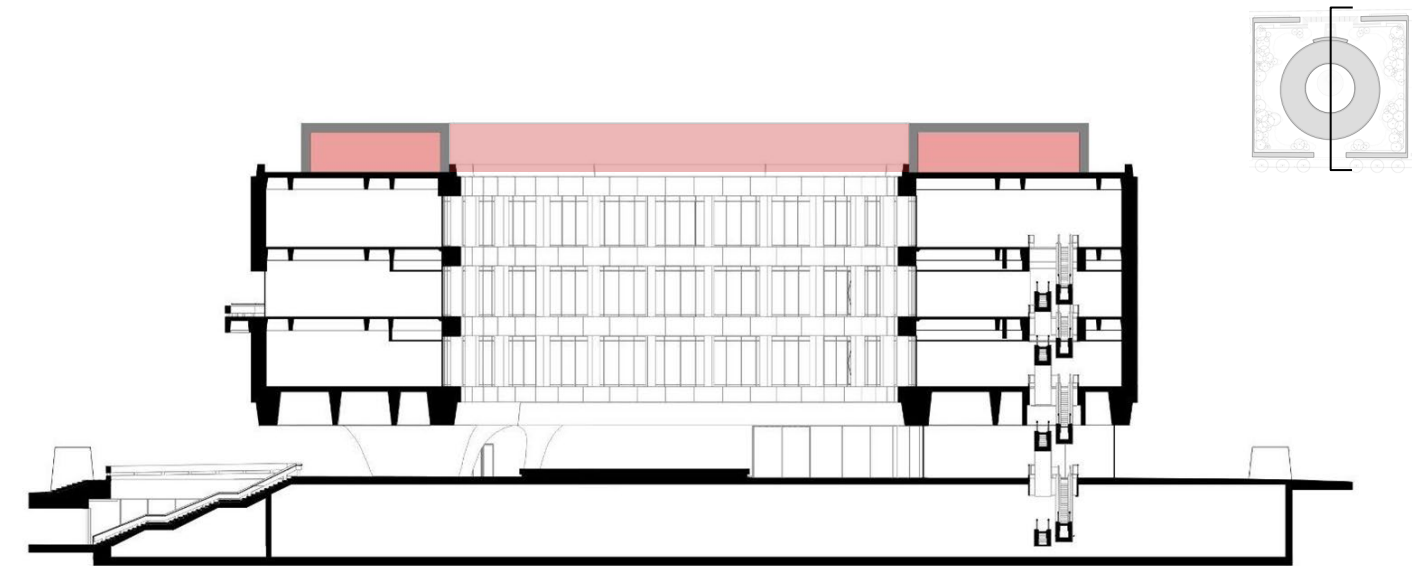
6 | EQUIPMENT IN ENCLOSURE ON ROOF

Placing mechanical equipment on the roof is a viable option. It allows the project to meet its public space goals to better serve its visitors and showcase art to support the Hirshhorn’s mission. It provides a mechanical system that is serviceable and resilient: protected from the elements.

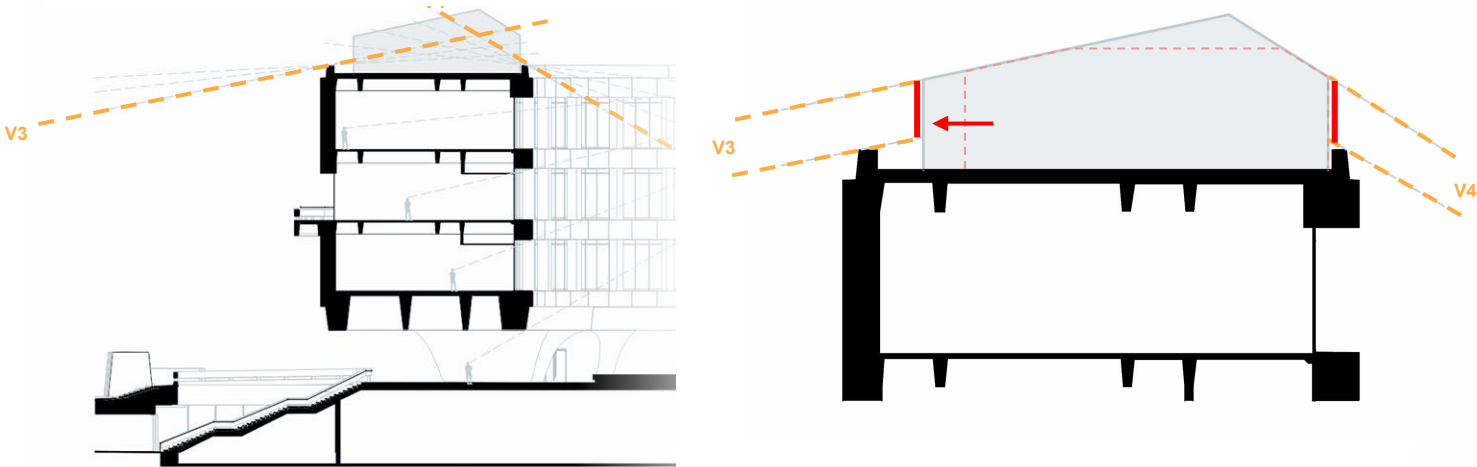
A STRATEGY TO SHAPE THE ROOFTOP TO VIEWSHEDS TO MINIMIZE HEIGHT AND SCALE
