Smithsonian Institution

Revitalization of the Historic Core  
**CONSULTING PARTIES MEETING #13**

May 24, 2023

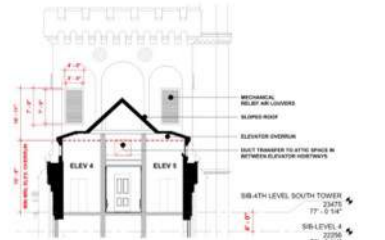
Partial axonometric view of the South Tower.

Section elevation depicting the size of the through wall louvers and extent of brick removal.	<ul style="list-style-type: none"> <li>- Roof Profile is a character defining feature. South Tower has a steep peaked roof clad in slate shingles.</li> <li>- Proposed work enables the removal of the existing non-code compliant elevator and its visible elevator overrun from the North Tower.</li> <li>- Existing elevator mechanical relief bulkhead is visible from the east and west of the South Tower.</li> <li>- Proposed elevators use Machine Room Less technology, which does not require overhead mechanical equipment above the elevator shaft. If this technology was not used, the elevator overruns would be significantly taller.</li> <li>- Alternate locations for these public elevators cannot be considered to avoid adverse effects to the South Tower exterior and interior. This is because the Adolf Cluss modifications inserted additional levels creating quarter level height differences between the finish floors of the South Tower and the Main Building.</li> <li>- Phase 1 of 106 consultation included a significantly taller mechanical relief bulkhead than the existing condition, found to have significant visual impact and adverse effect. Phase 1 of 106 consultation produced a through wall louver design, with consensus that this solution minimized adverse effect by eliminating visibility of the mechanical relief bulkhead.</li> <li>- Proposed elevator overruns will be visible from the east and west of the South Tower.</li> <li>- Proposed exterior changes have an adverse effect on the Castle's roofline, South Tower massing, and</li> </ul>

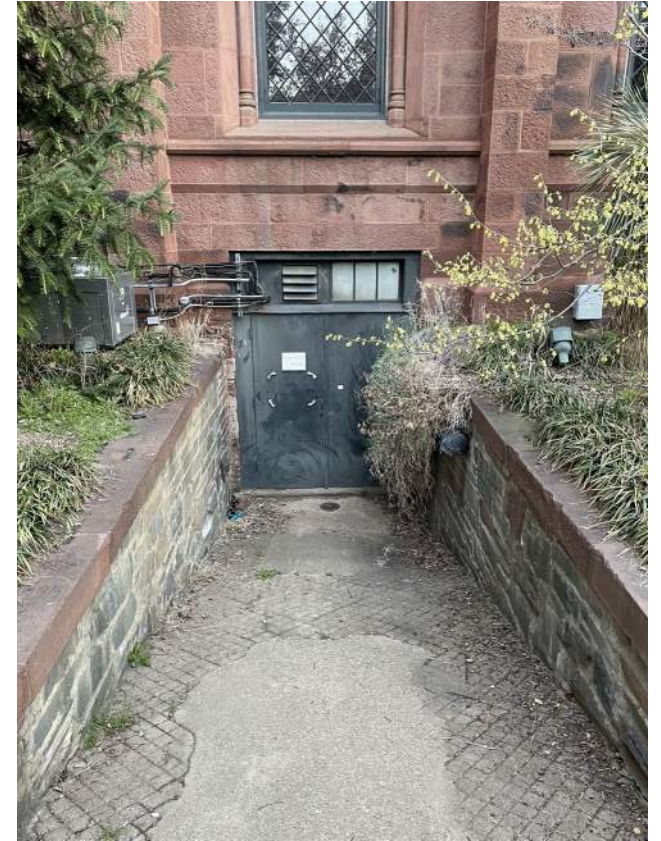
Existing ramp and door at the southeast corner of the Main Building.

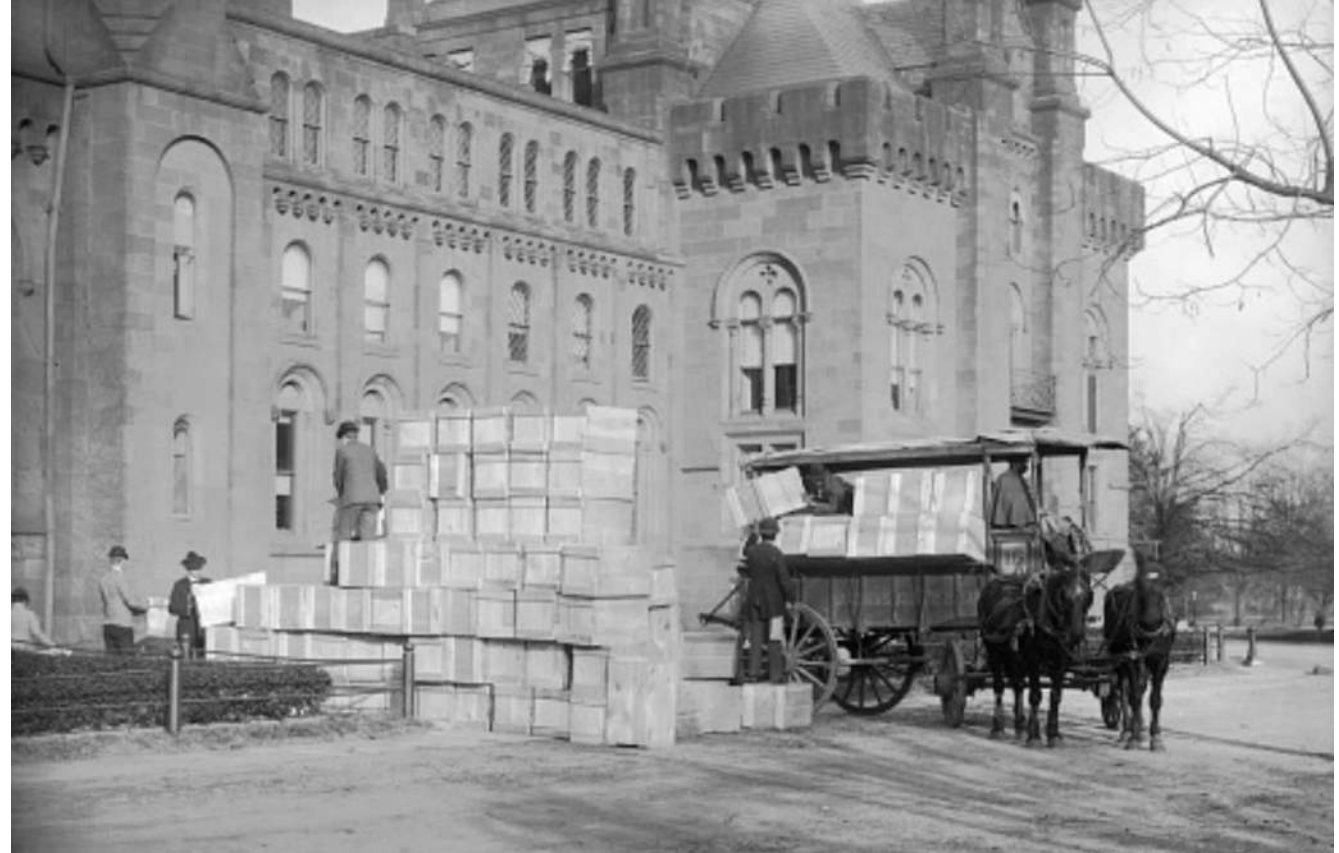
International Exchange Service Deliveries, 1910

- Large portions of the International Exchange Service moved to the basement of the Castle's Main Building, East Wing, and Range beginning in 1870
- In 1871 the loading ramp and door were installed

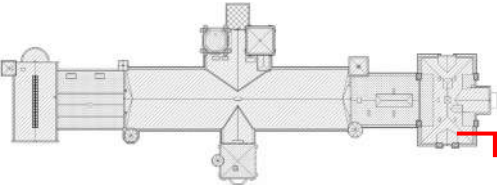
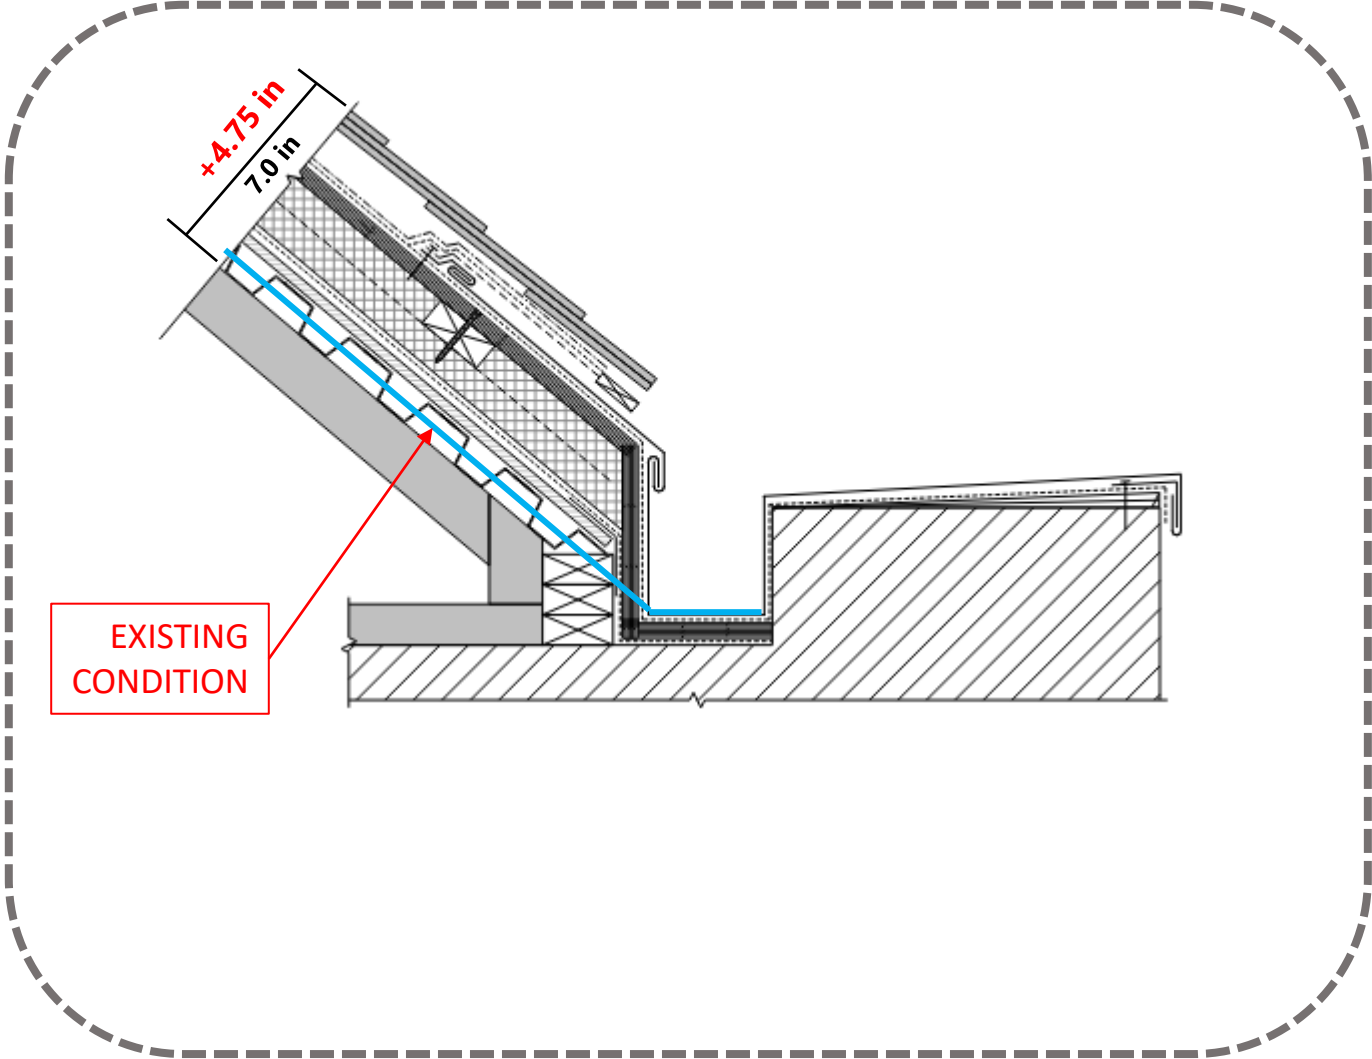
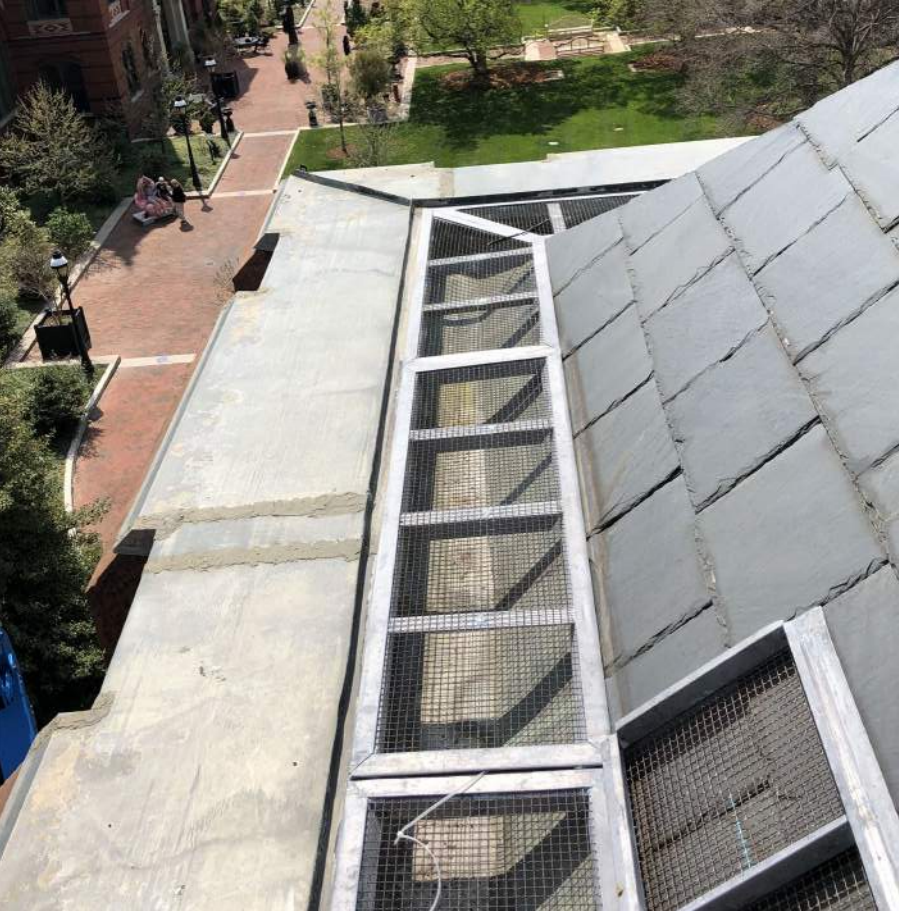
## EAST WING ROOF

ROOF | PROPOSED  
DIMENSIONAL CHANGE TO ACCOMMODATE INSULATION

EAST WING – SOUTHEAST CORNER OF THE ROOF

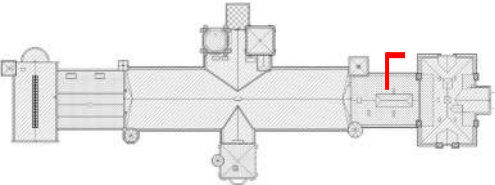
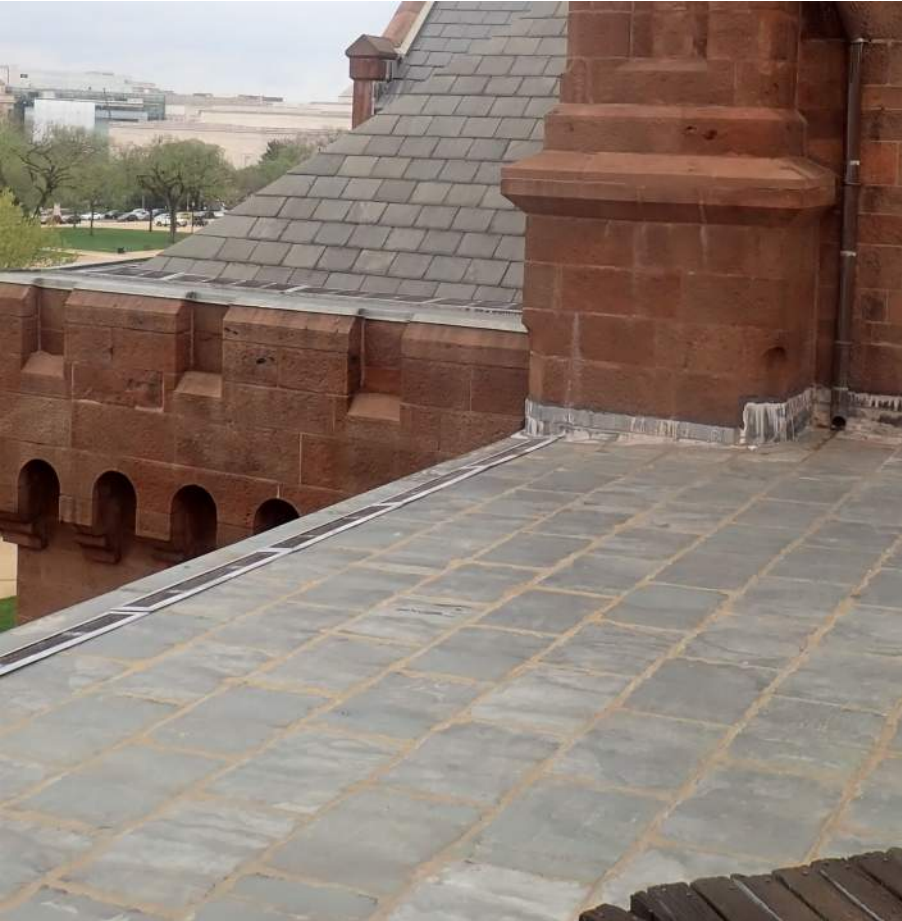
## EAST RANGE ROOF

ROOF | PROPOSED  
DIMENSIONAL CHANGE TO ACCOMMODATE INSULATION

EAST RANGE – ROOF LOOKING NORTHEAST

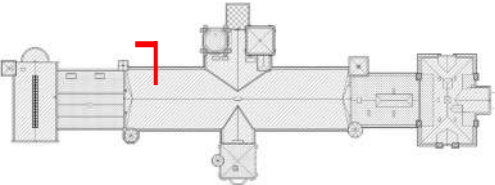
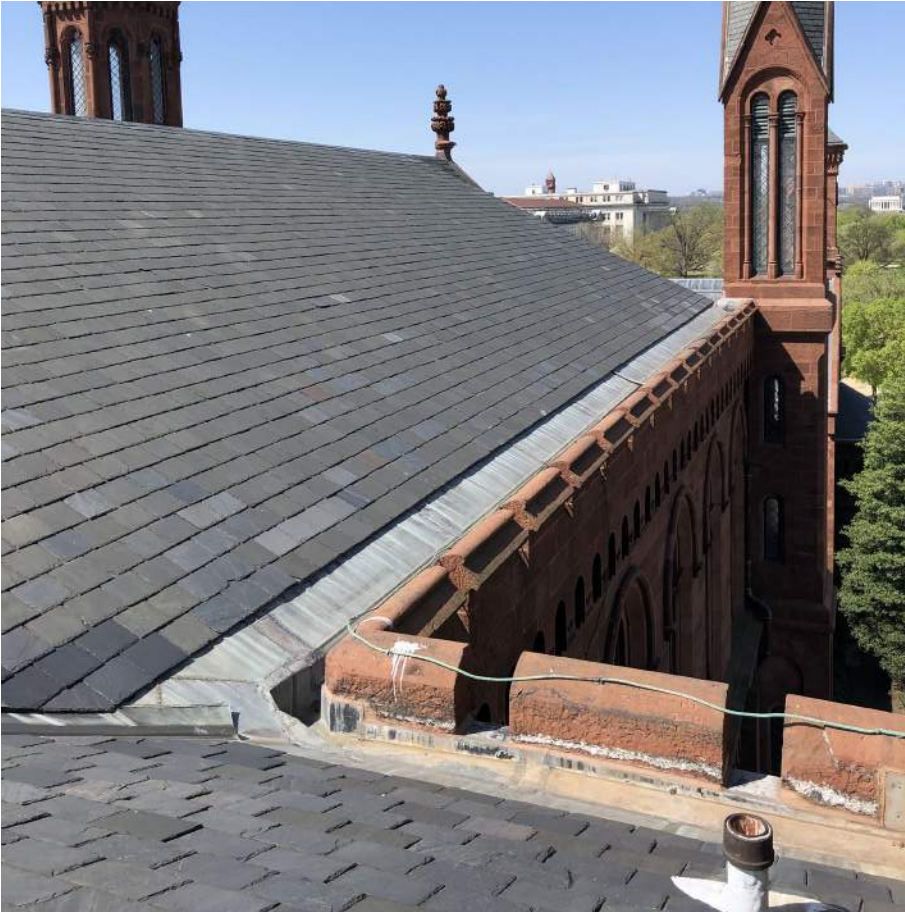
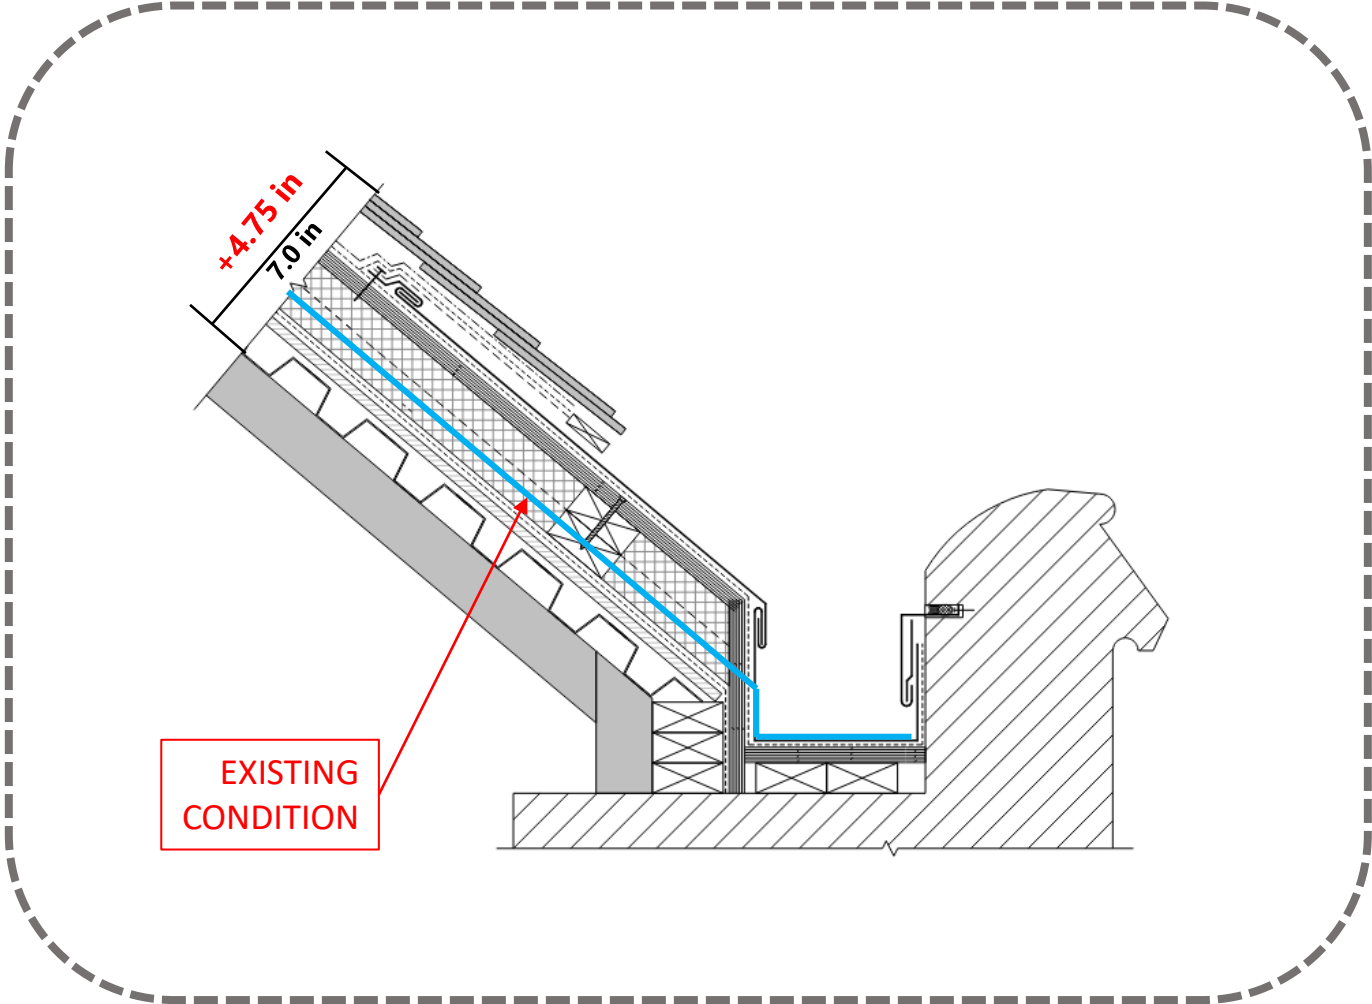
## GREAT HALL ROOF

ROOF | PROPOSED  
DIMENSIONAL CHANGE TO ACCOMMODATE INSULATION

MAIN HALL – NORTH ELEVATION ROOF LOOKING WEST

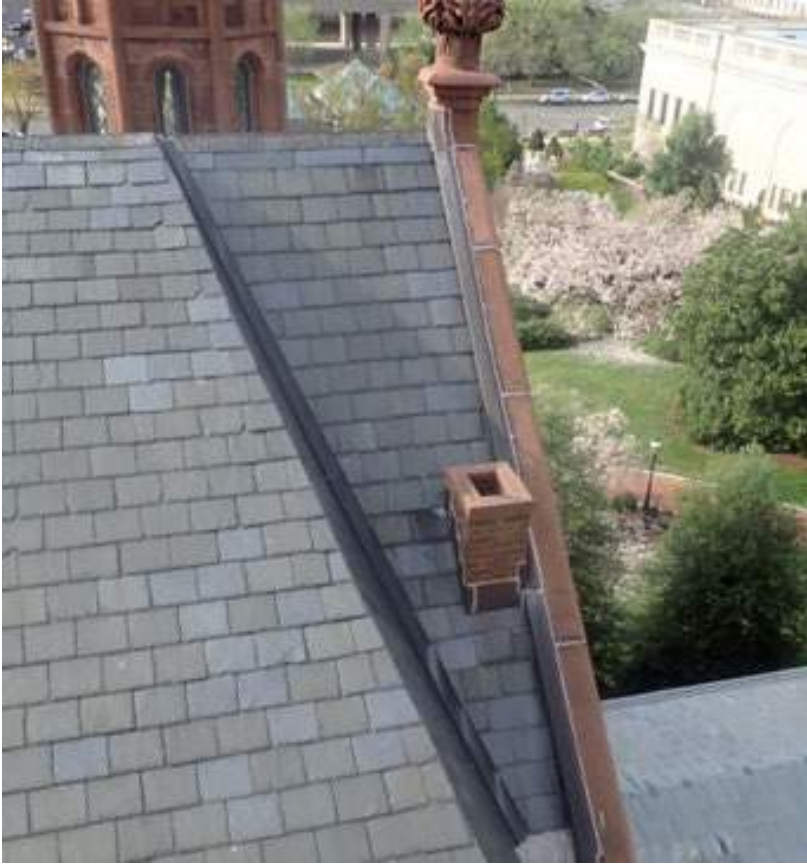
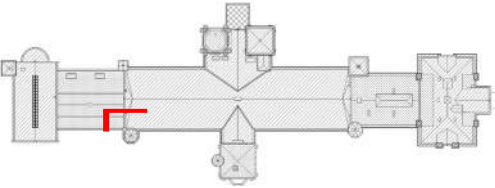
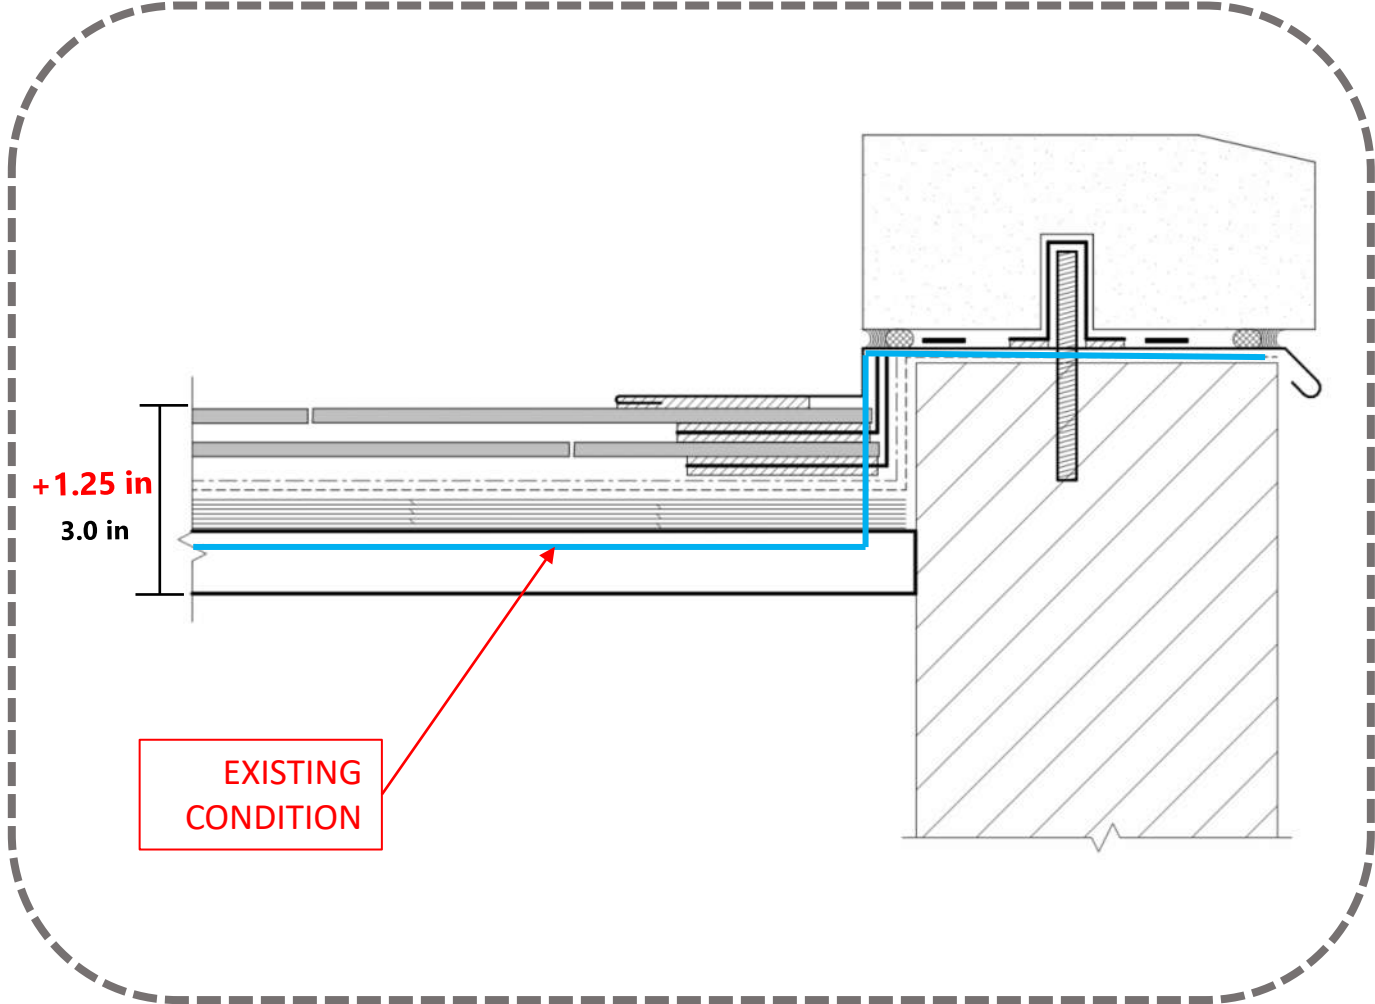
## GREAT HALL ROOF

ROOF | PROPOSED  
DIMENSIONAL CHANGE TO ACCOMMODATE INSULATION

MAIN HALL – WEST END OF NORTH ELEVATION ROOF

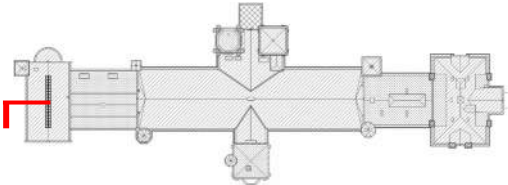
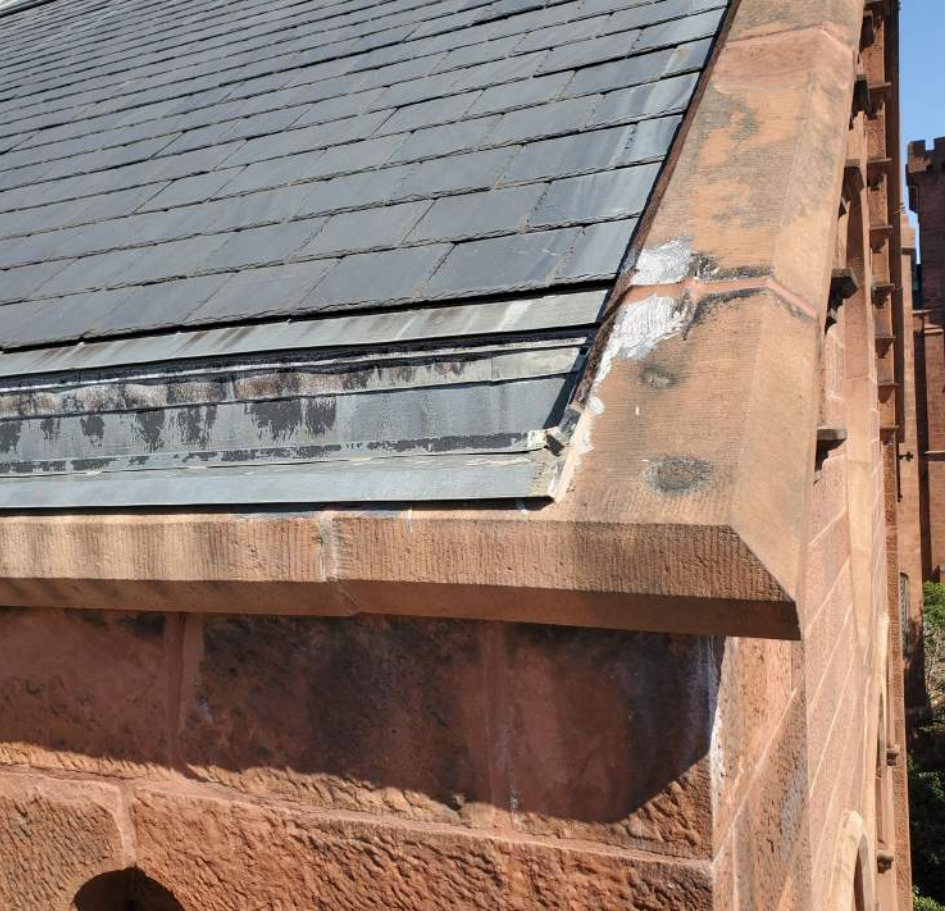
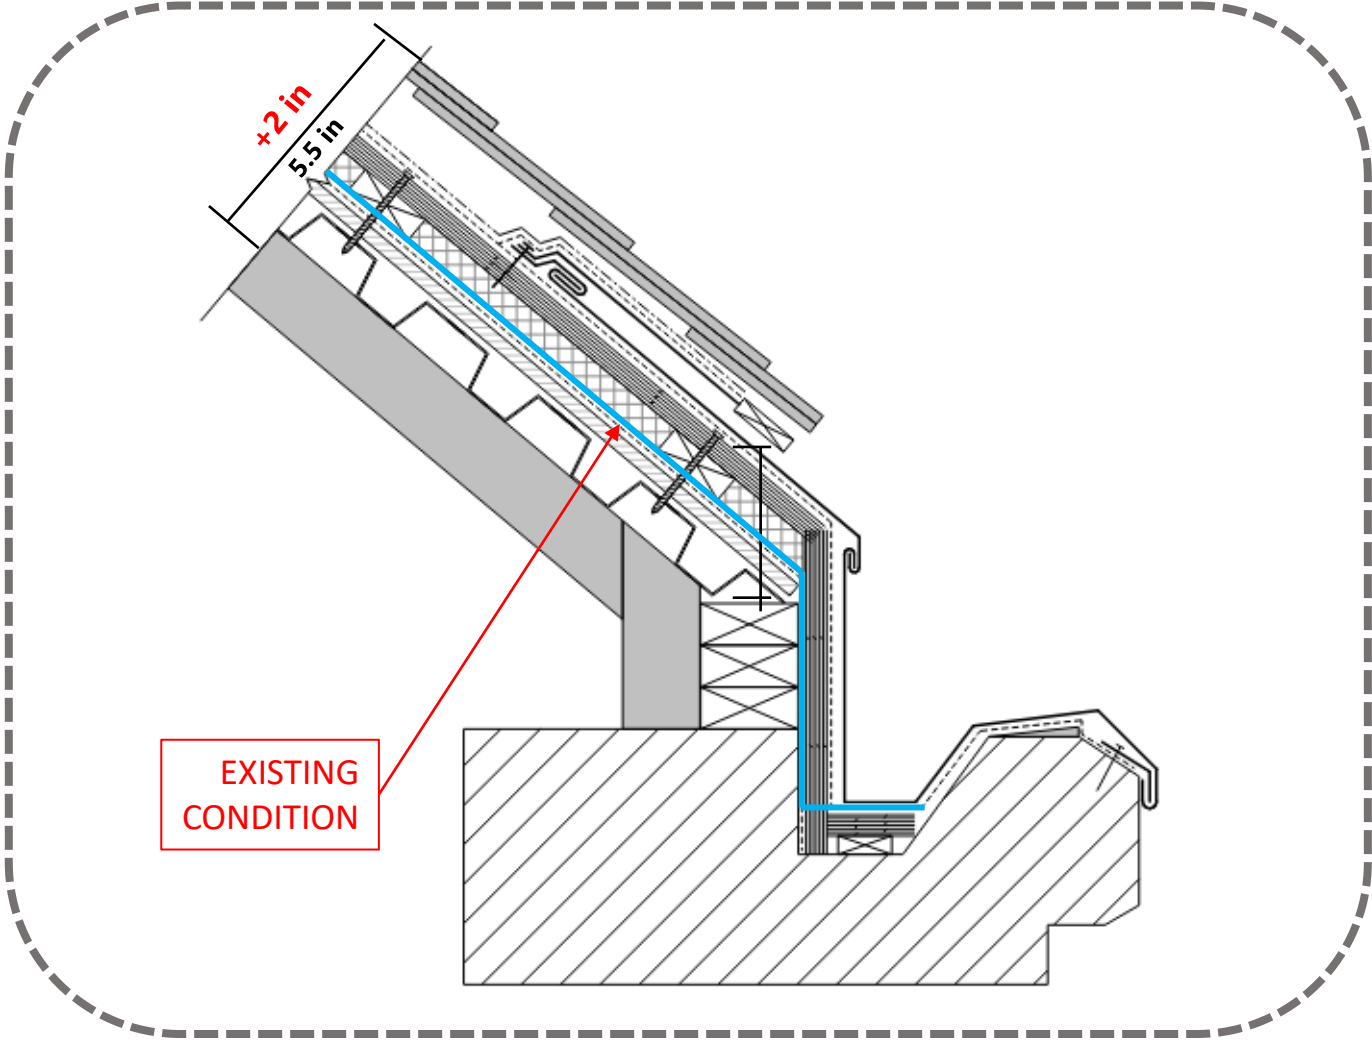
## WEST WING ROOF

ROOF | PROPOSED  
DIMENSIONAL CHANGE TO ACCOMMODATE INSULATION

WEST WING – SOUTHWEST CORNER OF THE ROOF

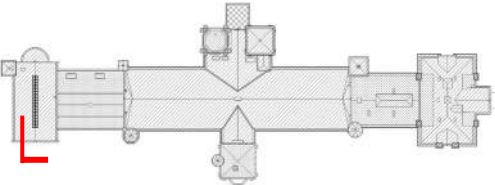
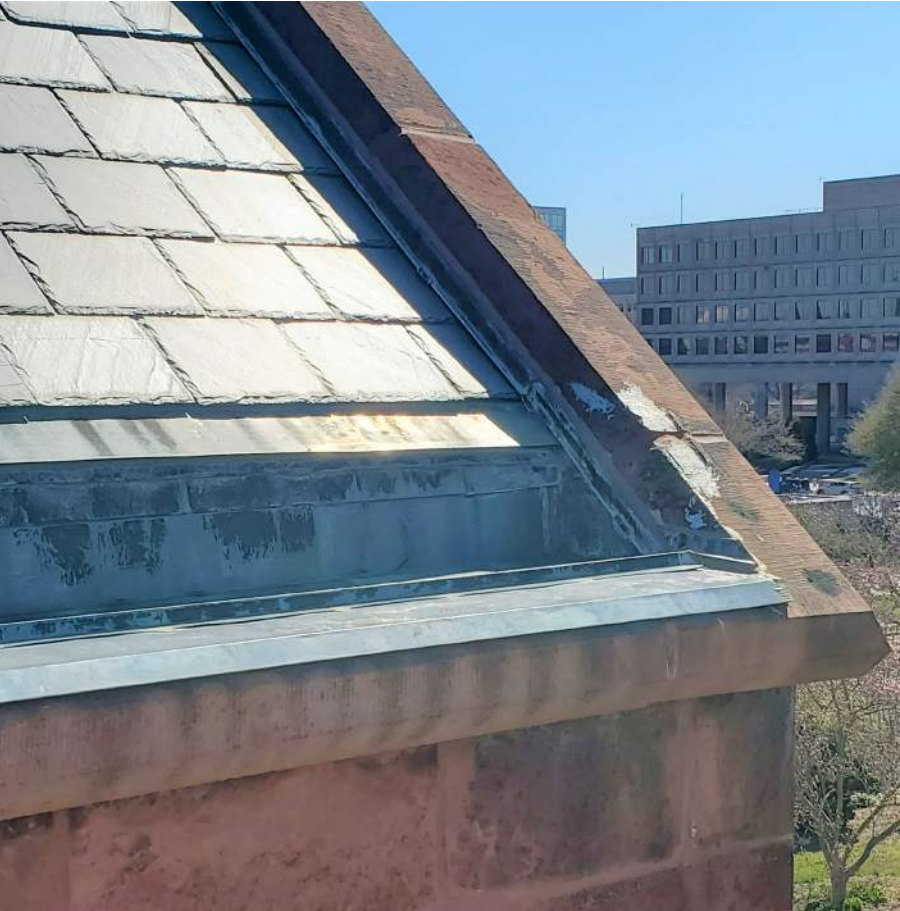
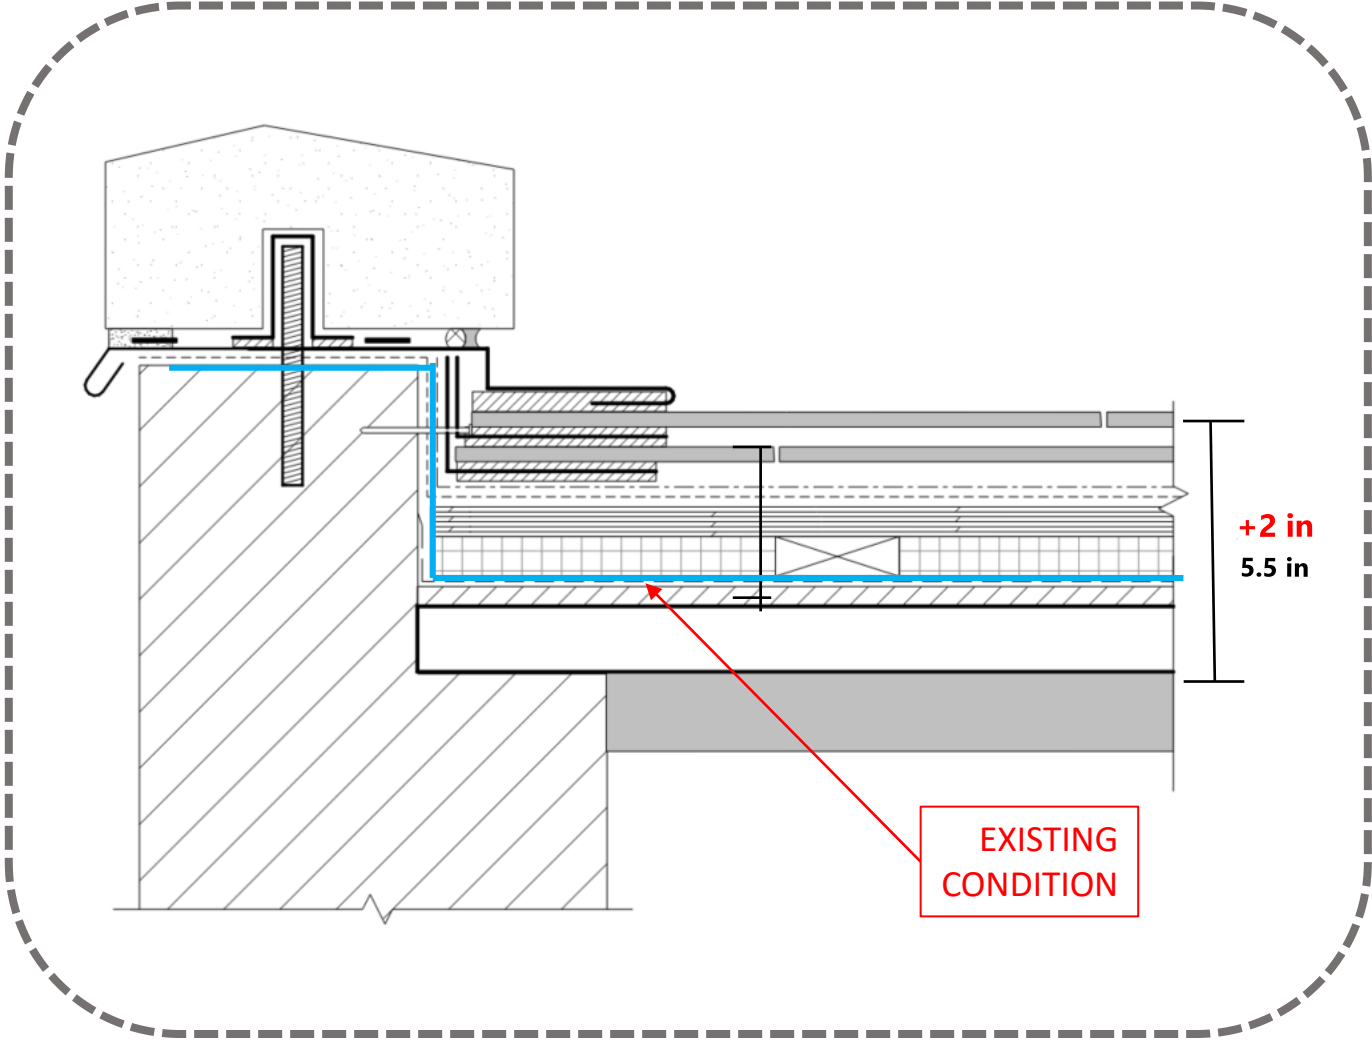
## WEST WING ROOF

ROOF | PROPOSED  
DIMENSIONAL CHANGE TO ACCOMMODATE INSULATION

WEST WING – SOUTHWEST CORNER OF THE ROOF

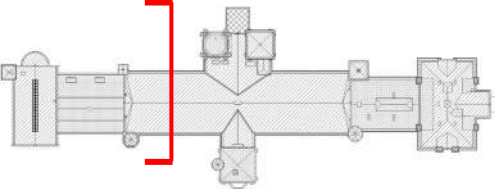
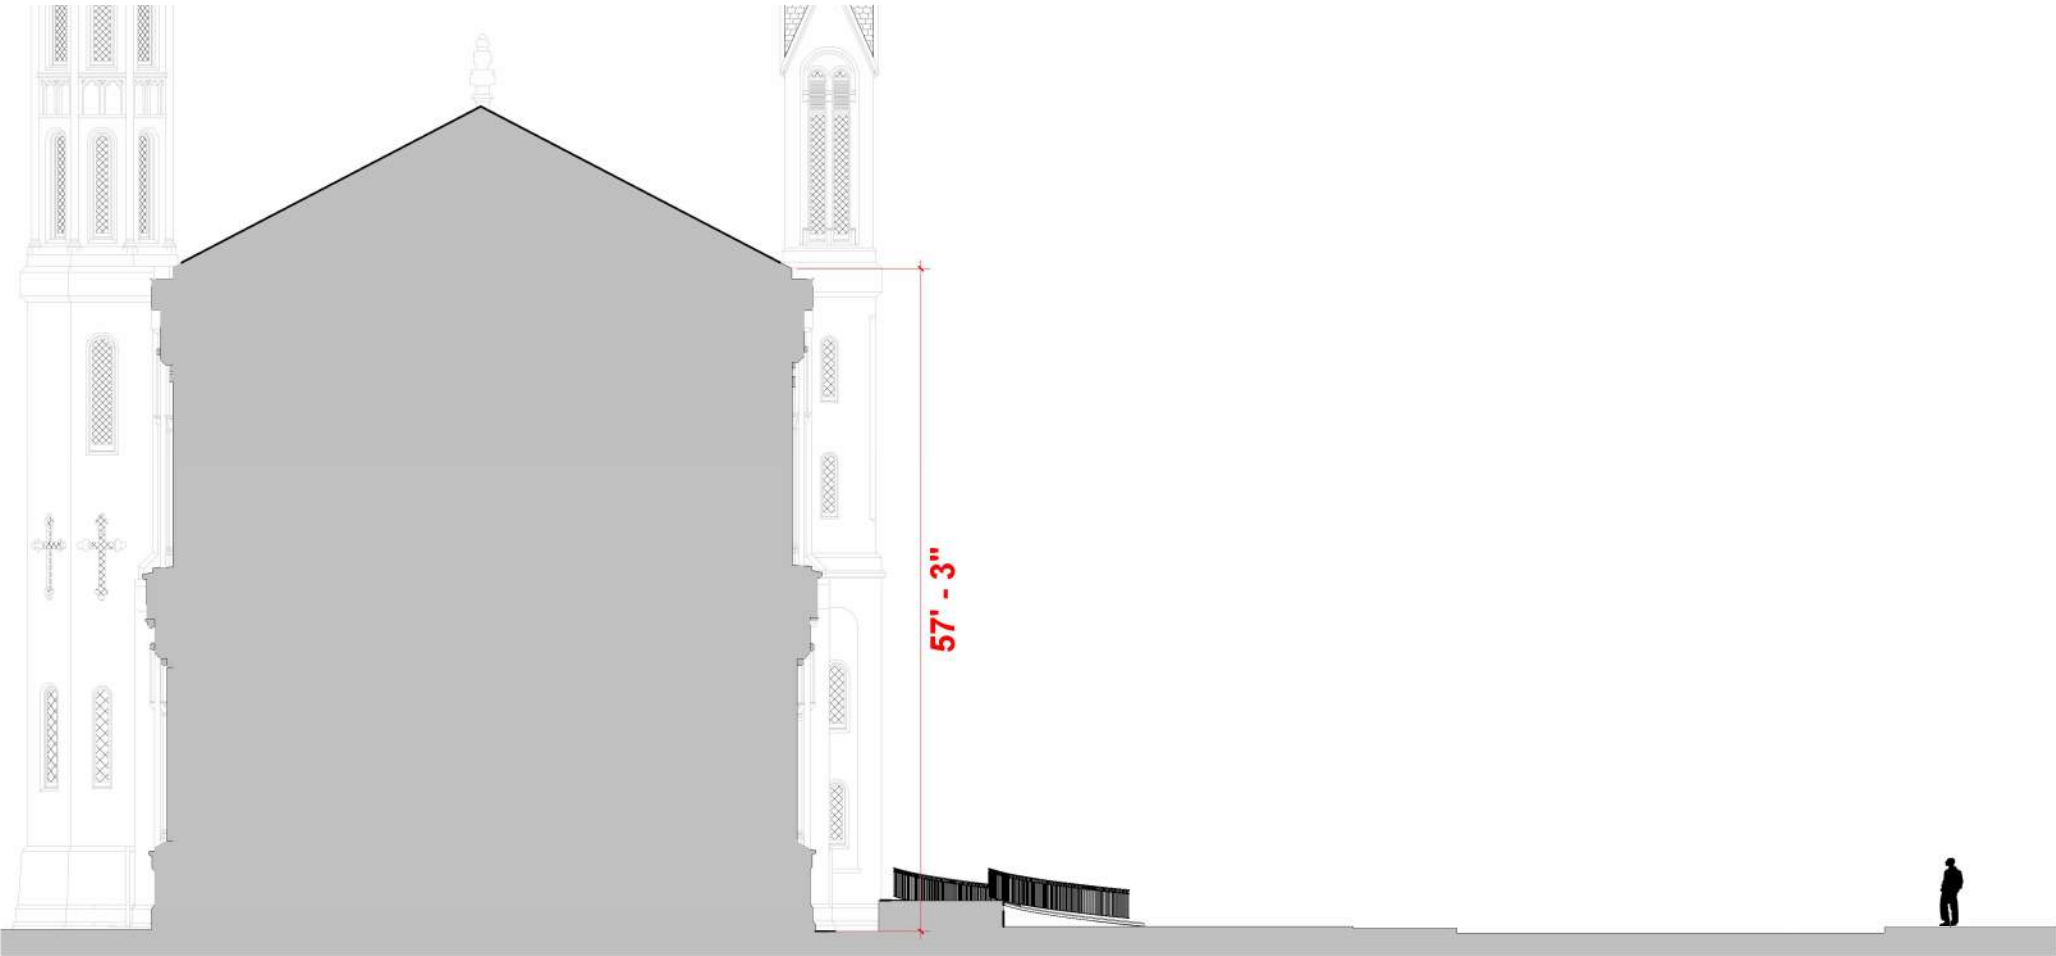
ROOF | PROPOSED SECTION

**CROSS SECTION**  
HEIGHT OF ROOF FROM GRADE

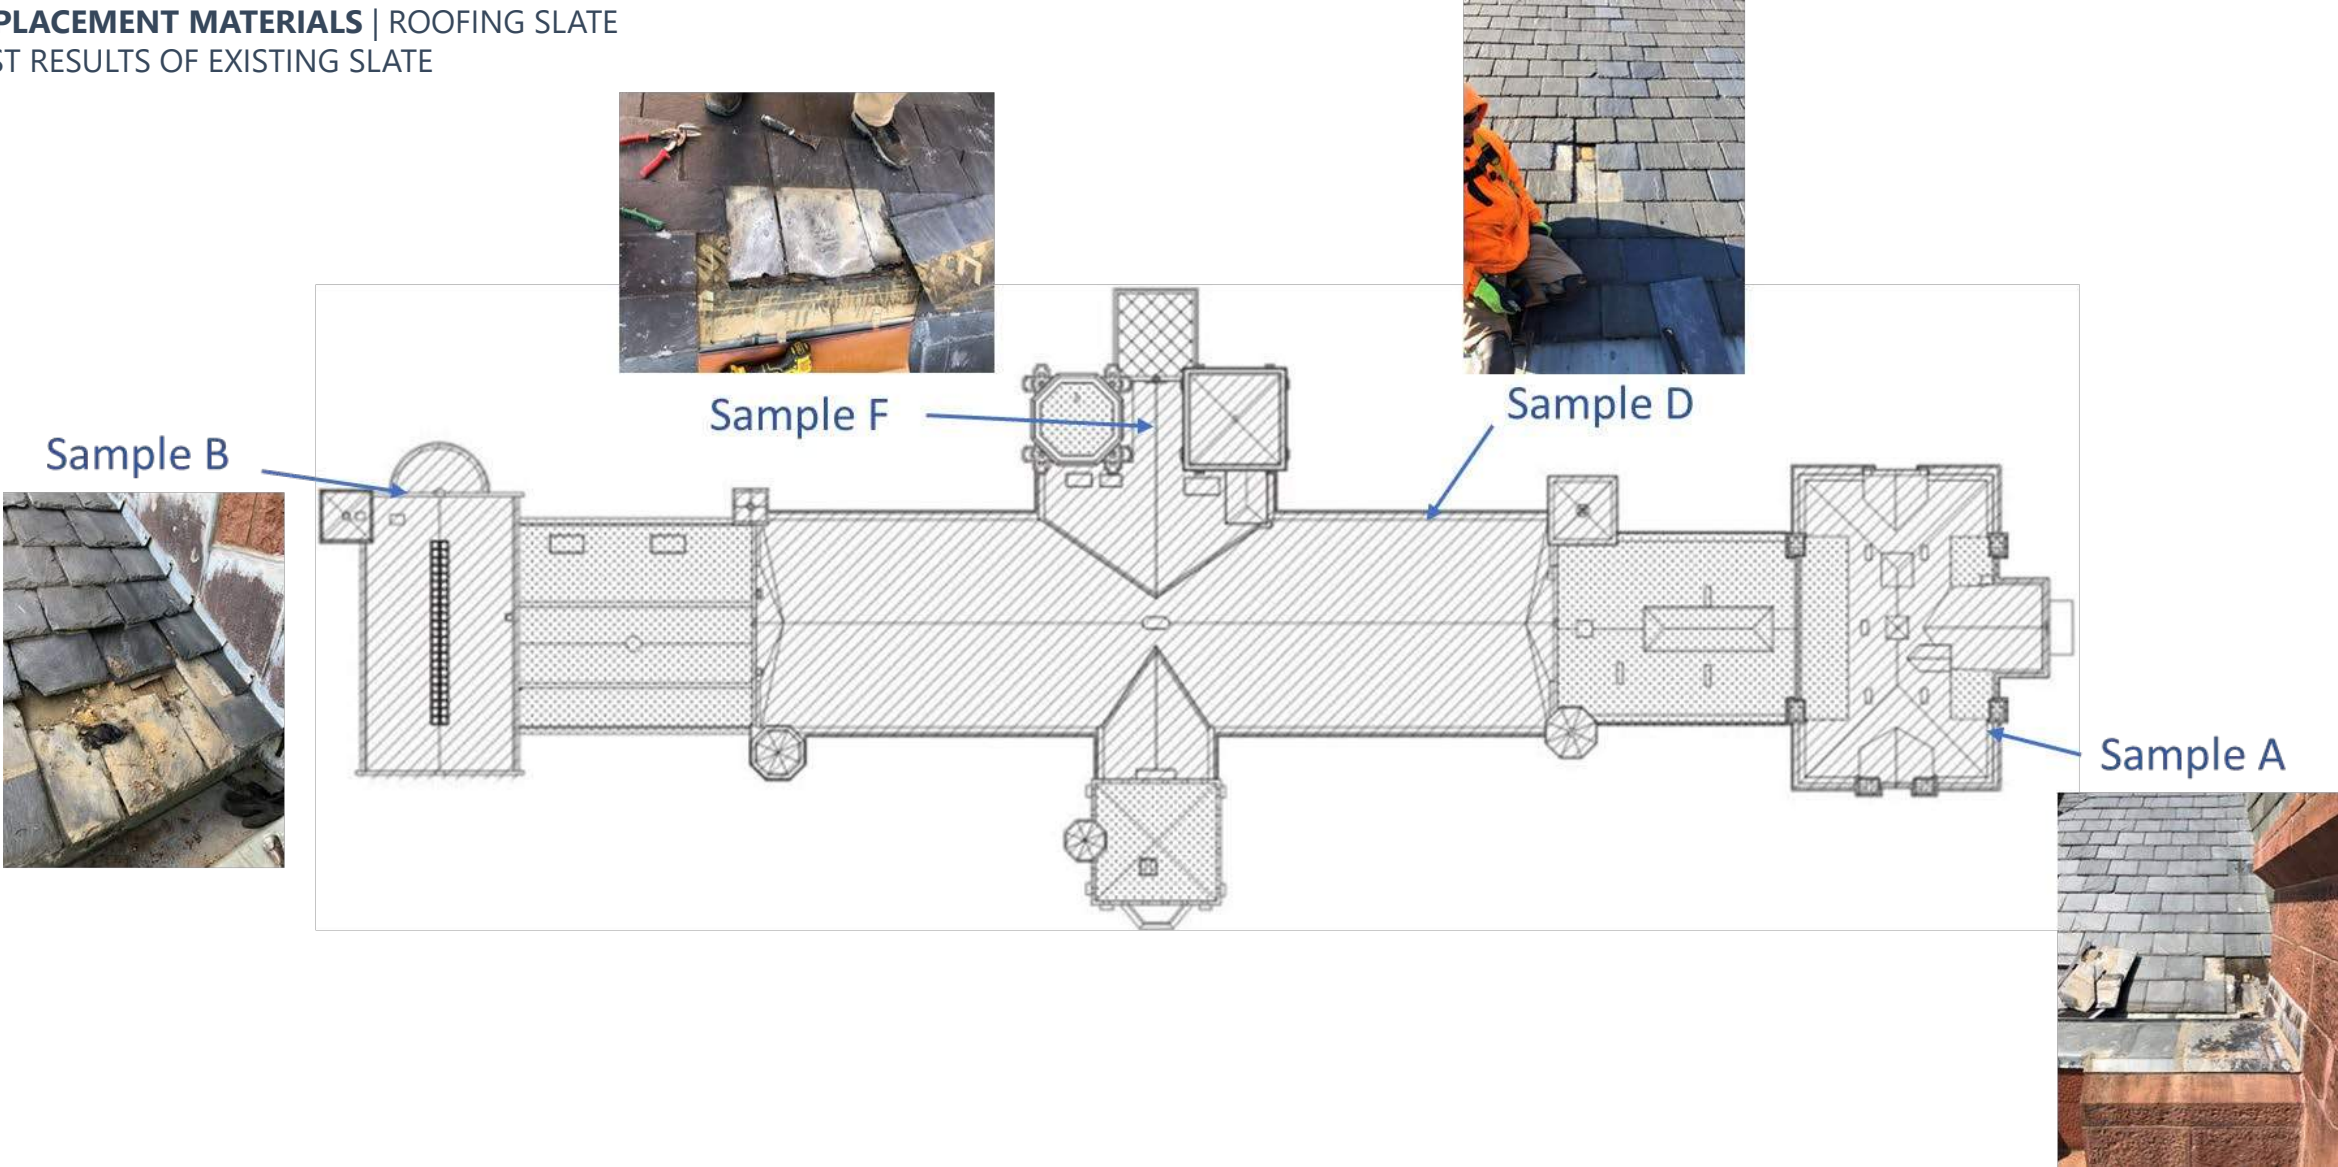
REPLACEMENT MATERIALS | ROOFING SLATE  
TEST RESULTS OF EXISTING SLATE

- Performance of existing slate varied greatly
  - 1 of 4 samples do not meet the maximum ASTM Absorption requirement (0.25%)
  - 2 of 4 samples do not meet the minimum breaking load (575 lb-force)
  - 3 out of 4 sample areas did not meet the minimum historic ASTM Modulus of Rupture requirement (9,000 psi)\*
- Due to large variation in quality and color, as well as increased risk of breakage, it is recommended that all roofing slate be replaced
- Complete replacement results in uniform color and extended surface life

ASTM C406 Requirements			Test Results of Slate from The Castle			
	Grade S1	Grade S2	Grade S3	Sample A** (East Wing)	Sample B** (West Wing)	Sample D** (Main Building)	Sample F** (Main Building)
Anticipated Service Life	Over 75 Years	40 – 75 Years	20 – 40 Years				
Absorption (% max.)	0.25	0.36	0.45	0.21	0.13	0.84	0.10
Depth of Softening (in., max.)	0.002	0.008	0.014	0.0020	0.0005	0.0004	-0.0024
Breaking Load (lb-force, min.)	575	575	575	383	716	285	663
Modulus of Rupture (psi, min.)*	9,000	9,000	9,000	7,878	7,881	4,840	11,052

\*Modulus of Rupture is no longer part of the ASTM Standard and is reported for information purposes only. The Modulus of Rupture strength requirement was replaced with a breaking load strength requirement when the standard was changed in 2005.

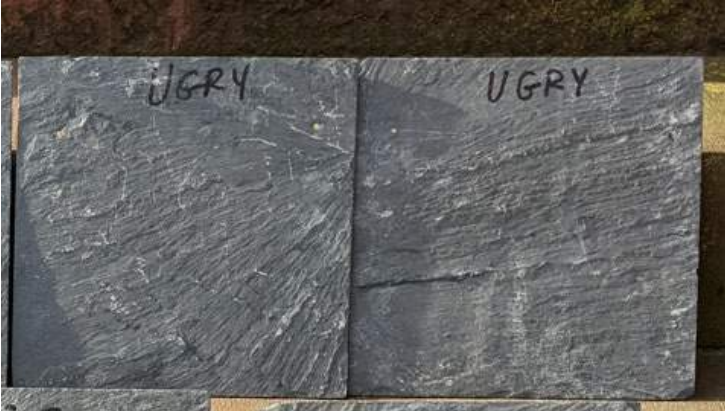
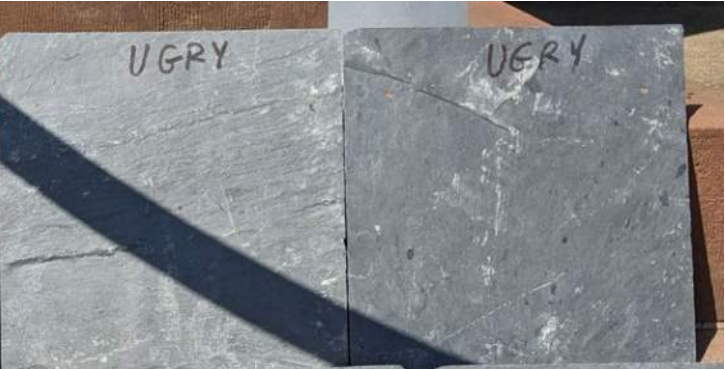
### HILLTOP SLATE

8 AM  
UPPER: **UNFADING GRAY**

12 PM  
UPPER: **UNFADING GRAY**

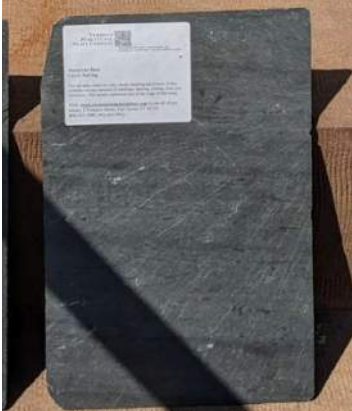
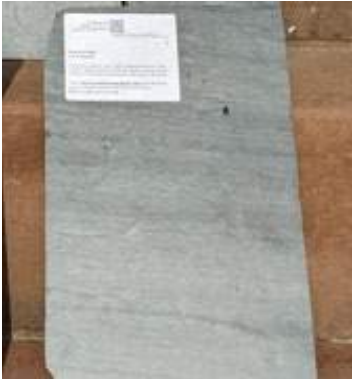
### VERMONT STRUCTURAL SLATE CO.

8 AM  
RIGHT: **HENDRICKS SLATE**

12 PM  
RIGHT: **HENDRICKS SLATE**

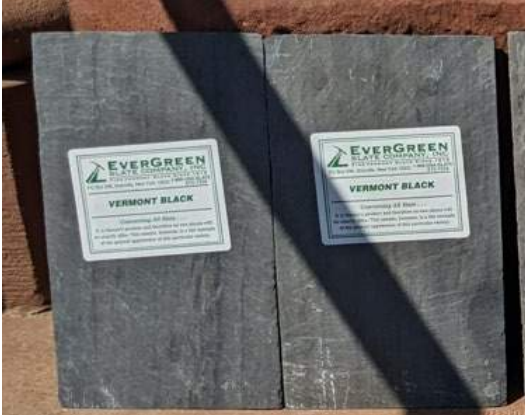
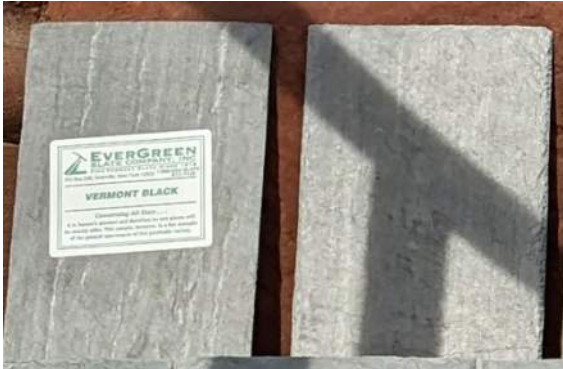
### EVERGREEN SLATE CO.

8 AM  
LEFT: **VERMONT BLACK**

12 PM  
LEFT: **VERMONT BLACK**
