Smithsonian Institution

Revitalization of the Historic Core  
**CONSULTING PARTIES MEETING #13**

May 24, 2023

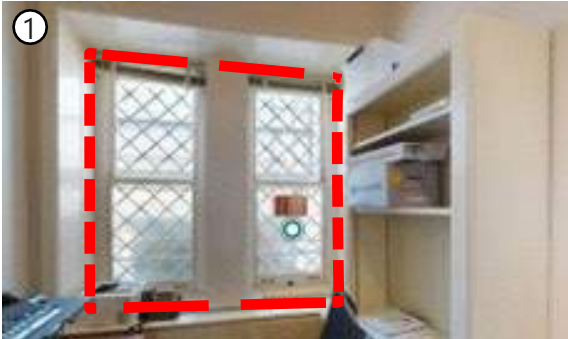
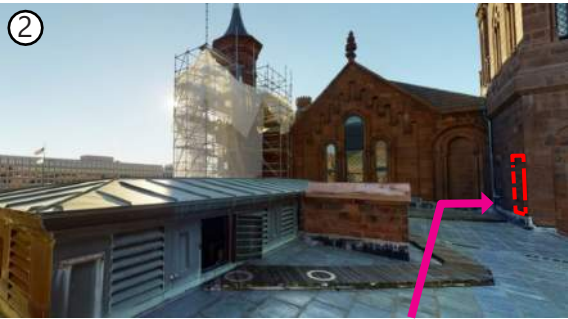
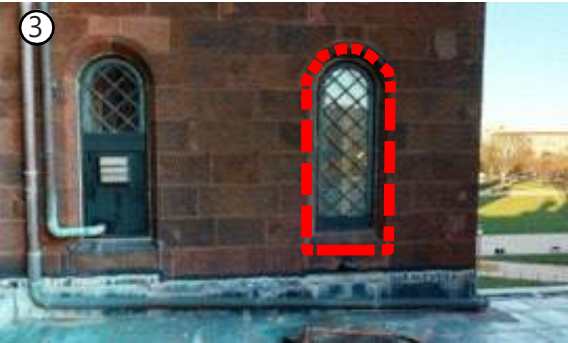
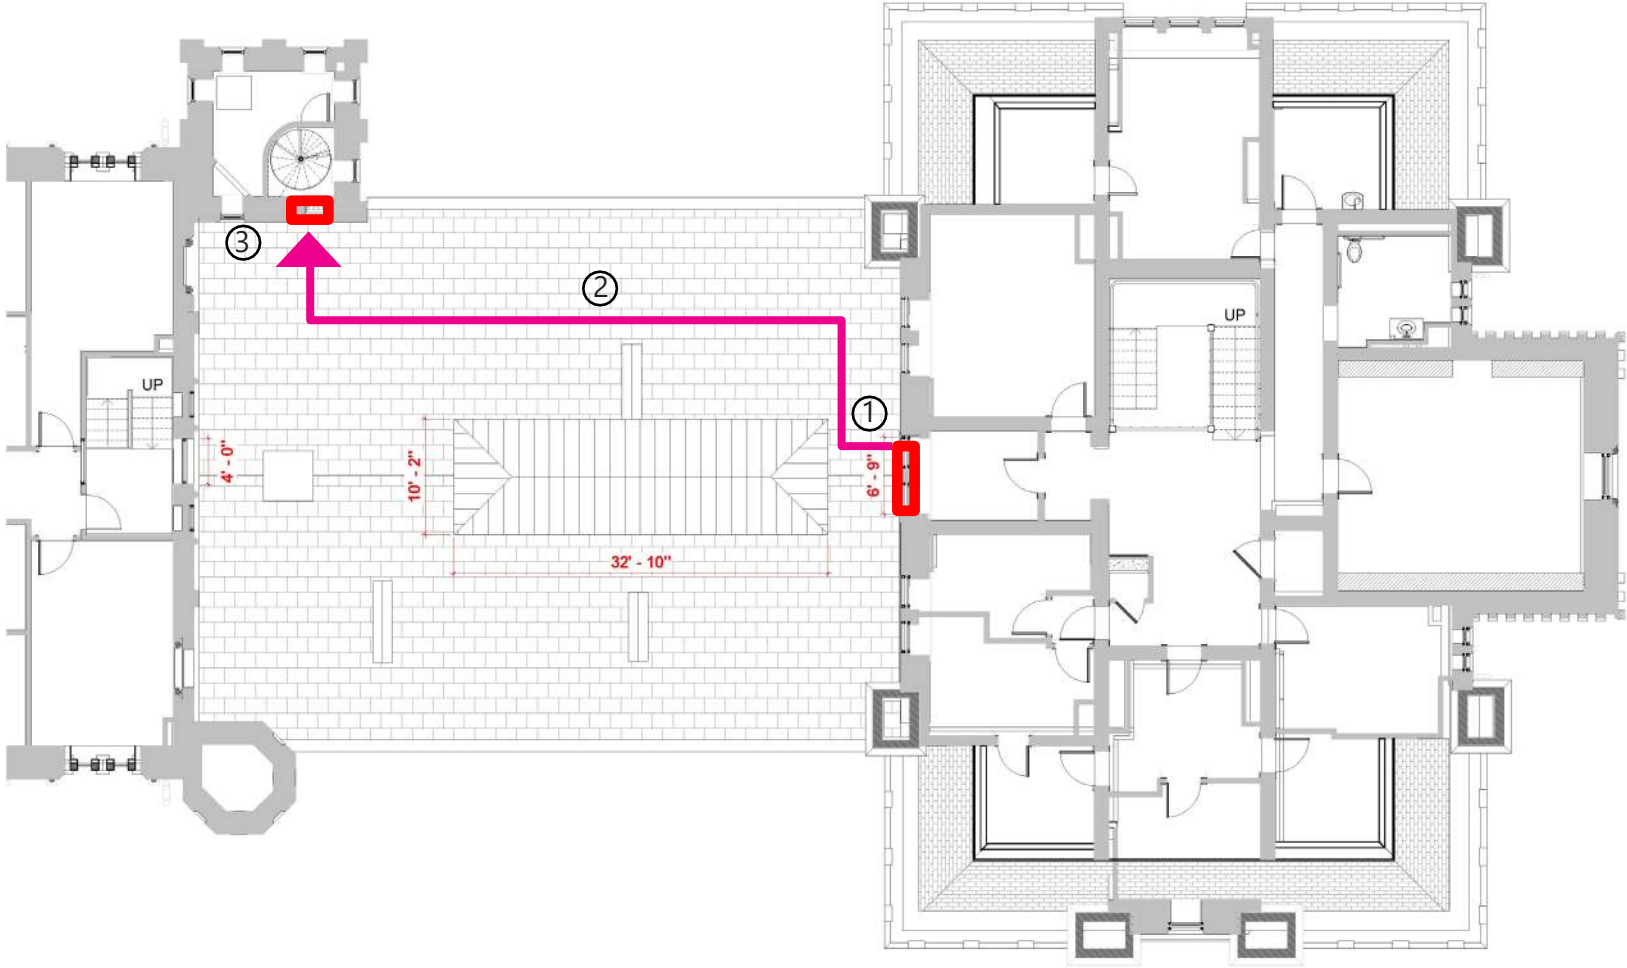
EAST RANGE  
4<sup>TH</sup> FLOOR - SECOND MEANS OF EGRESS  
EXISTING CONDITIONS

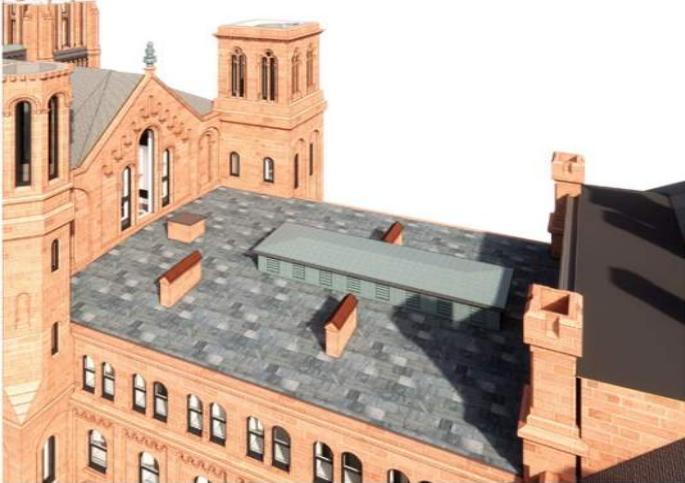
**Existing** Louvered Penthouse

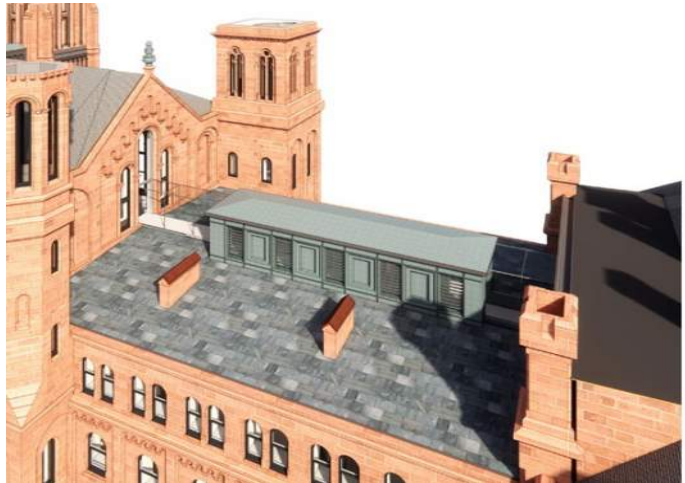
**Option 1** - Historic Rooftop Connector

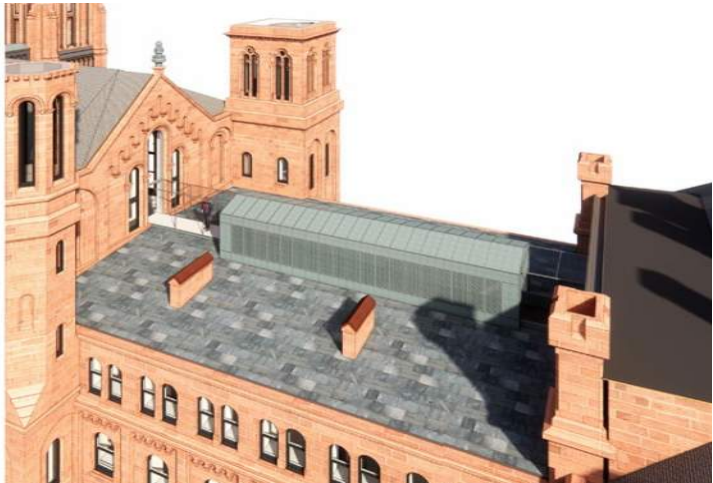
**Option 2**- Modern Rooftop Connector

*\*APPROVED BY CFA AND NCPC*

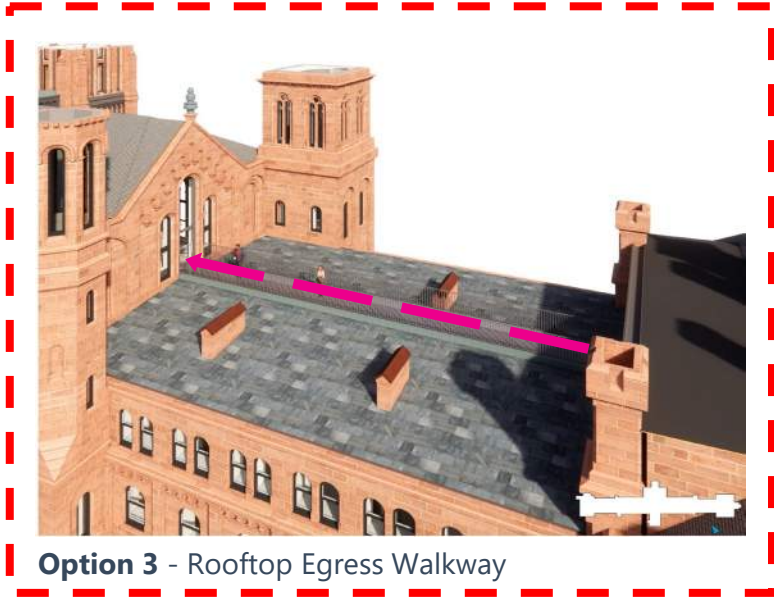
**Option 3** - Rooftop Egress Walkway

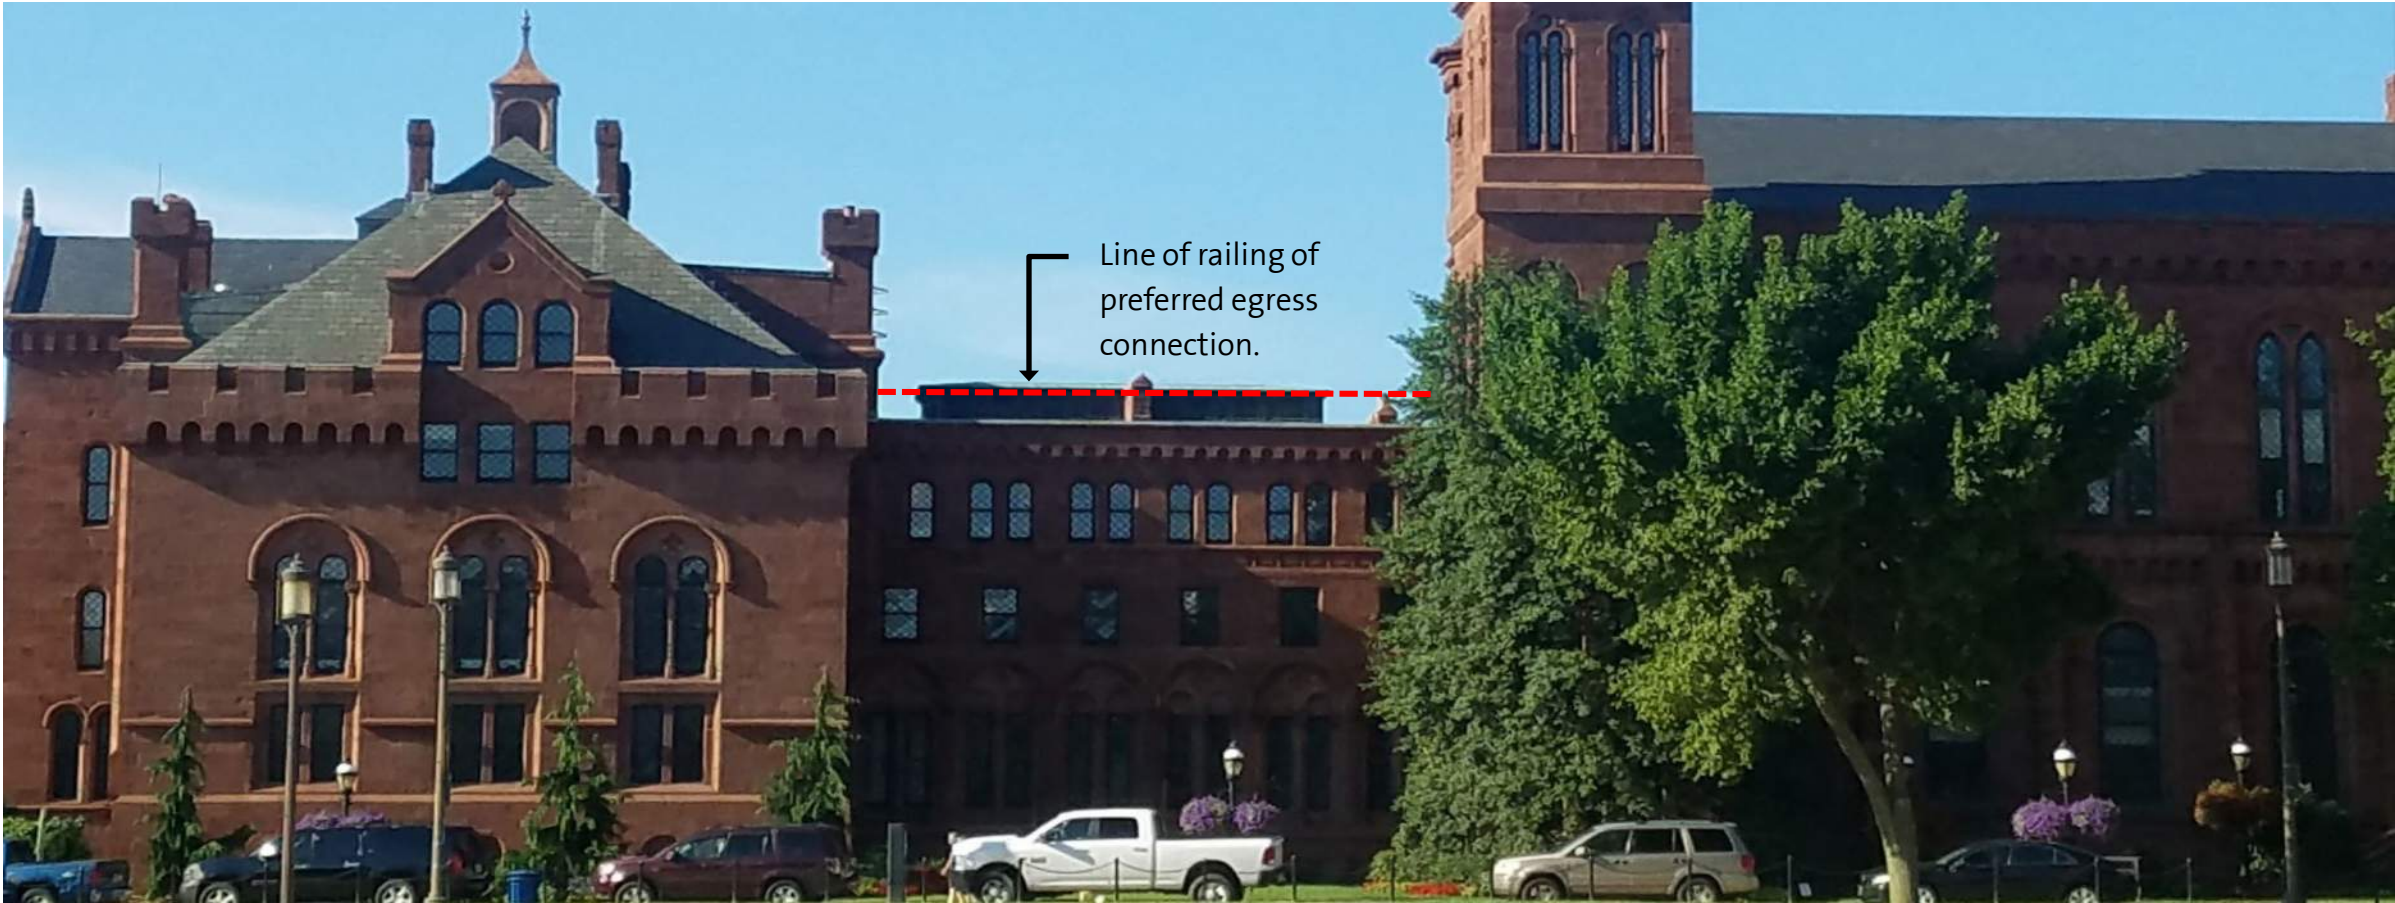
EAST RANGE  
4<sup>TH</sup> FLOOR - SECOND MEANS OF EGRESS  
UPDATED APPROACH

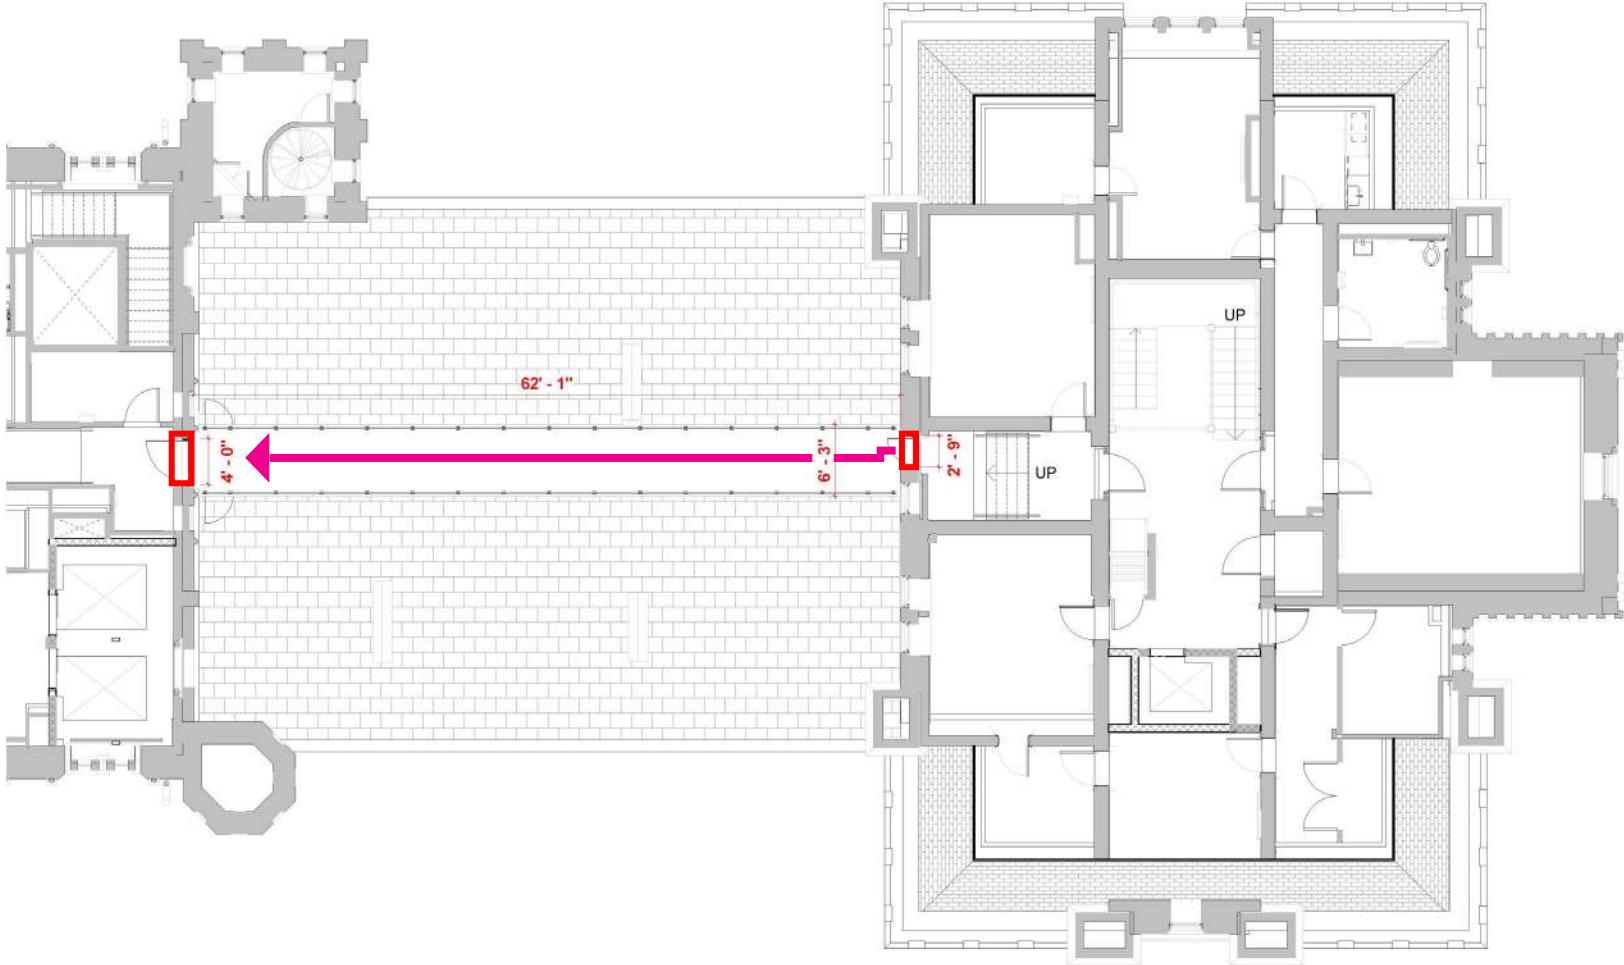
EAST RANGE  
4<sup>TH</sup> FLOOR - SECOND MEANS OF EGRESS  
PROPOSED PLAN

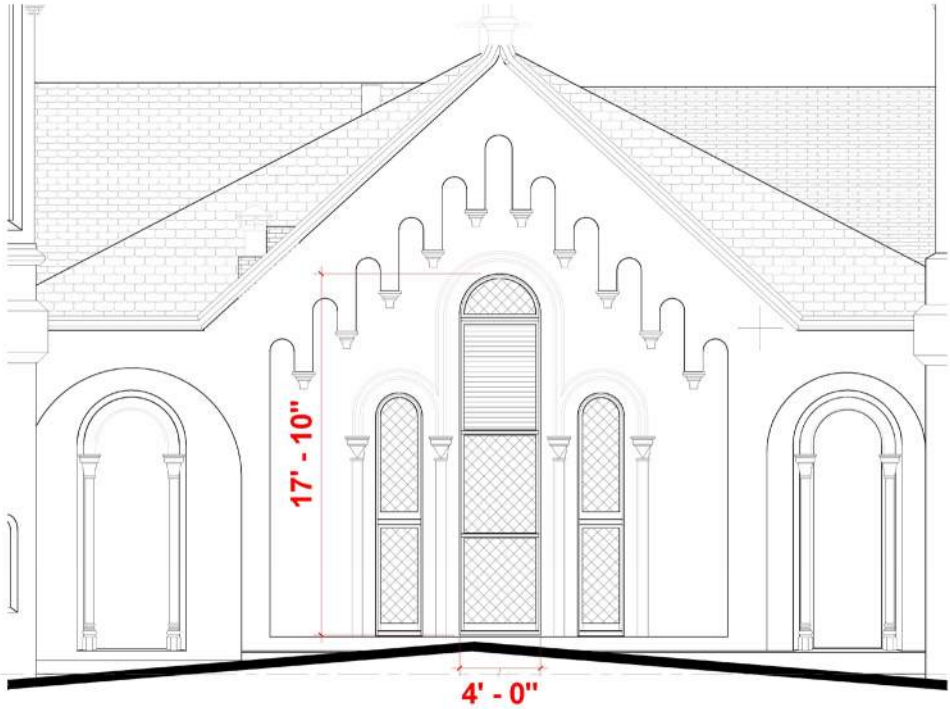
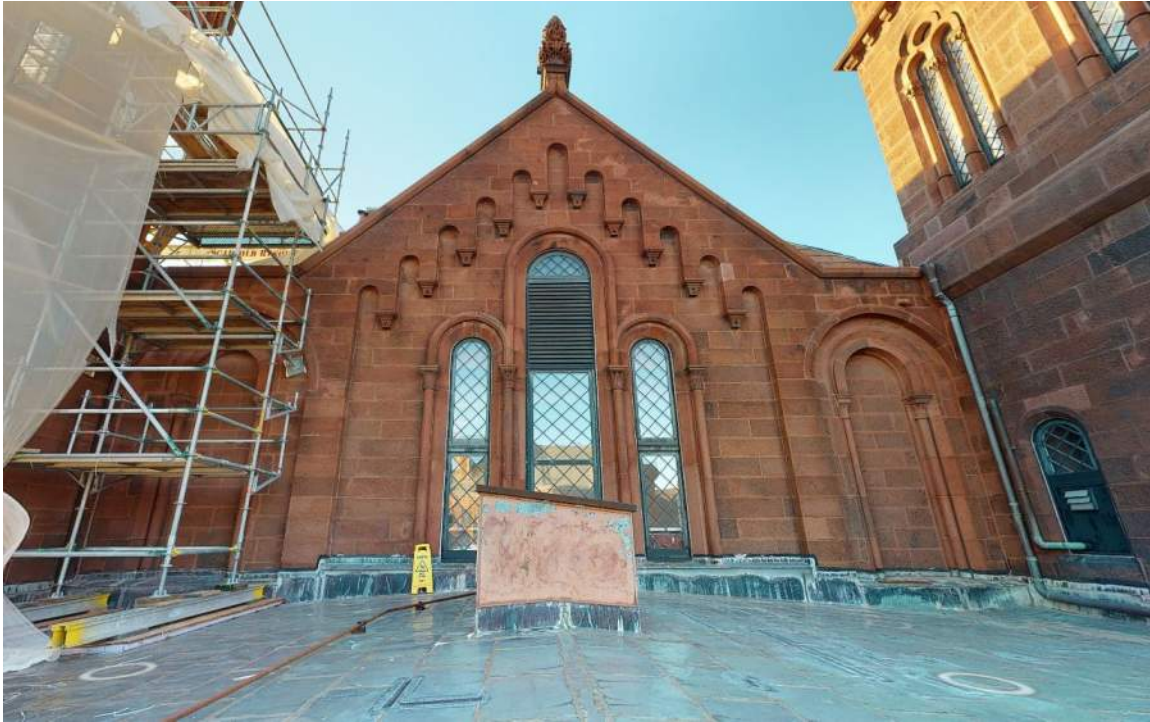
EAST RANGE  
4<sup>TH</sup> FLOOR - SECOND MEANS OF EGRESS  
MAIN BUILDING ELEVATION (EAST)  
INSERTION OF DOOR AT EXISTING WINDOW

SIB-LEVEL 4 EAST WING  
21671  
71' - 1 1/4"

EXISTING

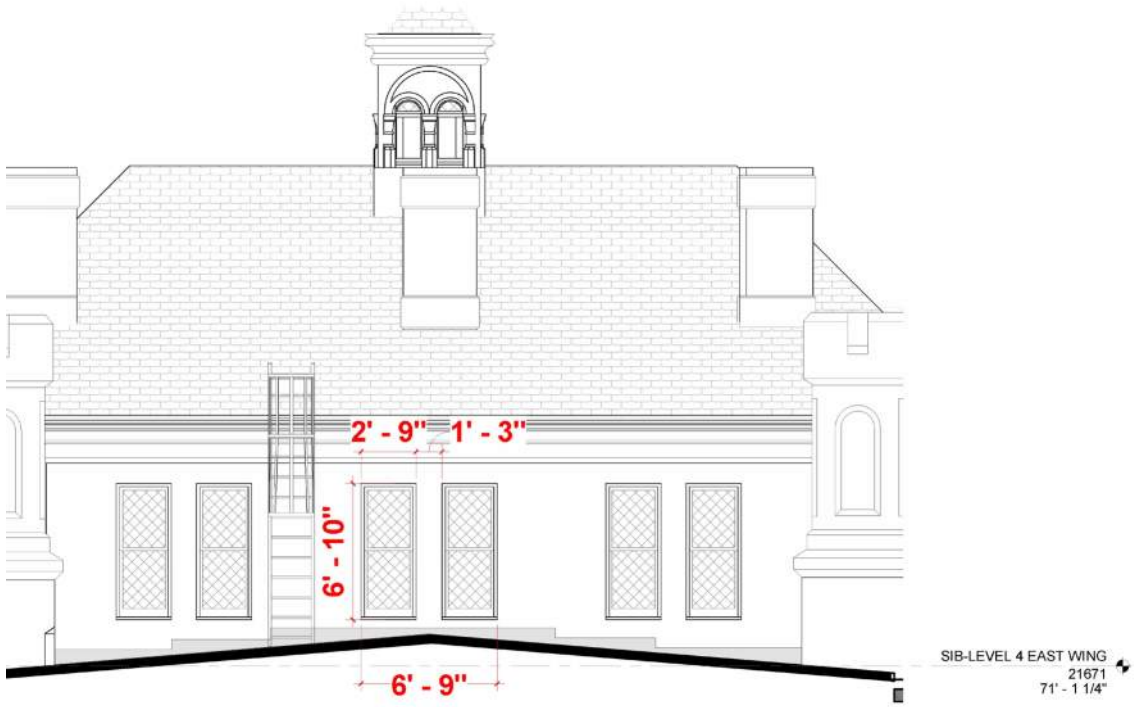
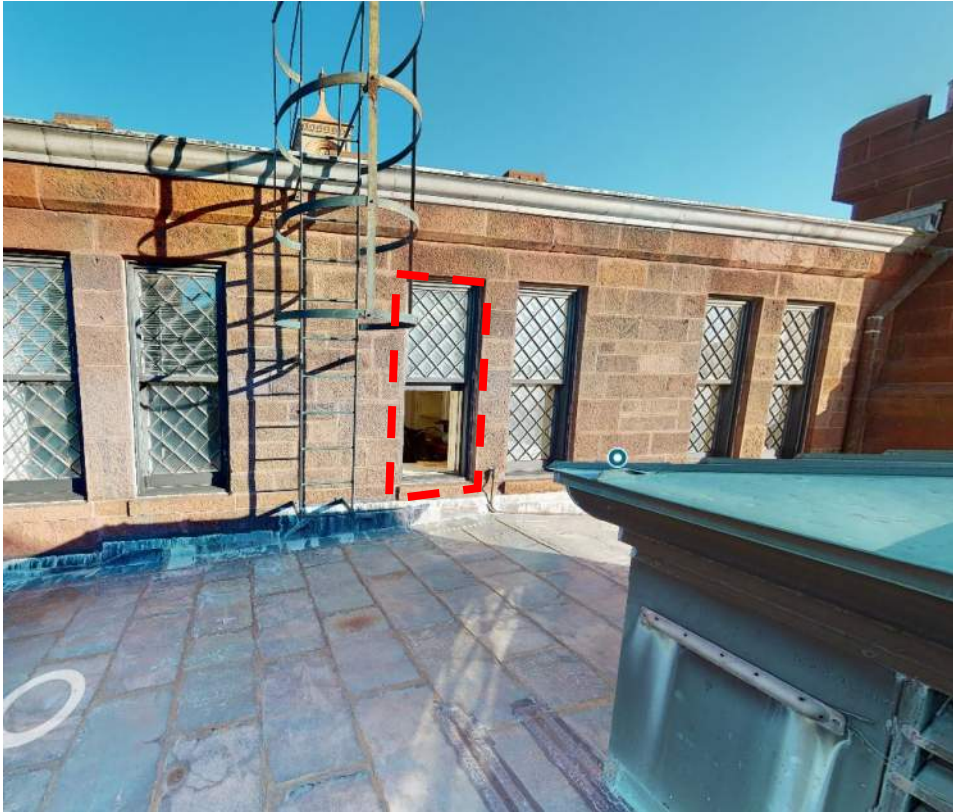
EAST WING ELEVATION (WEST)

INSERTION OF DOOR IN EXISTING WINDOW OPENING

EXISTING

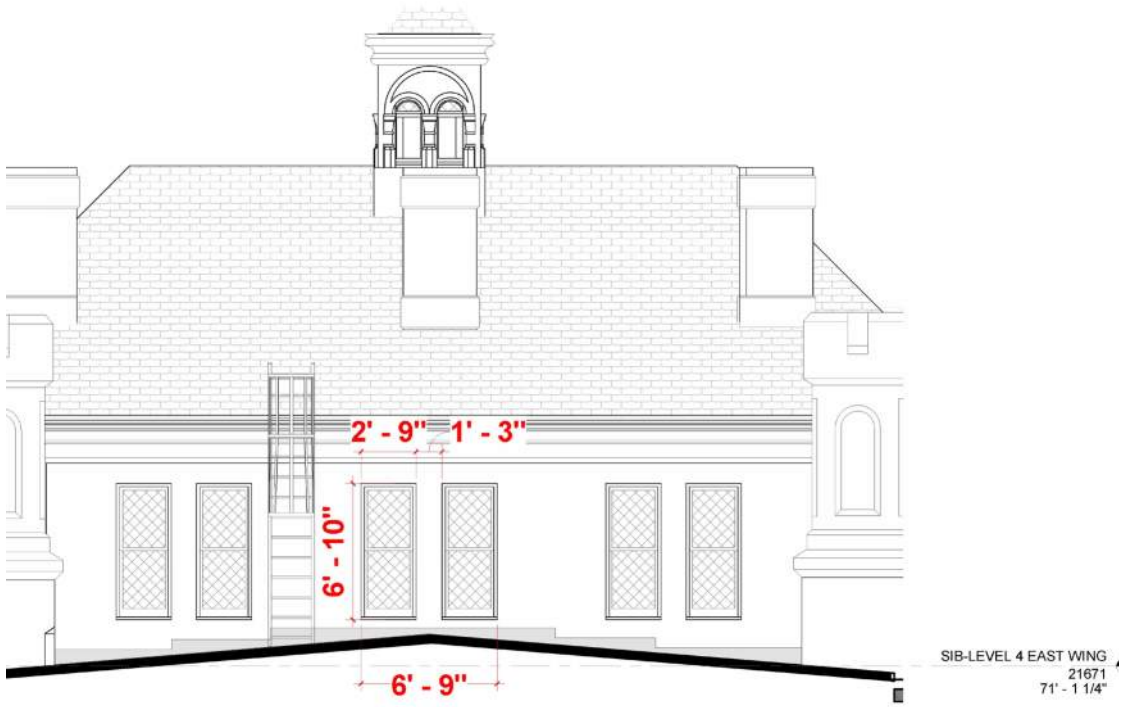
EAST WING ELEVATION (WEST)

INSERTION OF DOOR IN EXISTING WINDOW OPENING

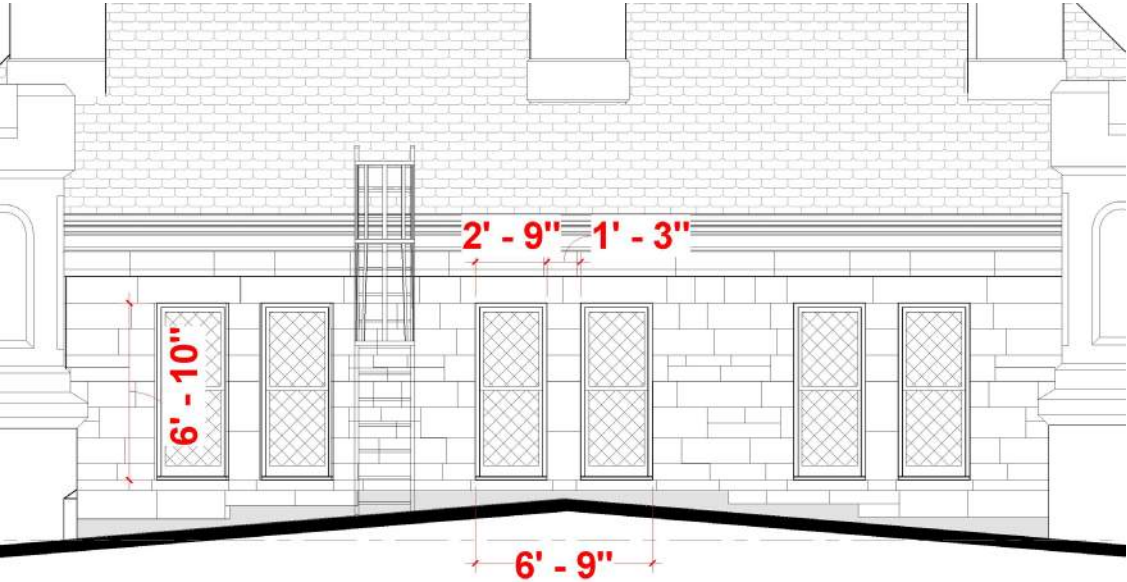
**EAST RANGE**  
**4<sup>TH</sup> FLOOR - SECOND MEANS OF EGRESS**  
 ELEVATIONS – MASONRY ALTERATIONS

- EXISTING SENECA SANDSTONE UNIT
- EXISTING FLASHING

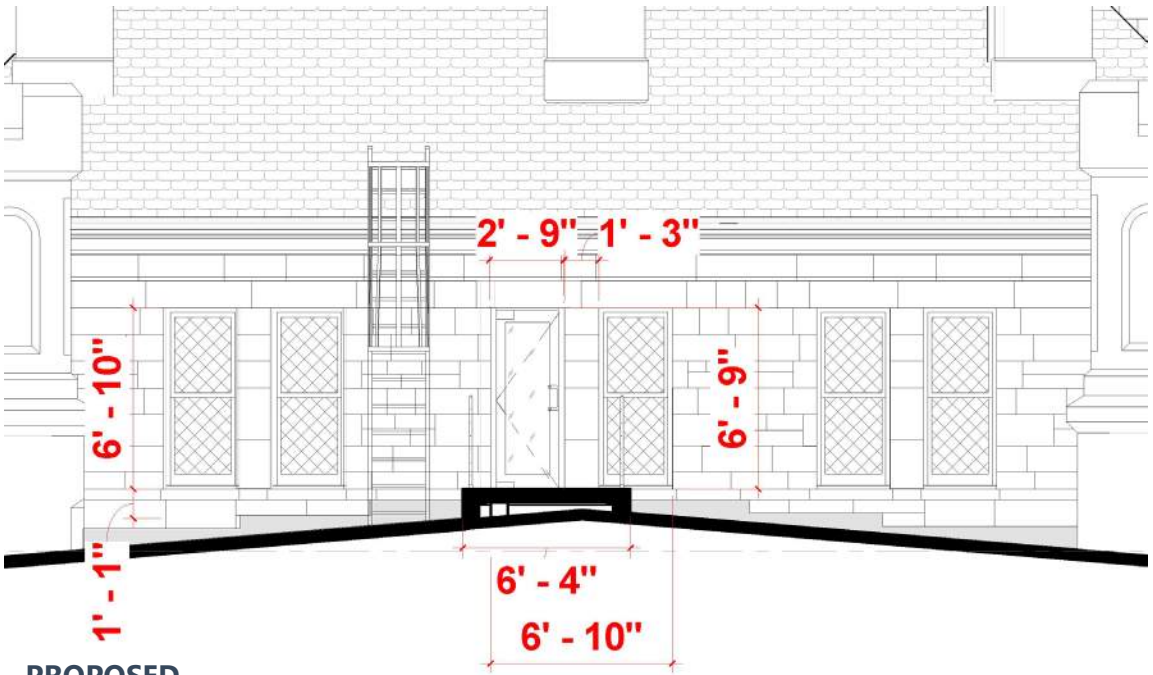
PROPOSED

\*NO ALTERATION TO HISTORIC SANDSTONE

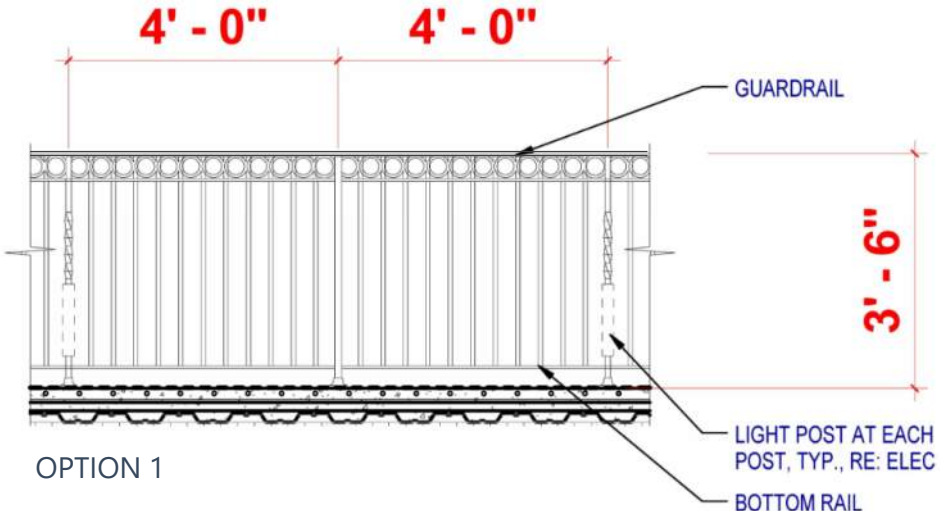
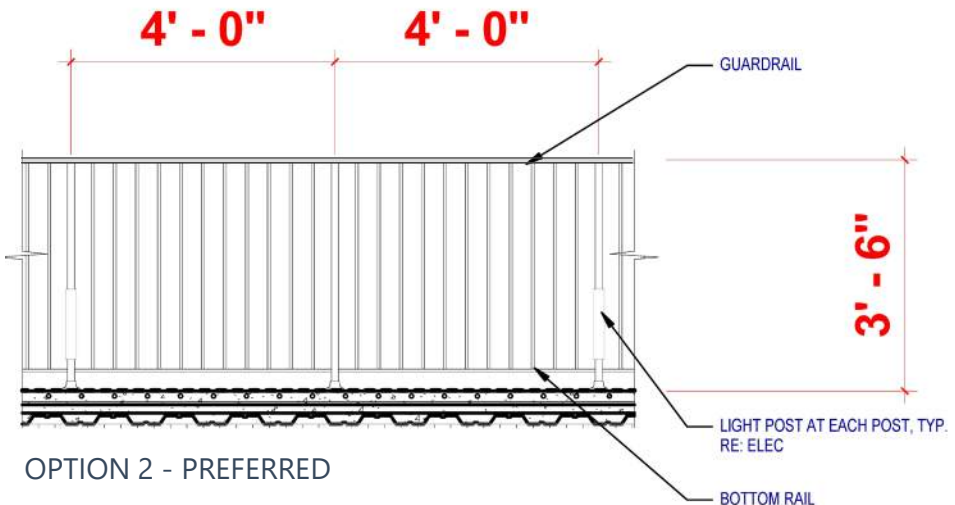
INTEGRATED LIGHT POST  
\*LIGHTING ON EMERGENCY CIRCUIT ONLY

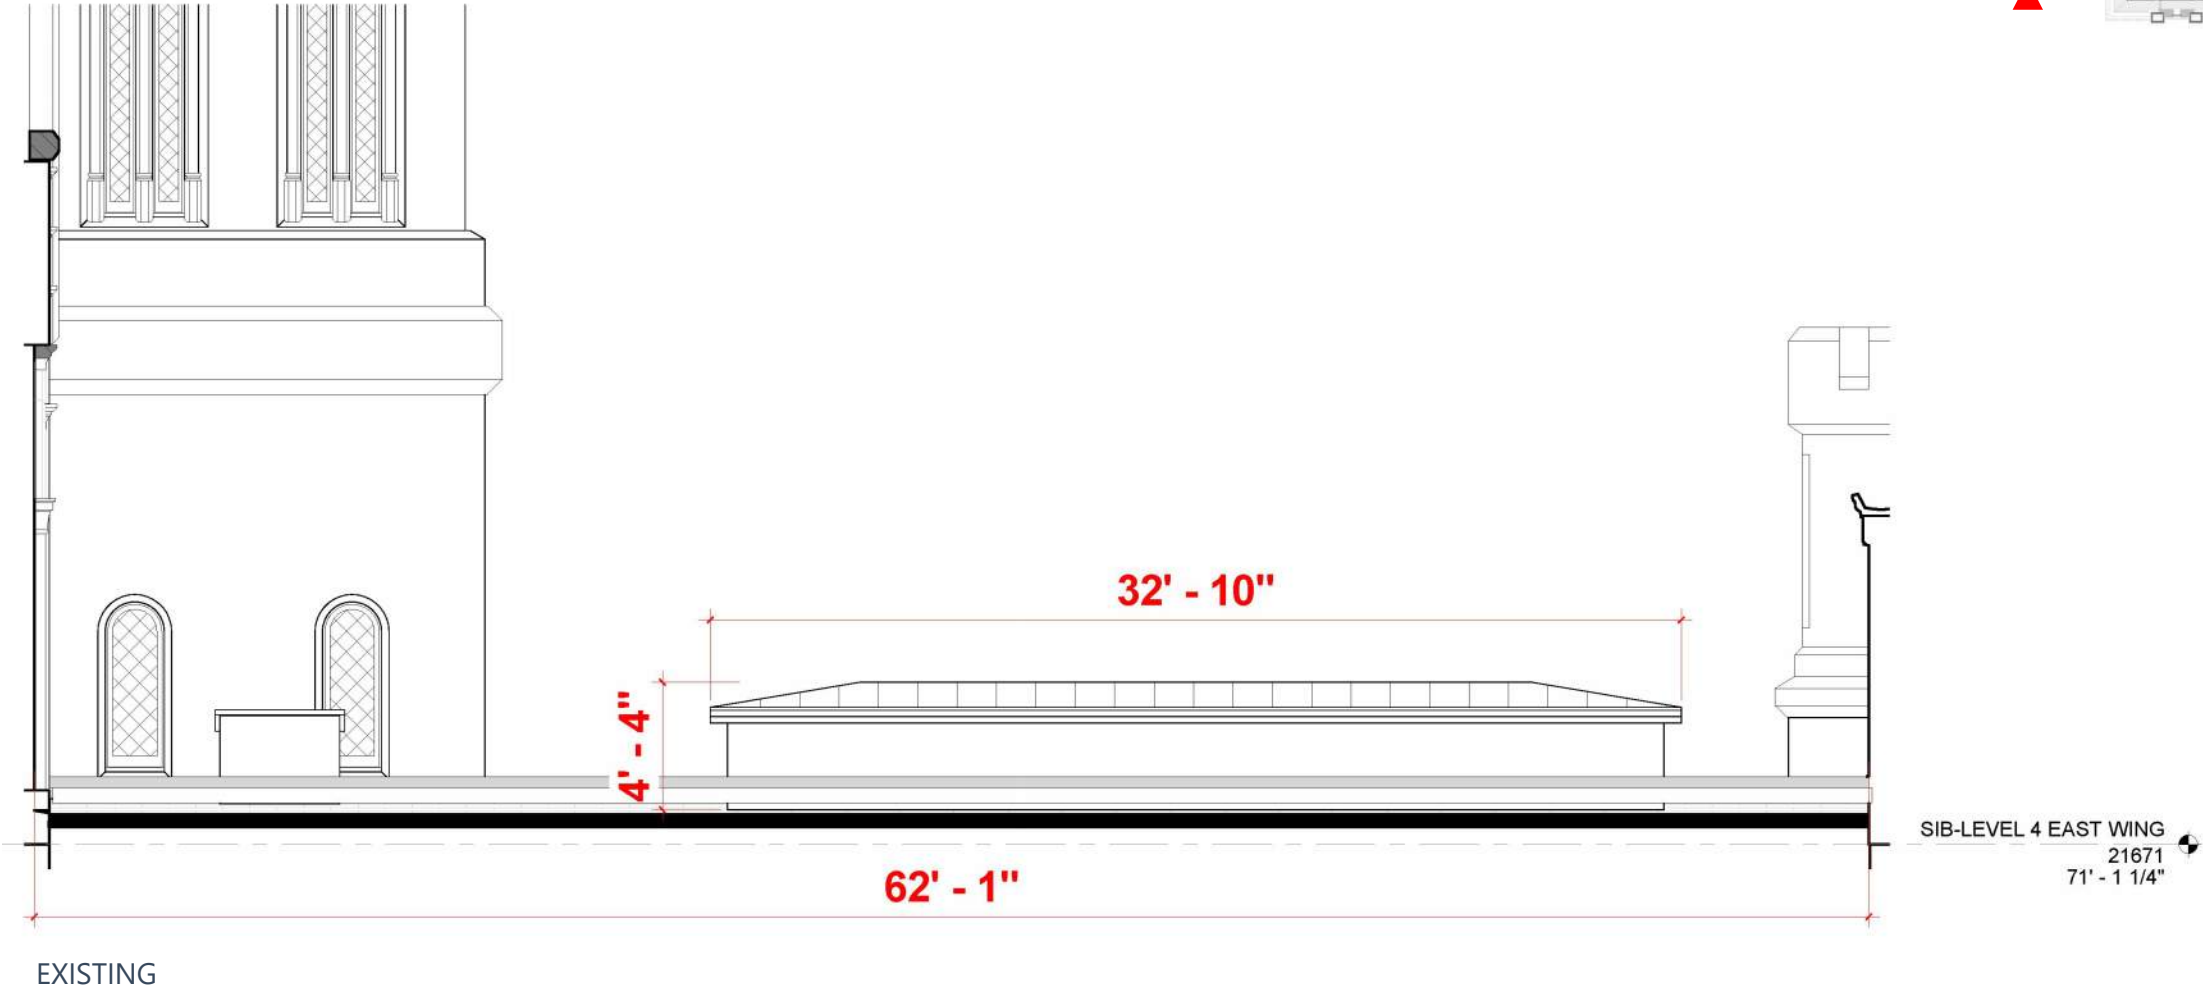
EAST RANGE  
4<sup>TH</sup> FLOOR - SECOND MEANS OF EGRESS  
EXISTING ELEVATION

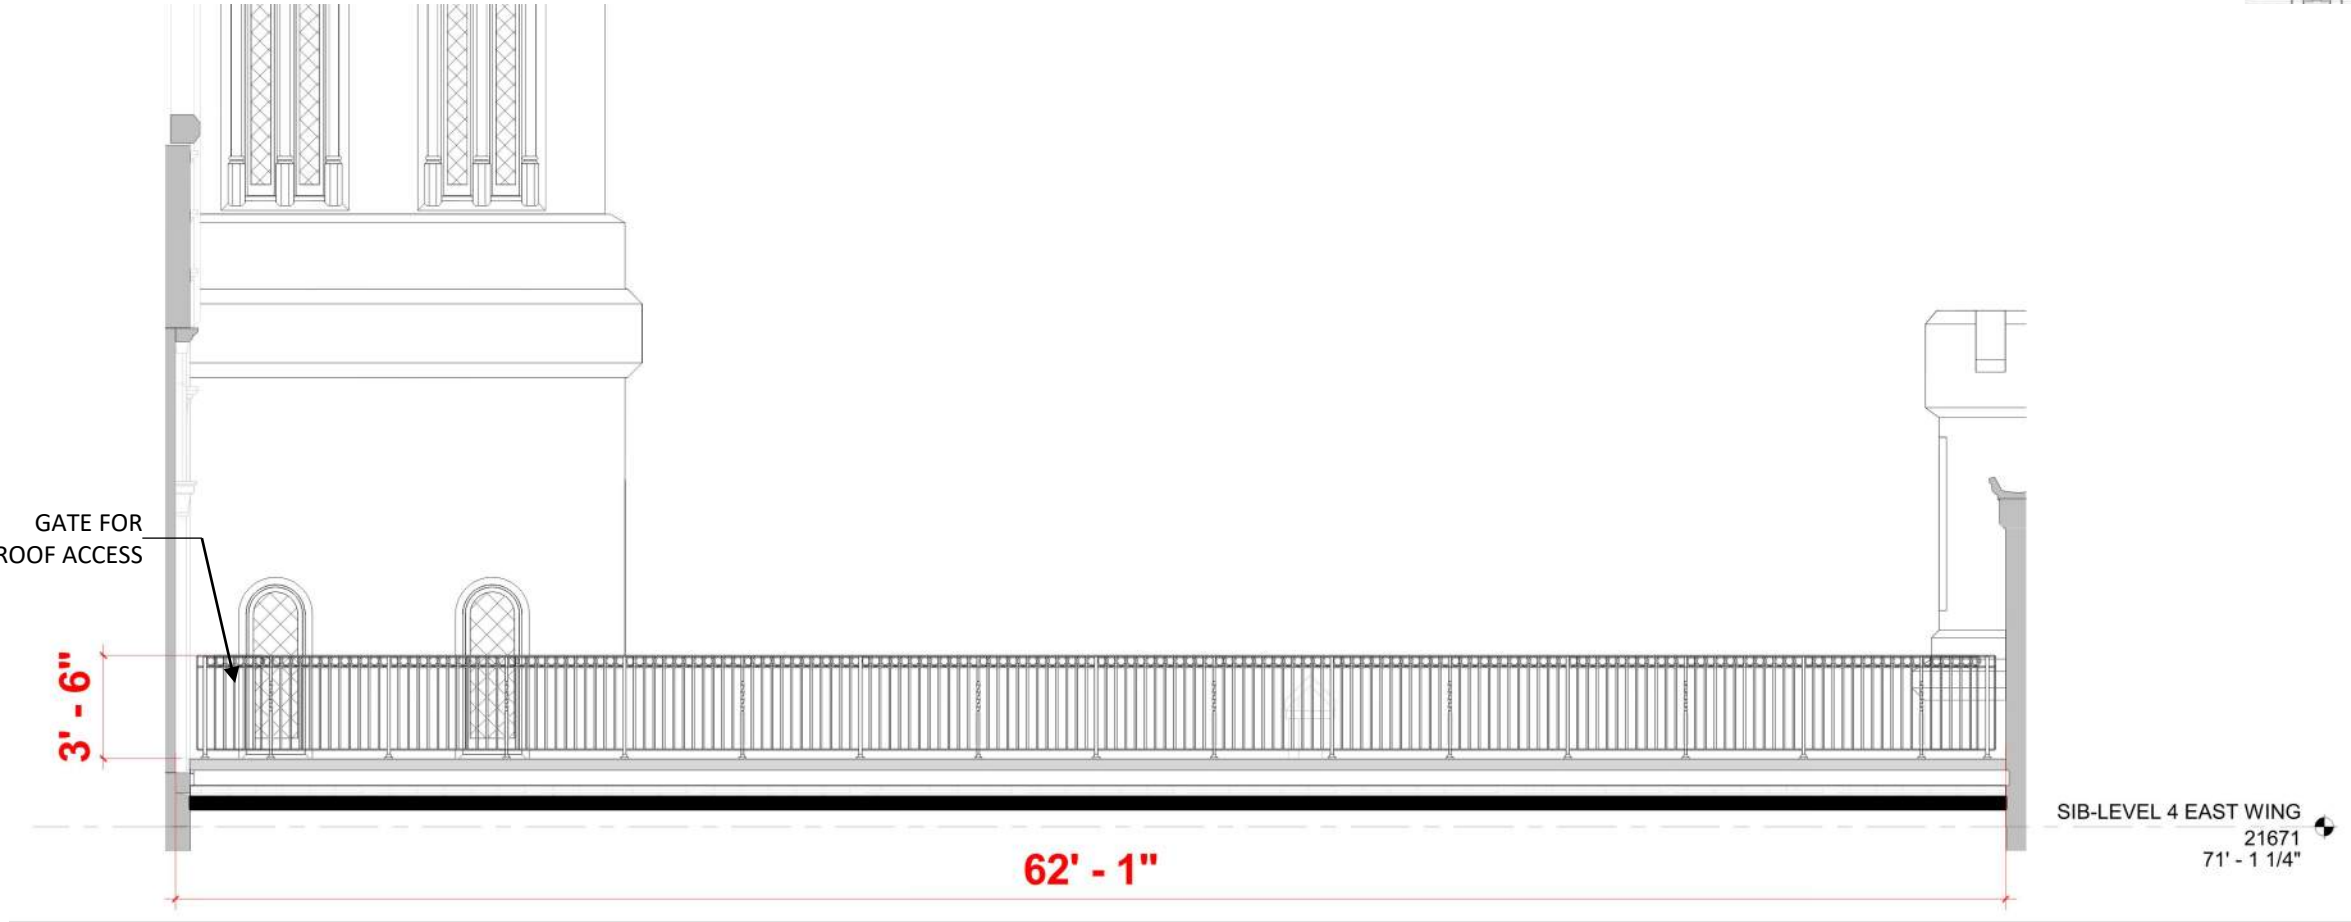
ELEVATION – OPTION 1

EAST RANGE  
4<sup>TH</sup> FLOOR - SECOND MEANS OF EGRESS  
PROPOSED ELEVATION  
OPTION 1

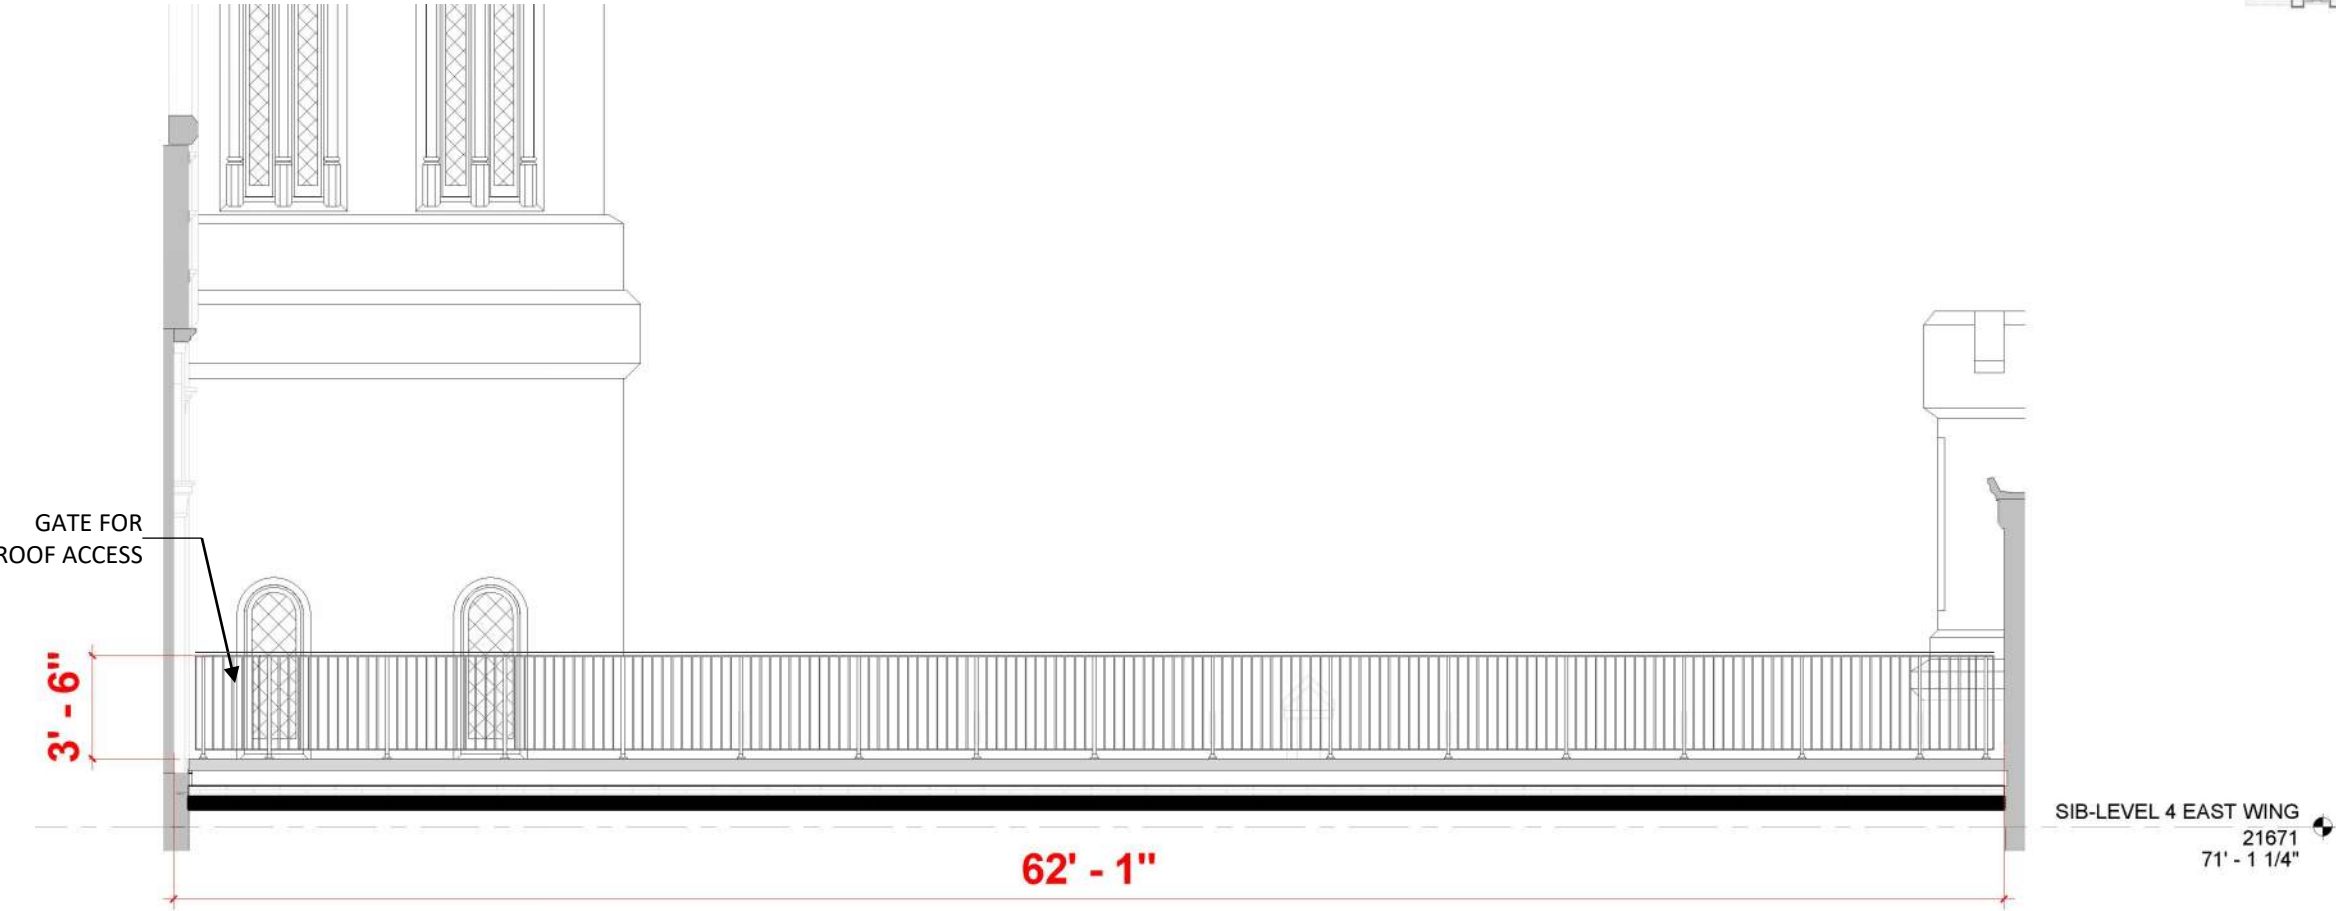
ELEVATION - OPTION 2

EAST RANGE  
4<sup>TH</sup> FLOOR - SECOND MEANS OF EGRESS  
PROPOSED ELEVATION  
OPTION 2 - PREFERRED

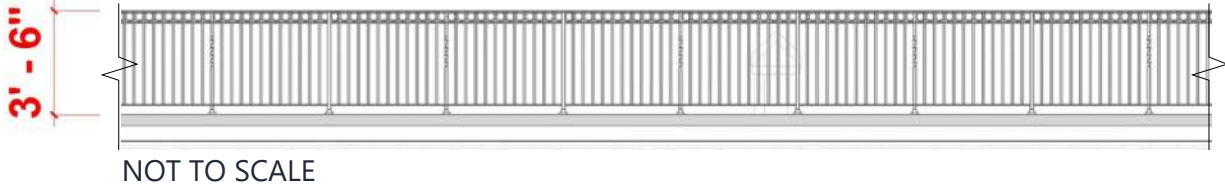
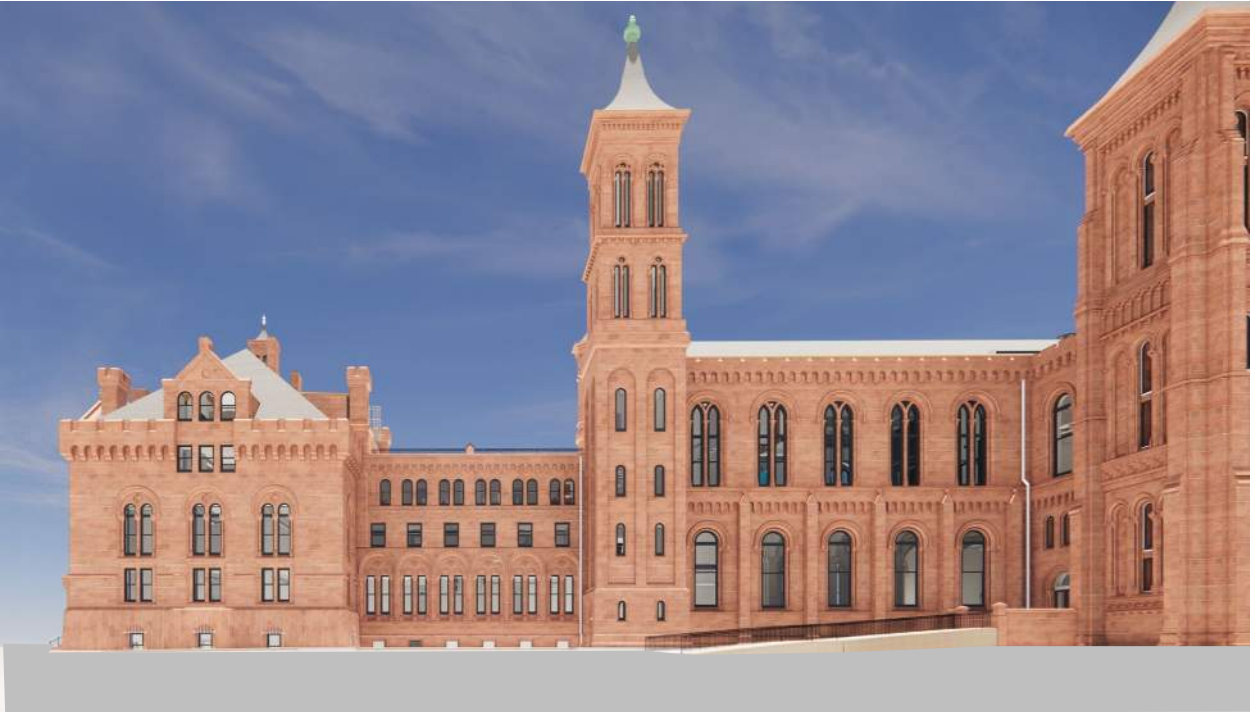
EAST RANGE  
4<sup>TH</sup> FLOOR - SECOND MEANS OF EGRESS  
RAILING DESIGN  
OPTION 1

VIEW FROM NATIONAL MALL

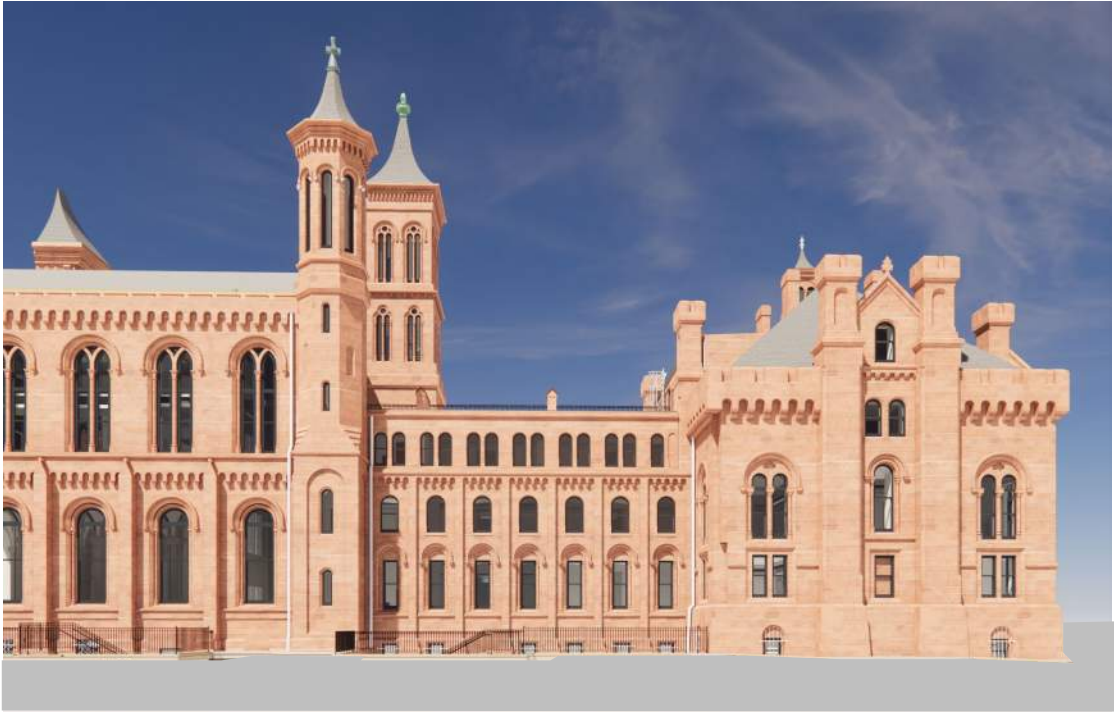
VIEW FROM HAUPT GARDEN
