Smithsonian Institution

Revitalization of the Historic Core  
**CONSULTING PARTIES MEETING #13**

May 24, 2023

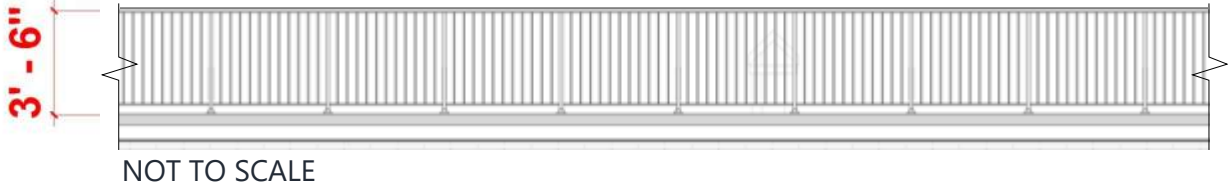
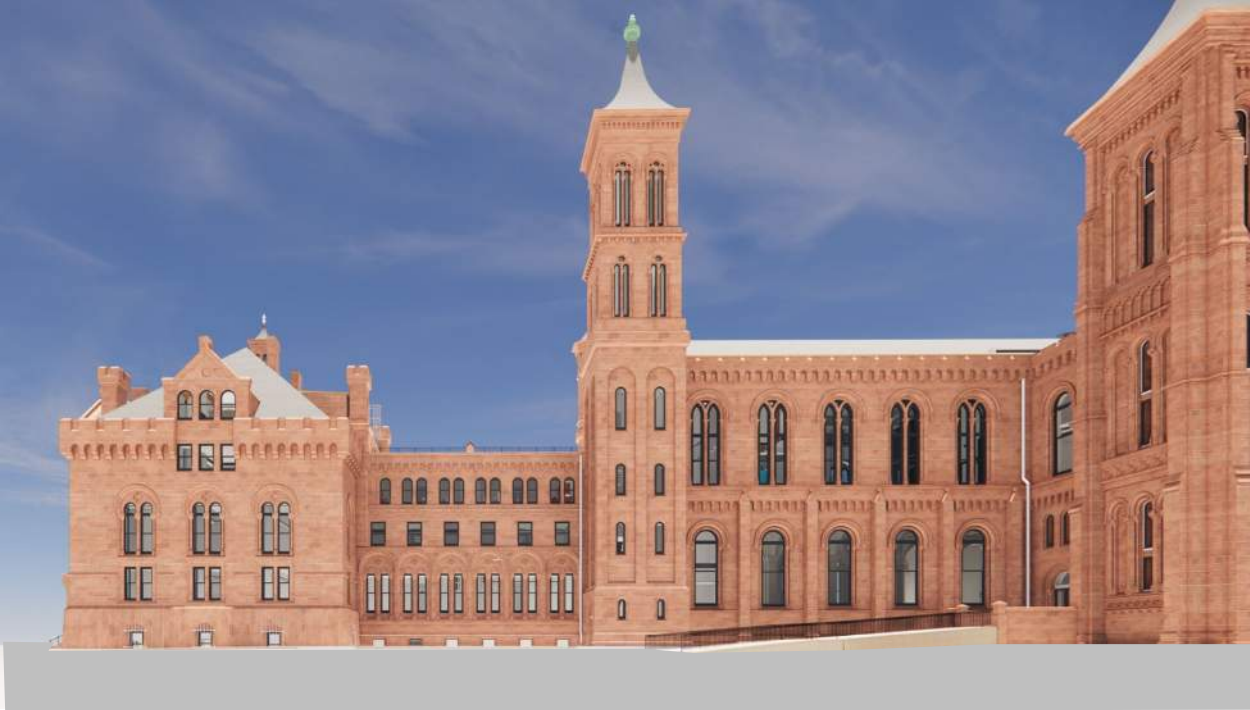
EAST RANGE  
4<sup>TH</sup> FLOOR - SECOND MEANS OF EGRESS  
RAILING DESIGN  
OPTION 2 - PREFERRED

VIEW FROM NATIONAL MALL

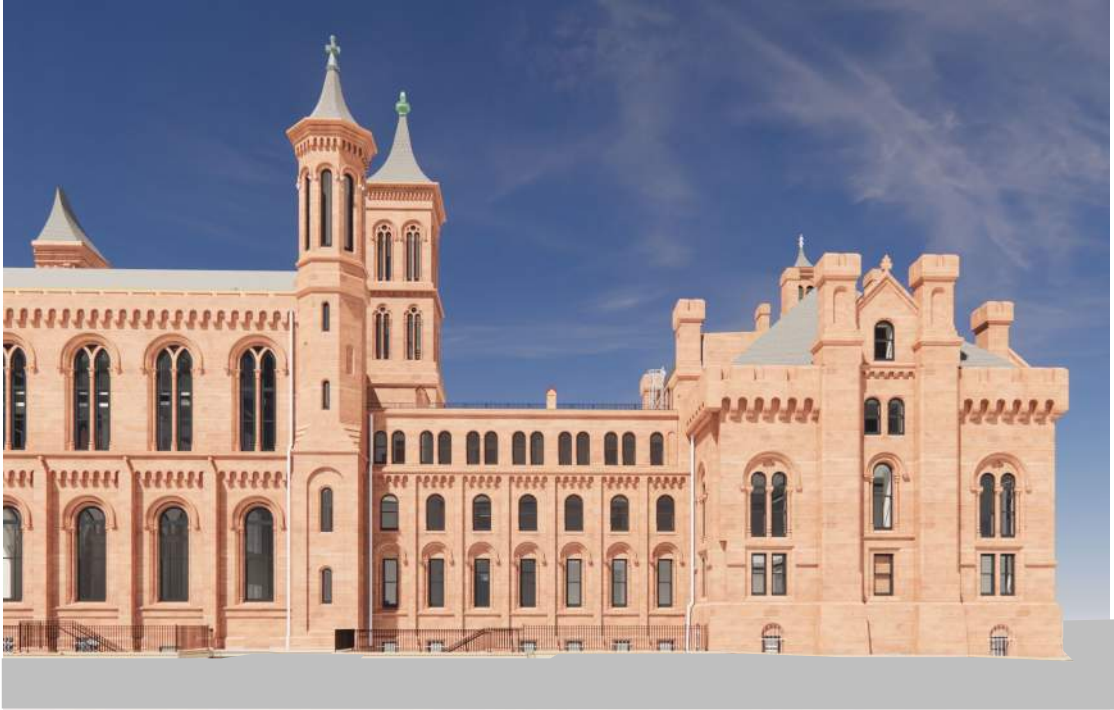
VIEW FROM HAUPT GARDEN

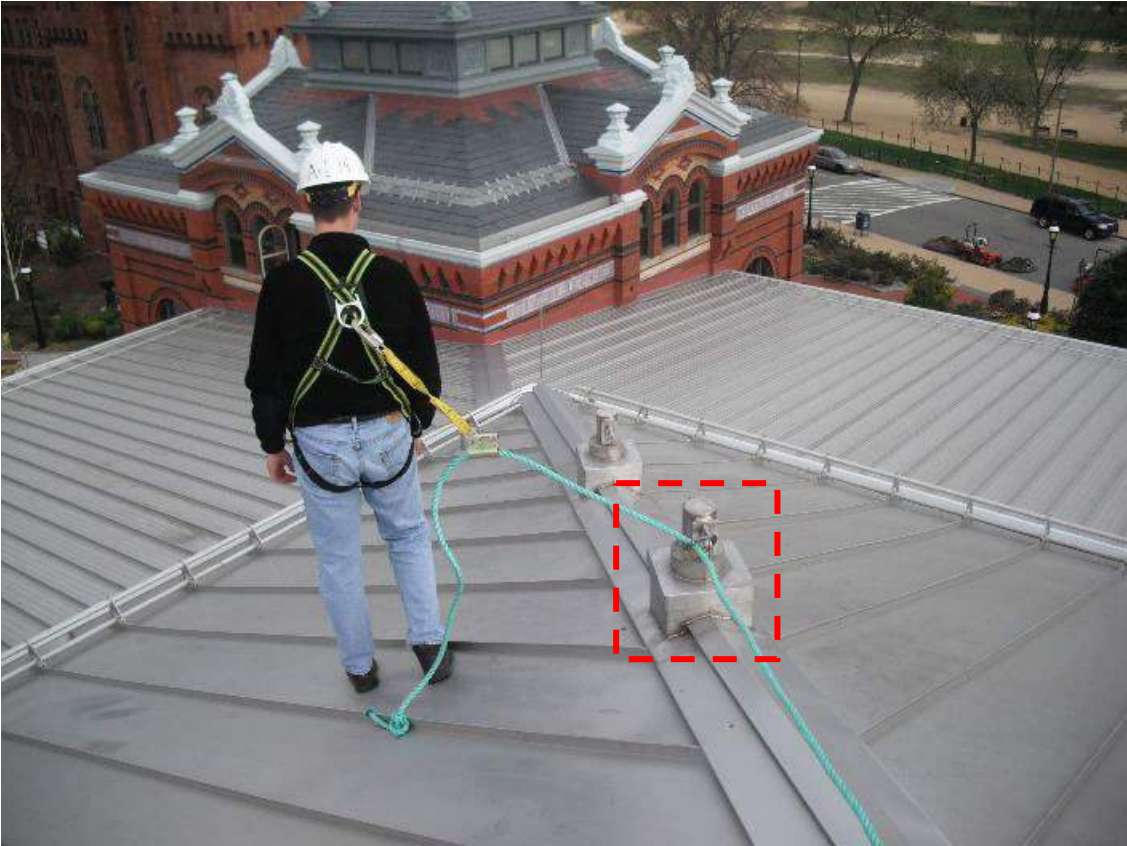
FALL AND LIGHTNING PROTECTION | PROPOSED  
INSTALLATION EXAMPLE AT AIB

EXAMPLE OF REDIRECT STANCHION

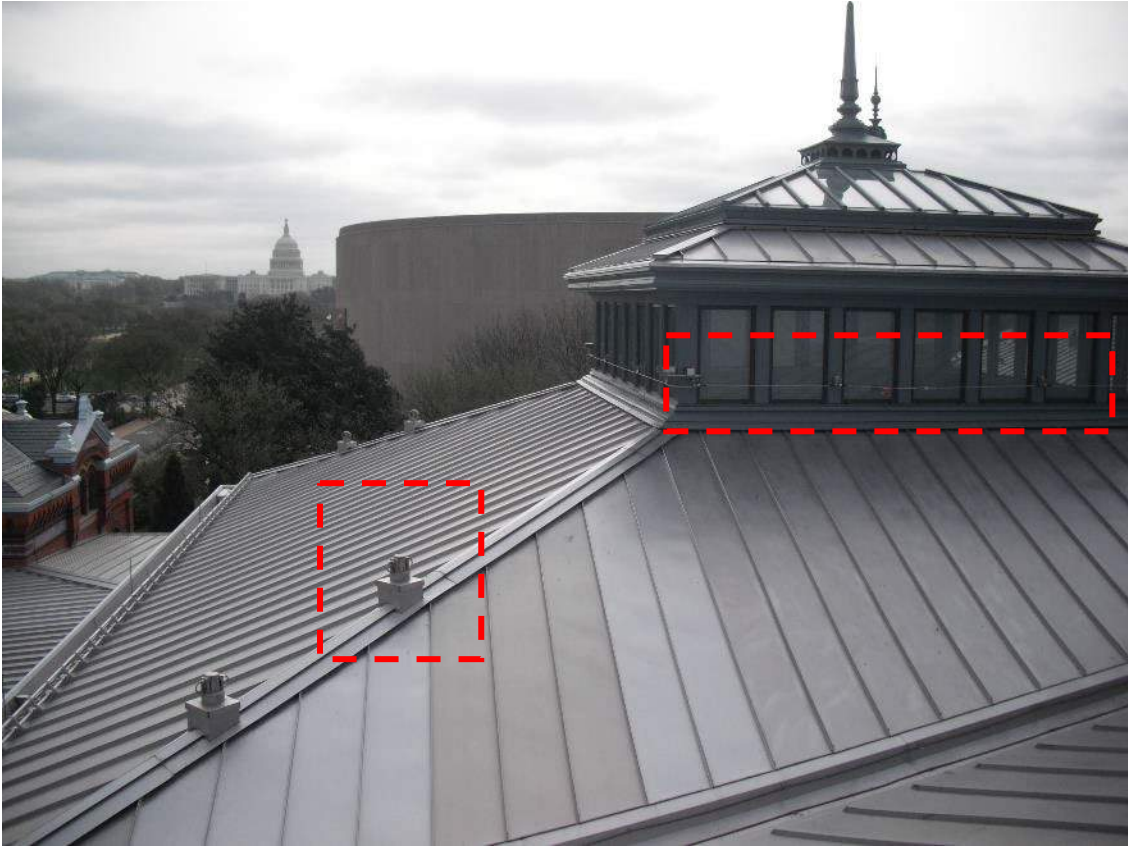
EXAMPLE OF REDIRECT STANCHION AND HORIZONTAL LIFELINE

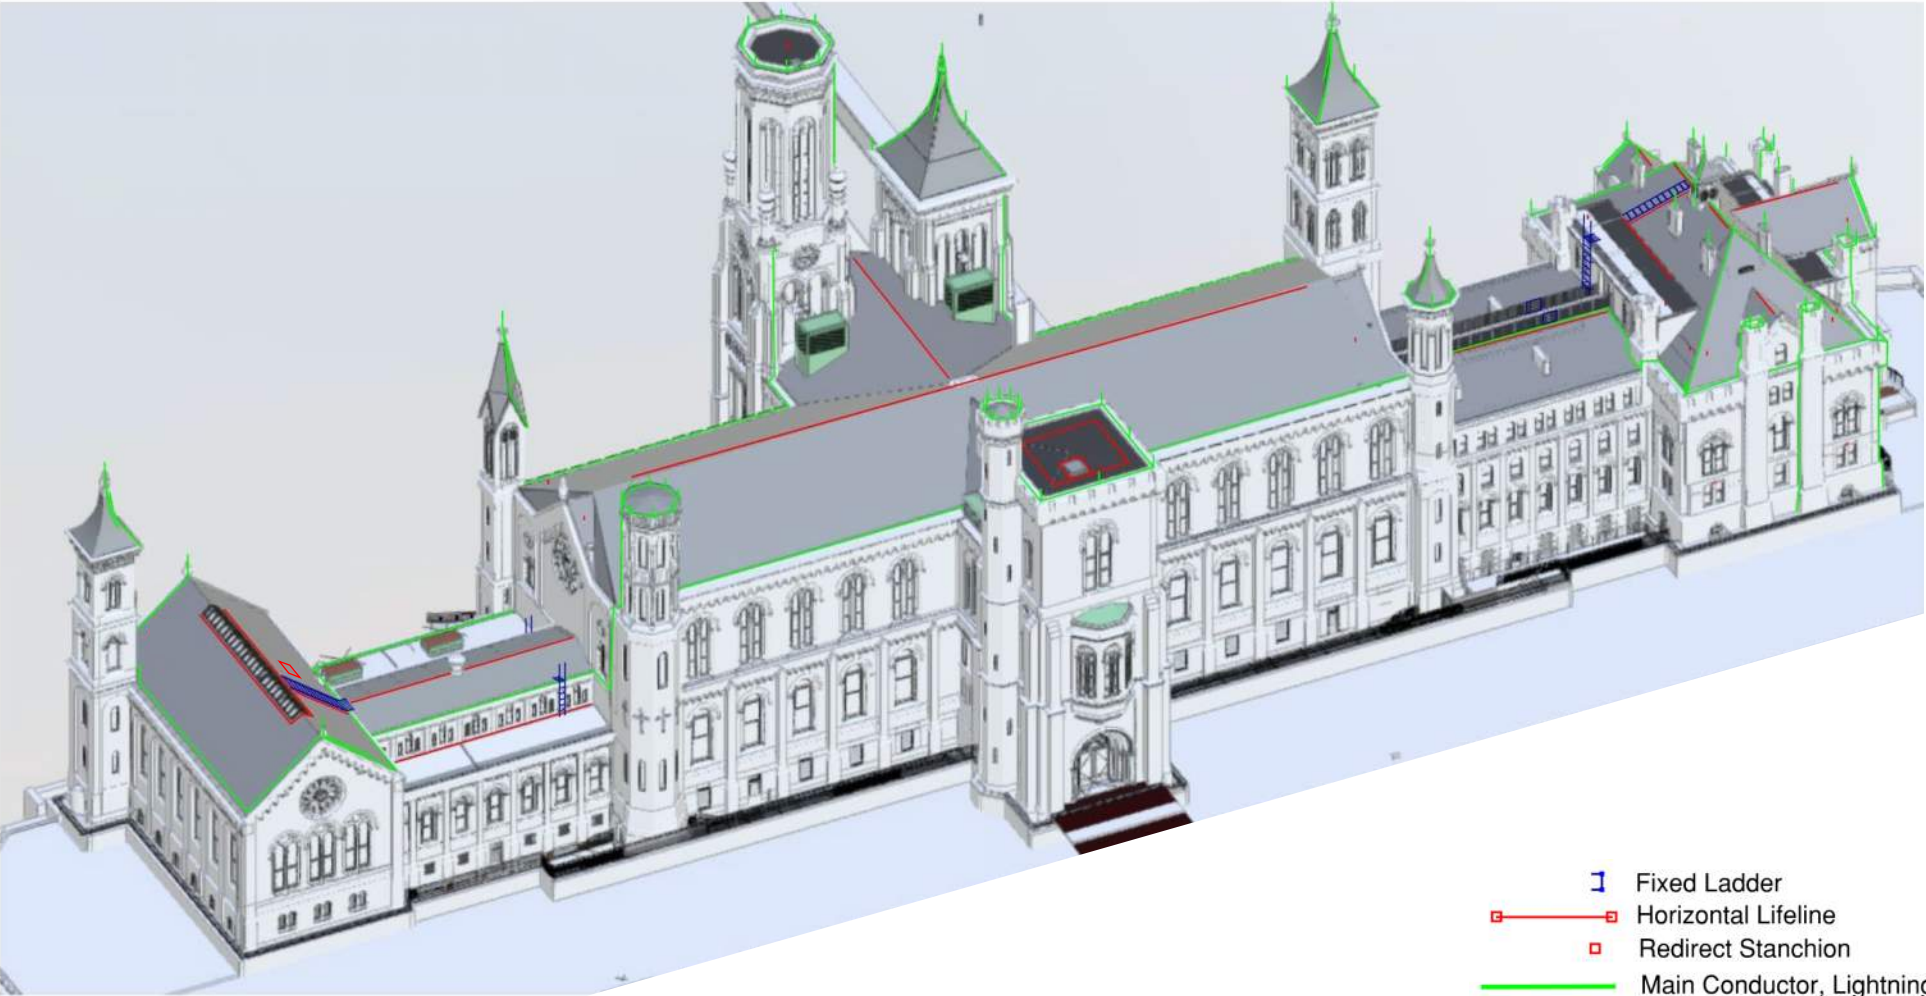
## FALL AND LIGHTNING PROTECTION | PROPOSED ROOF PLAN

Fixed Ladder
-

Horizontal Lifeline
-

Redirect Stanchion
-

Main Conductor, Lightning Protection
-

Air Terminal, 1/2" Cu, Lightning Protection
-

Ladder along slope of roof

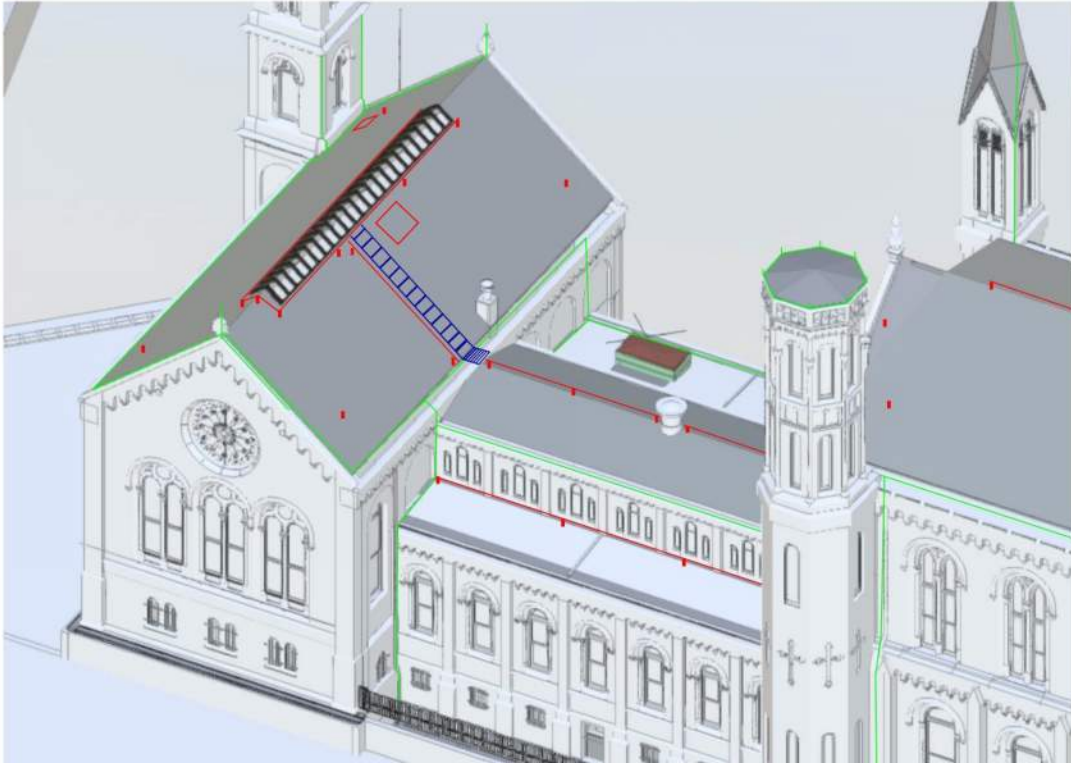
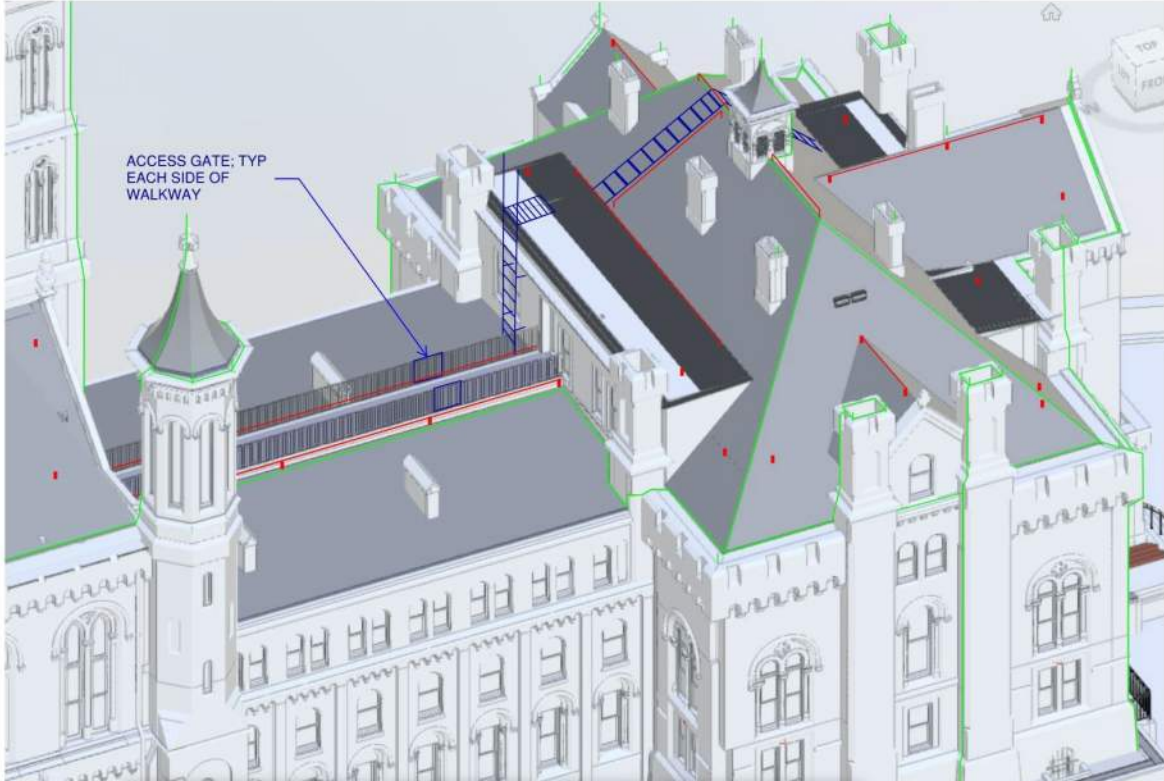
## FALL AND LIGHTNING PROTECTION | PROPOSED ROOF PLAN

Fixed Ladder
-

Horizontal Lifeline
-

Redirect Stanchion
-

Main Conductor, Lightning Protection
-

Air Terminal, 1/2" Cu, Lightning Protection
-

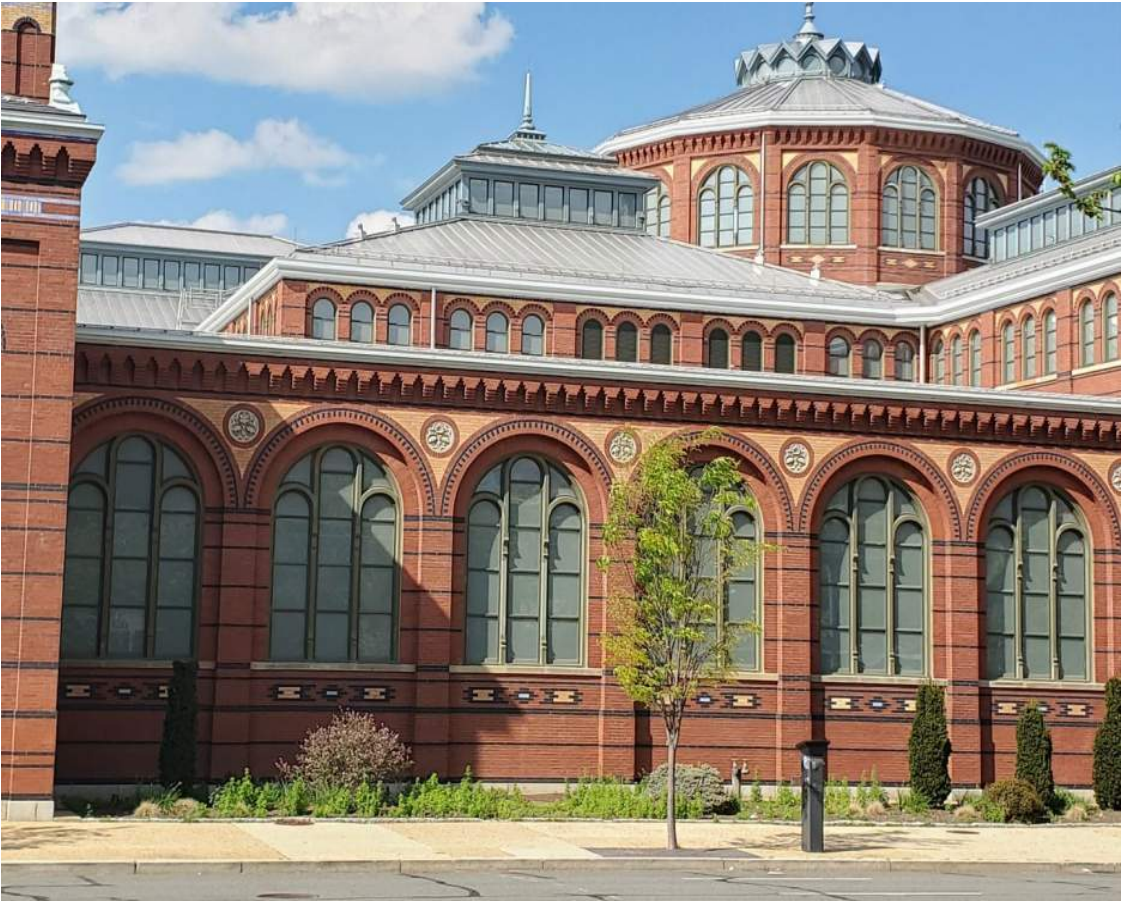
FALL AND LIGHTNING PROTECTION | PROPOSED  
INSTALLATION EXAMPLE AT AIB

VISIBILITY OF FALL PROTECTION - FROM GROUND

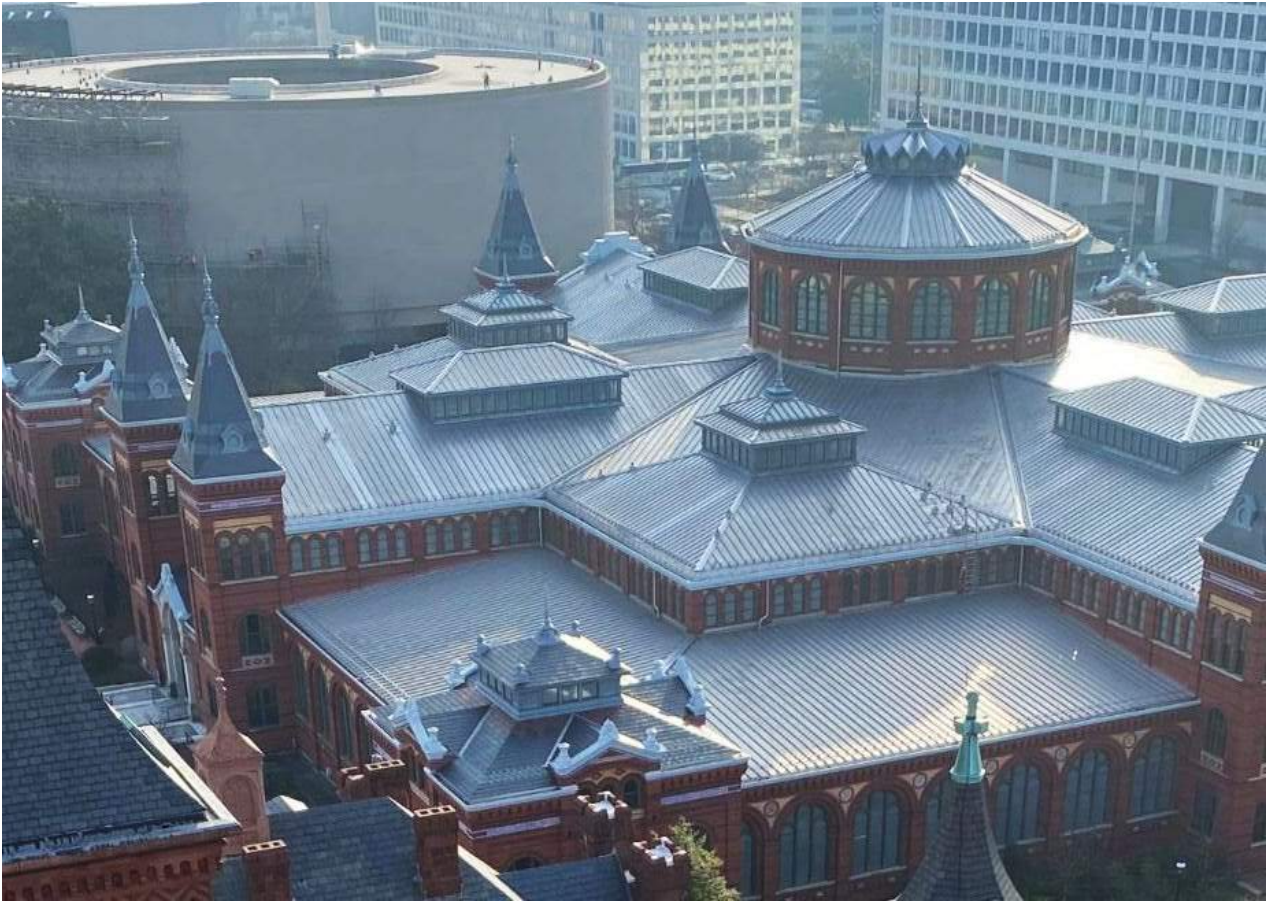
VISIBILITY OF FALL PROTECTION - BIRDSEYE

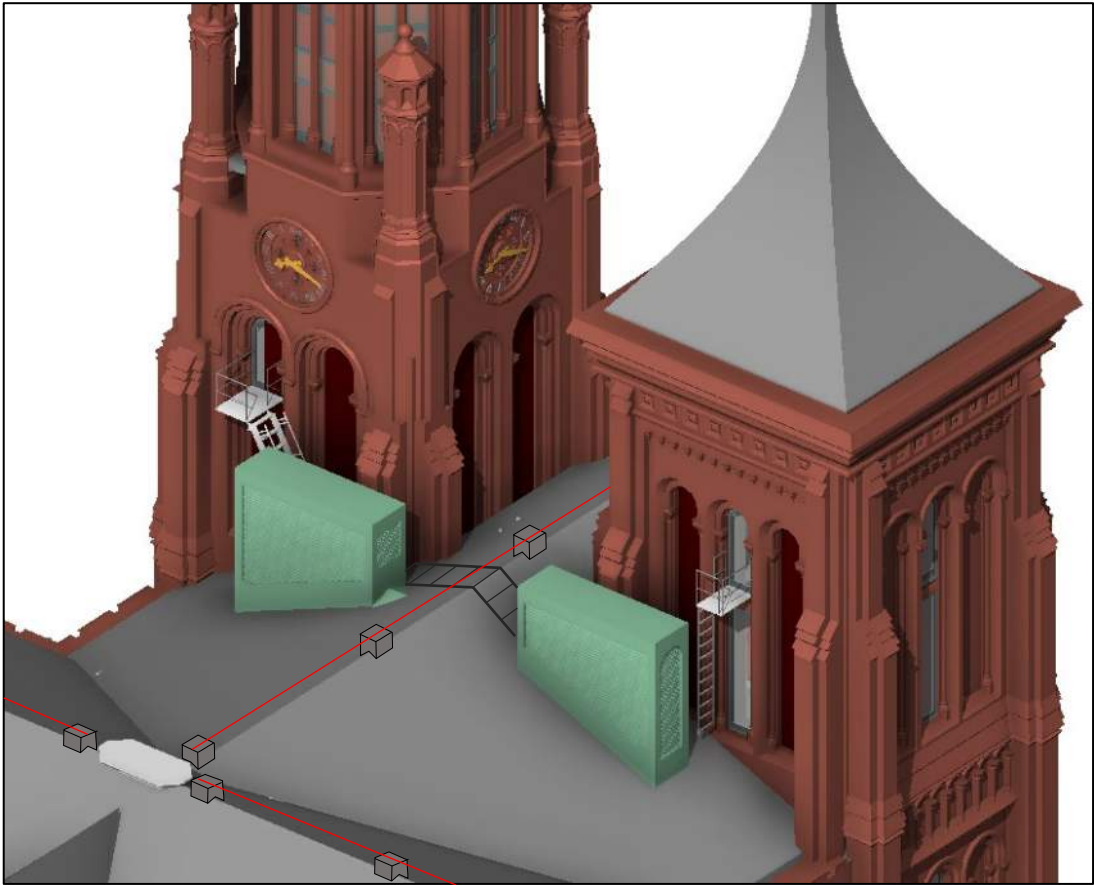
## ROOF ACCESS | MAIN BUILDING VISUALIZATION

**ROOF ACCESS – OPTION A**  
*PLATFORM AND LADDER FROM FLAG AND NORTH TOWER  
STANCHIONS AND HORIZONTAL LIFELINES*

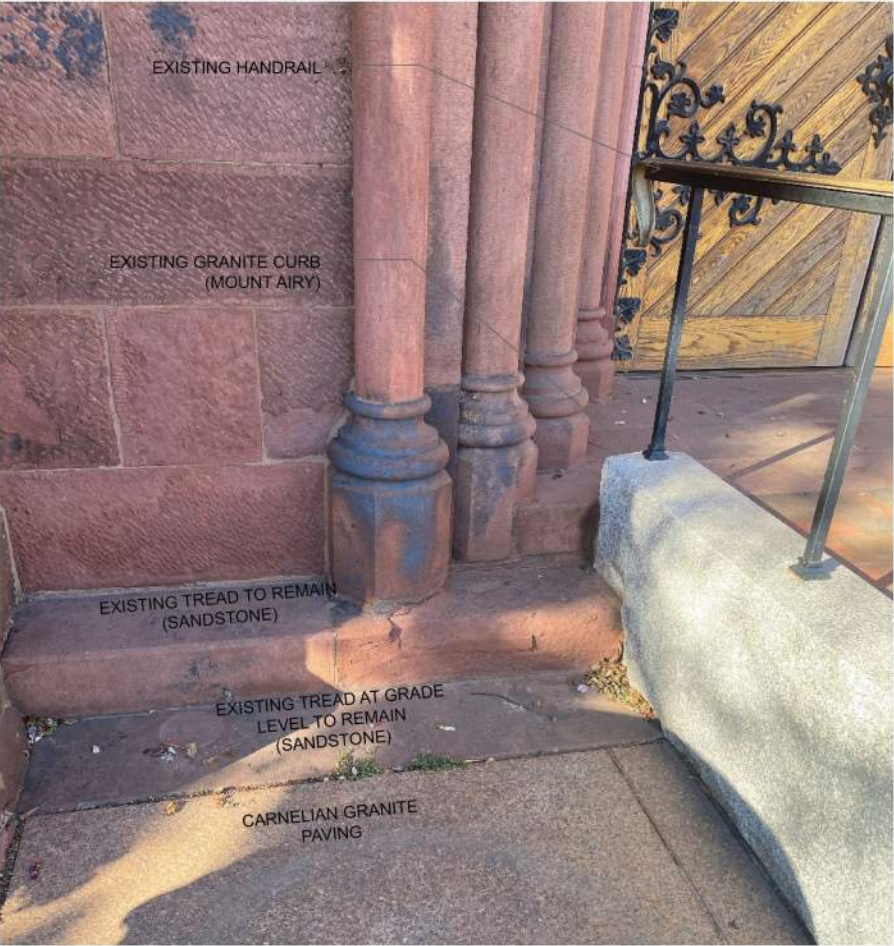
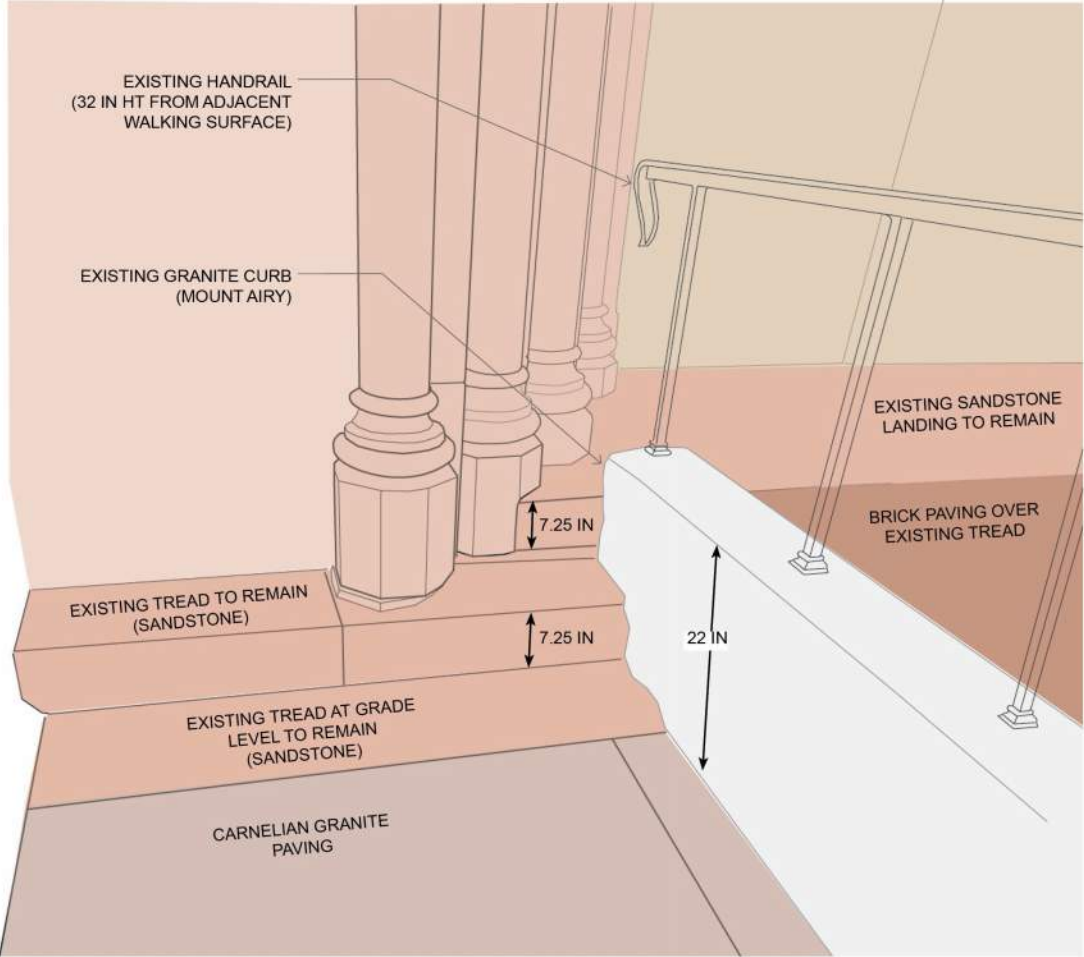
## SIB SOUTH ENTRANCE | CURB & RAILING STUDY EXISTING CONDITIONS

EXISTING CONDITIONS

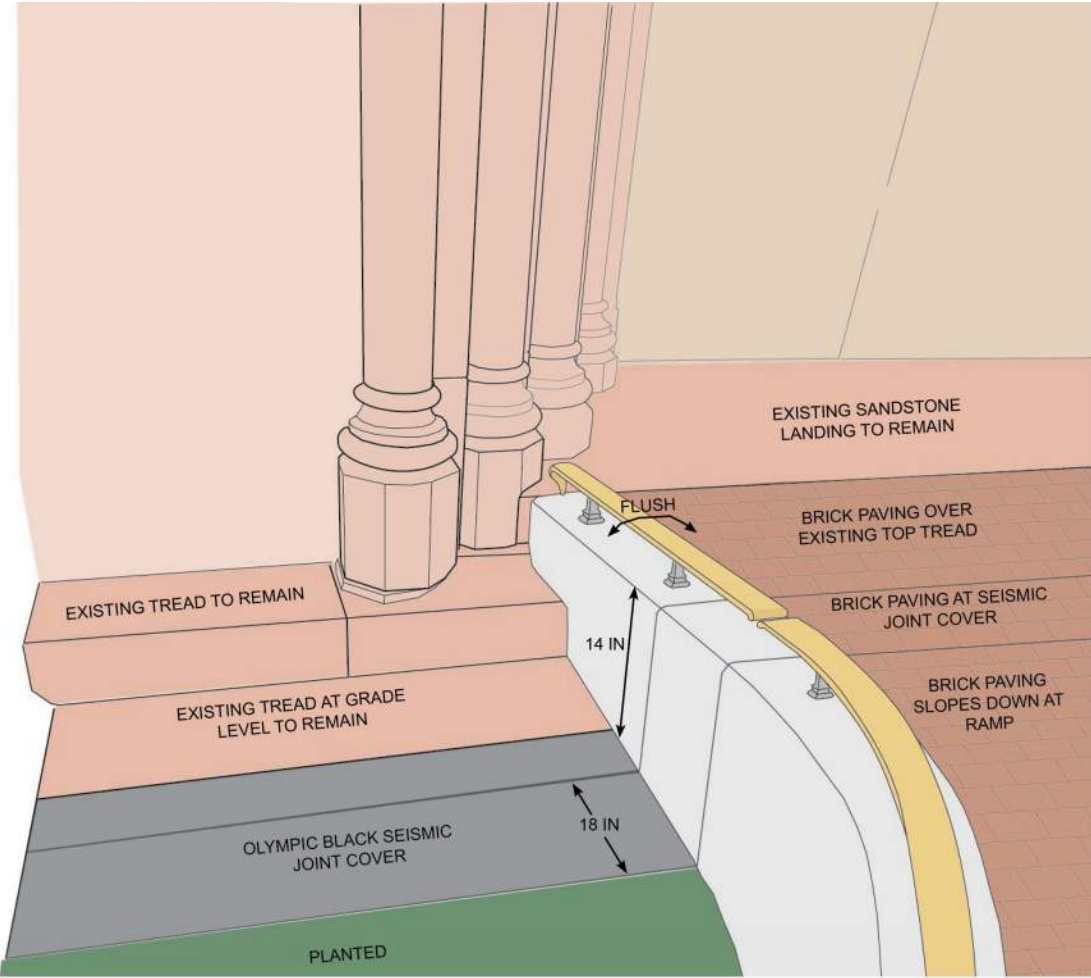
CURB HEIGHT LEVEL WITH ADJACENT WALKING SURFACE FROM SIB TO SEISMIC JOINT, THEN STAYS LEVEL AS WALKING SURFACE SLOPES AWAY

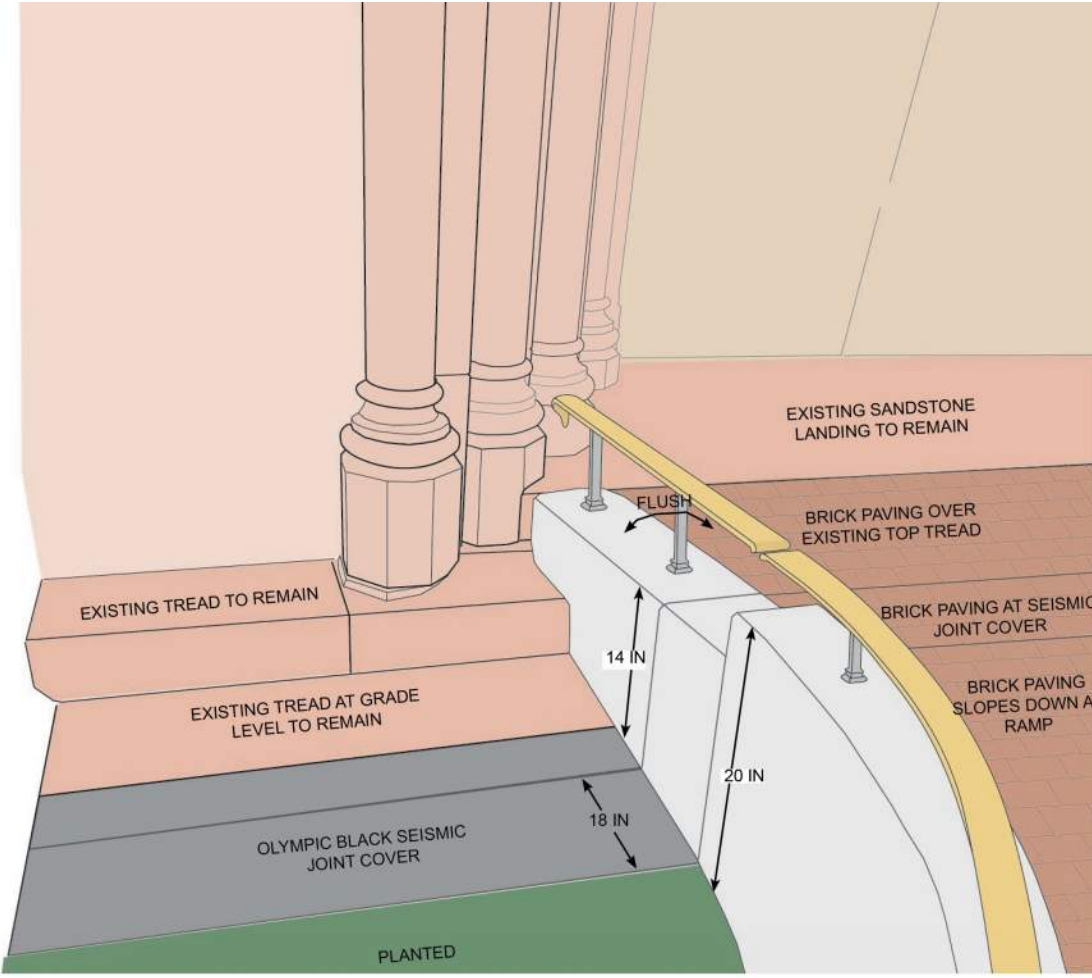
CURB HEIGHT LEVEL WITH ADJACENT WALKING SURFACE FROM SIB TO SEISMIC JOINT, THEN STEPS UP TO MATCH HEIGHT OF CURB AT PLANTER

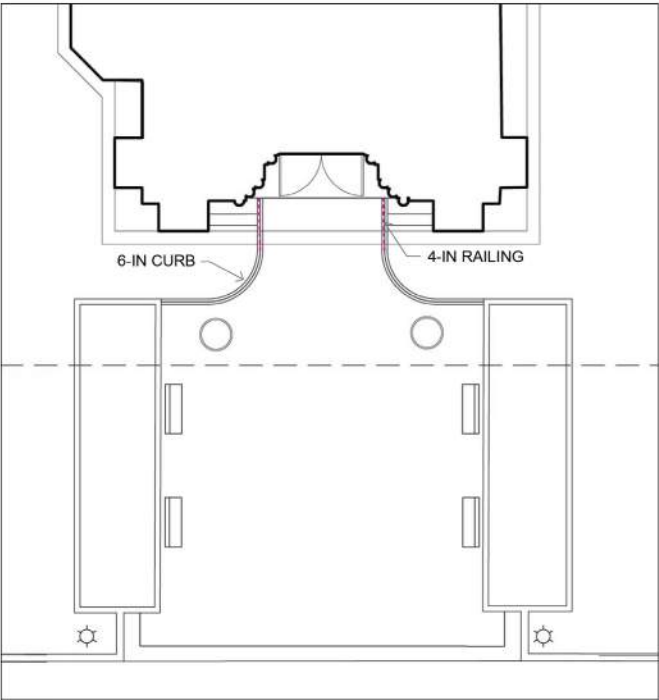
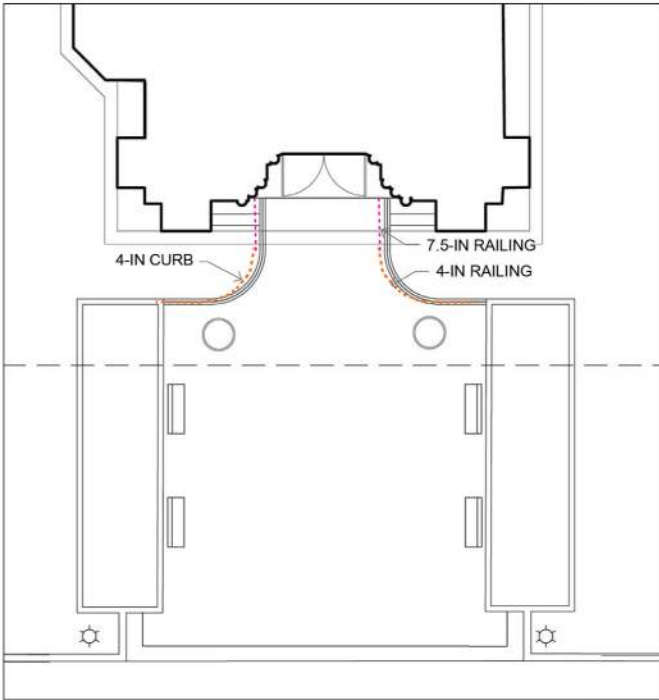
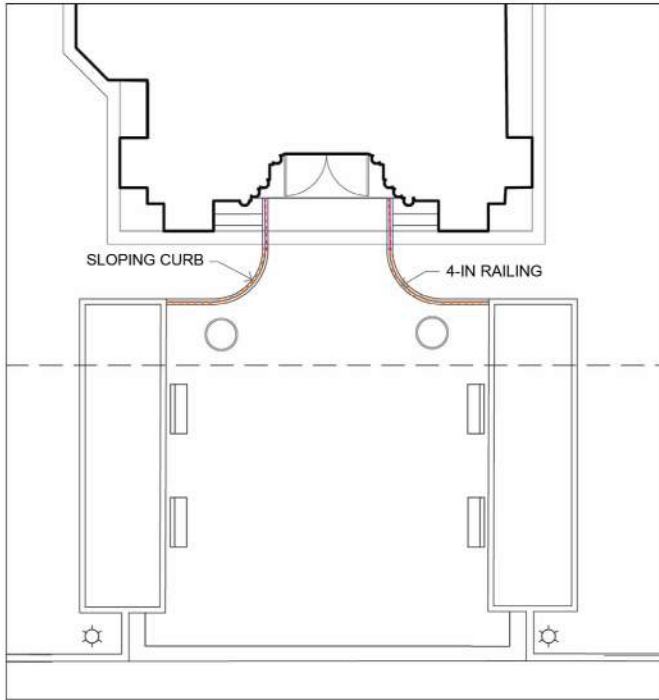
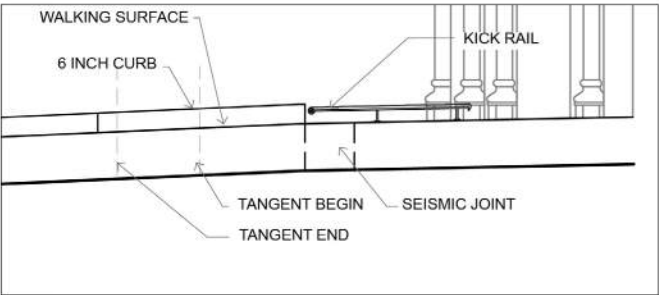
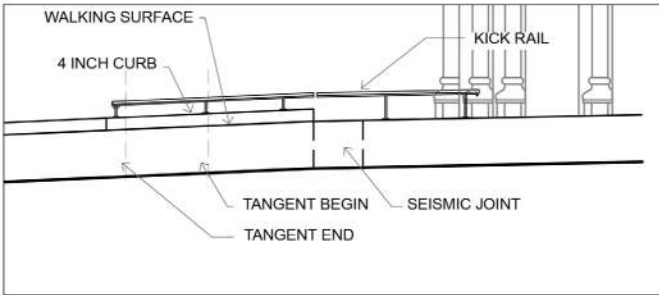
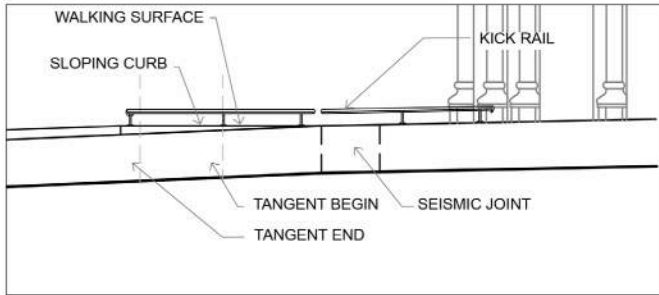
## SIB SOUTH ENTRANCE | CURB & RAILING STUDY

OPTION 1 - PREFERRED

OPTION 2

OPTION 3

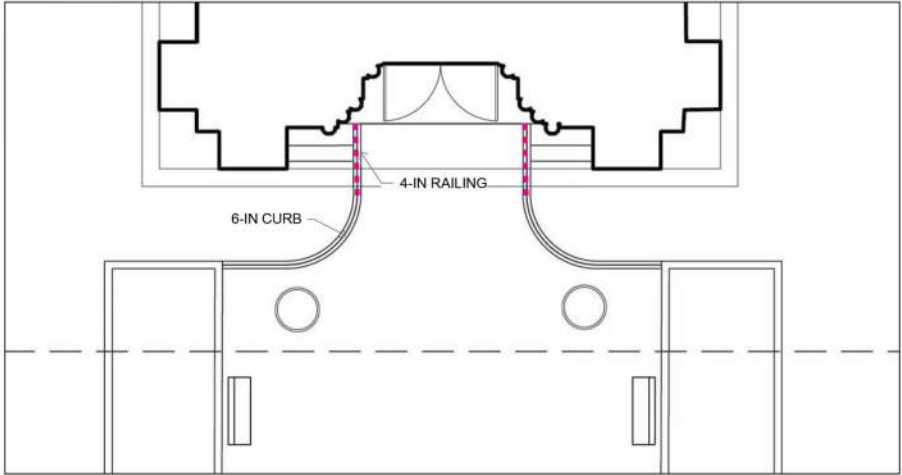
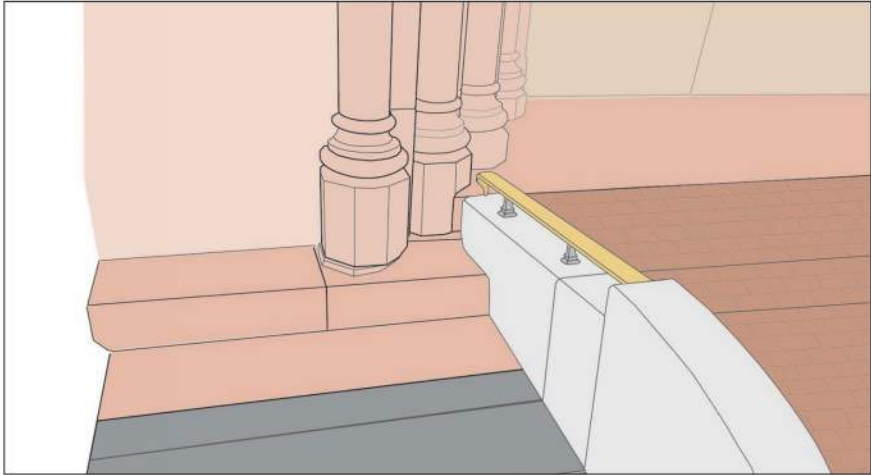
## SIB SOUTH ENTRANCE | CURB & RAILING STUDY OPTION 1 - PREFERRED

PLAN

AXON LOOKING NORTH AT SOUTH ENTRANCE LANDING AND WESTERN CURB

SECTION FROM WALKING SURFACE LOOKING WEST

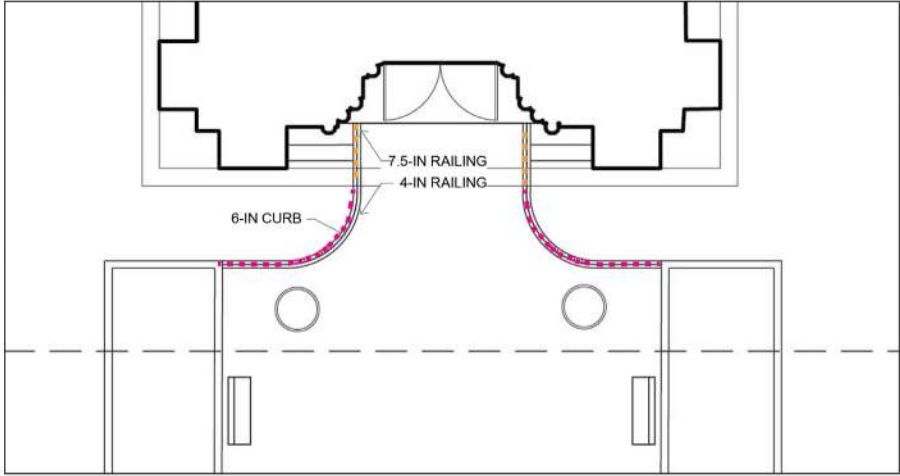
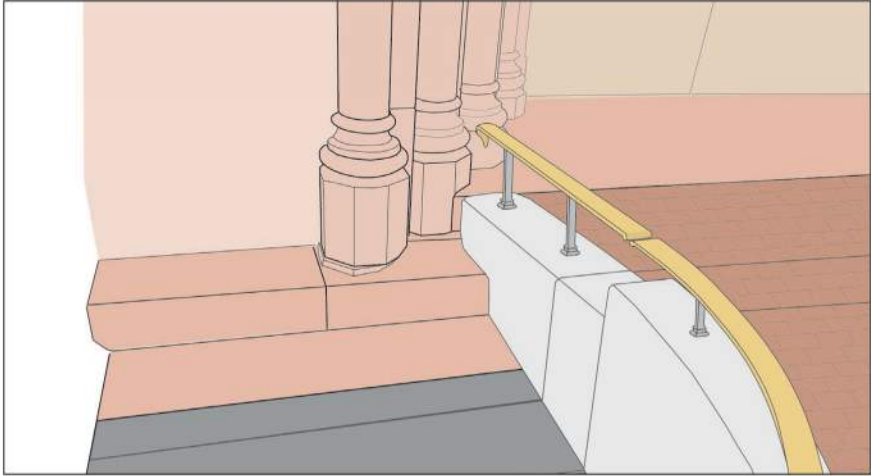
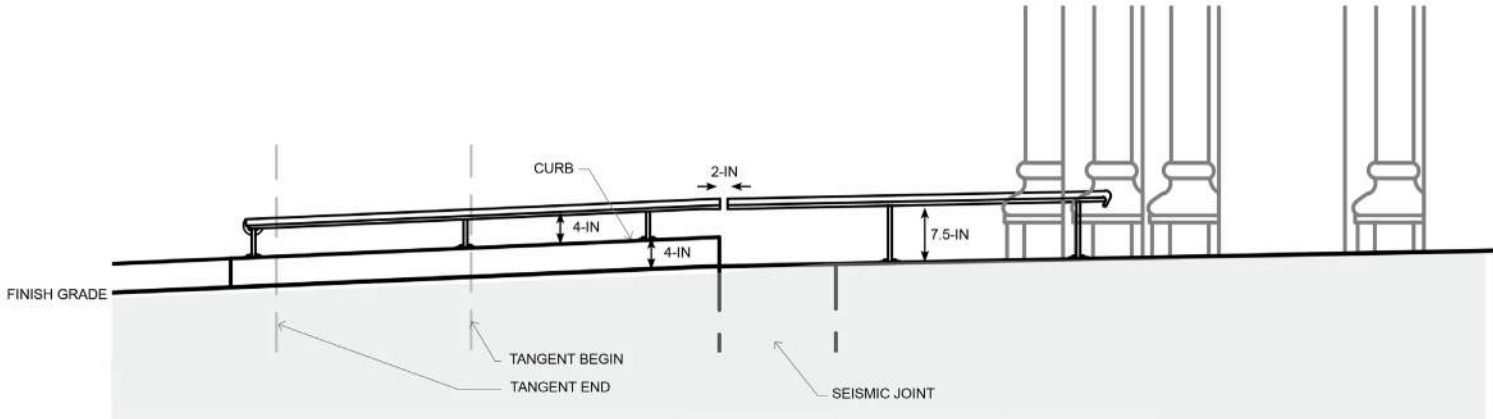
## SIB SOUTH ENTRANCE | CURB & RAILING STUDY OPTION 2

PLAN

AXON LOOKING NORTH AT SOUTH ENTRANCE LANDING AND WESTERN CURB

SECTION FROM WALKING SURFACE LOOKING WEST

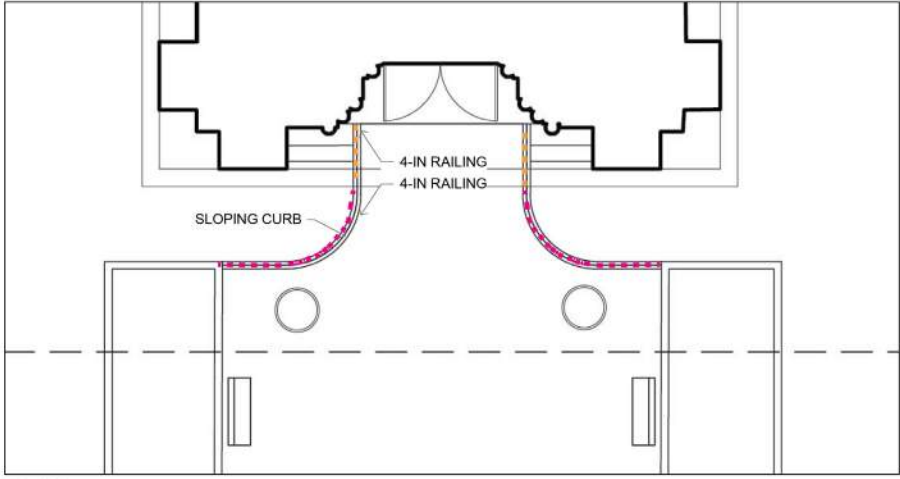
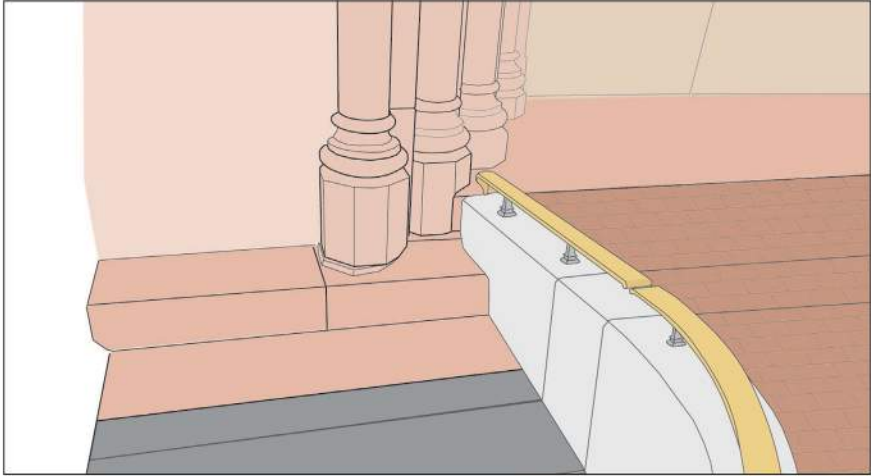
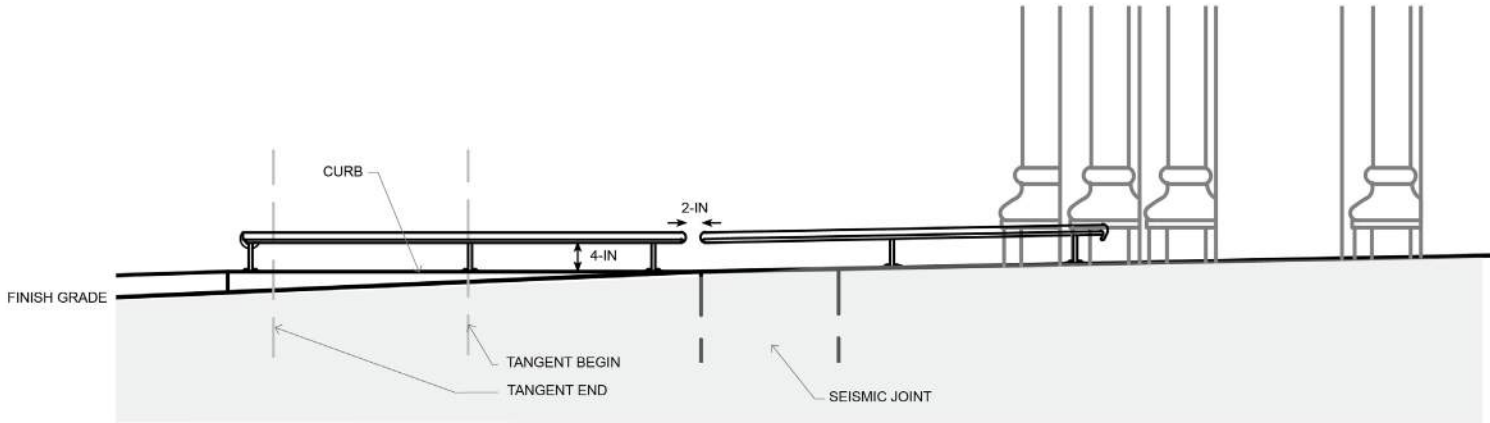
## SIB SOUTH ENTRANCE | CURB & RAILING STUDY OPTION 3

PLAN

AXON LOOKING NORTH AT SOUTH ENTRANCE LANDING AND WESTERN CURB

SECTION FROM WALKING SURFACE LOOKING WEST

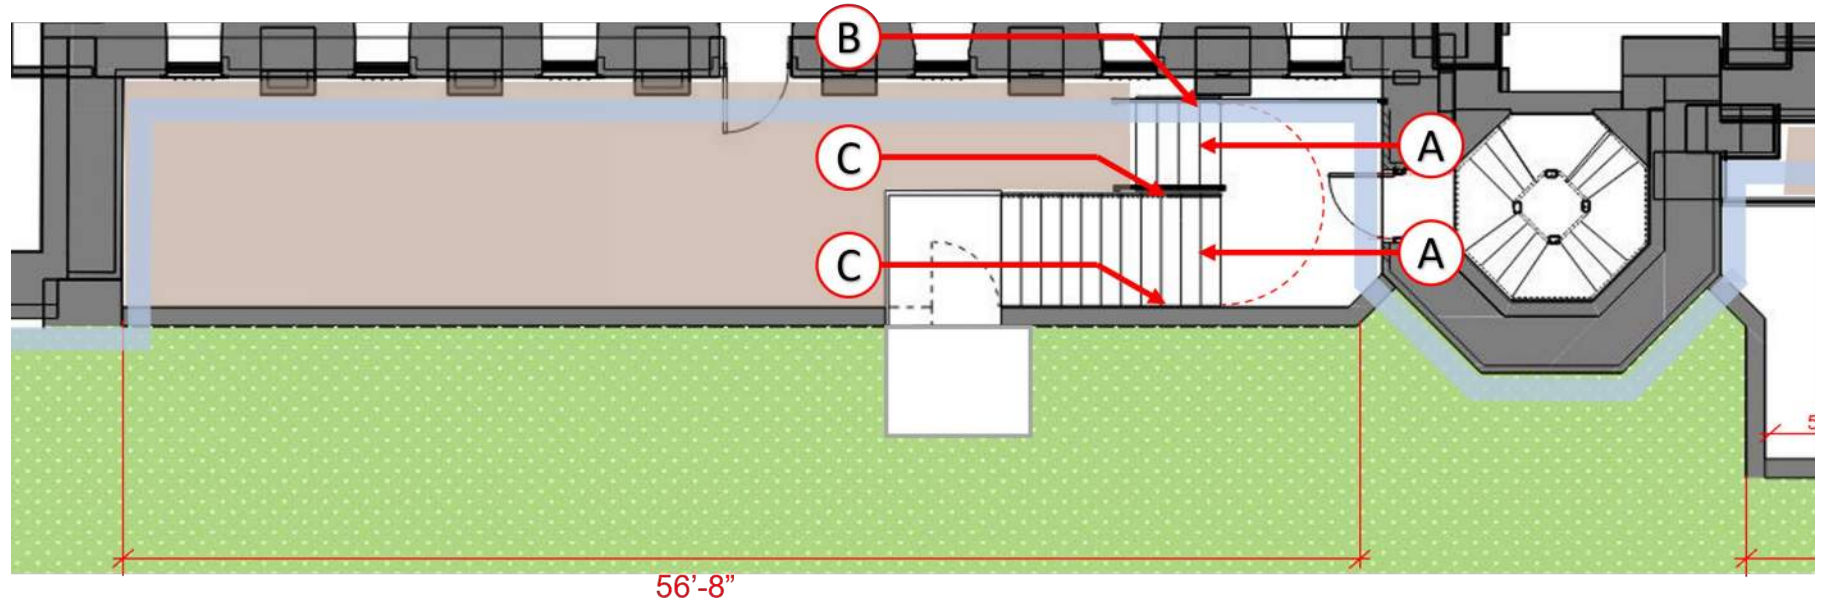
PARTIAL PLAN | SOUTHWEST AREAWAY (CP8)

Original proposal based on 2" concrete formliner, available information regarding joint cover clearance, and schematic calculated egress widths

Continued CD development and updated information requires additional clearances for:

- A. **Converging egress point; critical to maintain required egress width (46")**
- B. Seismic joint cover movement (18" joint + 6" movement = 24")
- C. Tolerance for areaway finish materials (pending future Consulting Parties review; allocating 5" for material)

Modifications result in 2" remaining space for joint cover movement; 24" joint cover movement is required

- **Requires stair to shift 22" south**

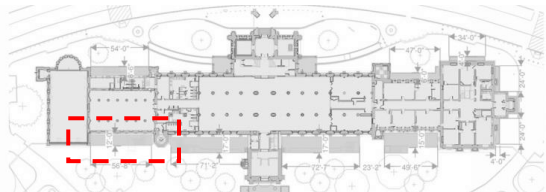
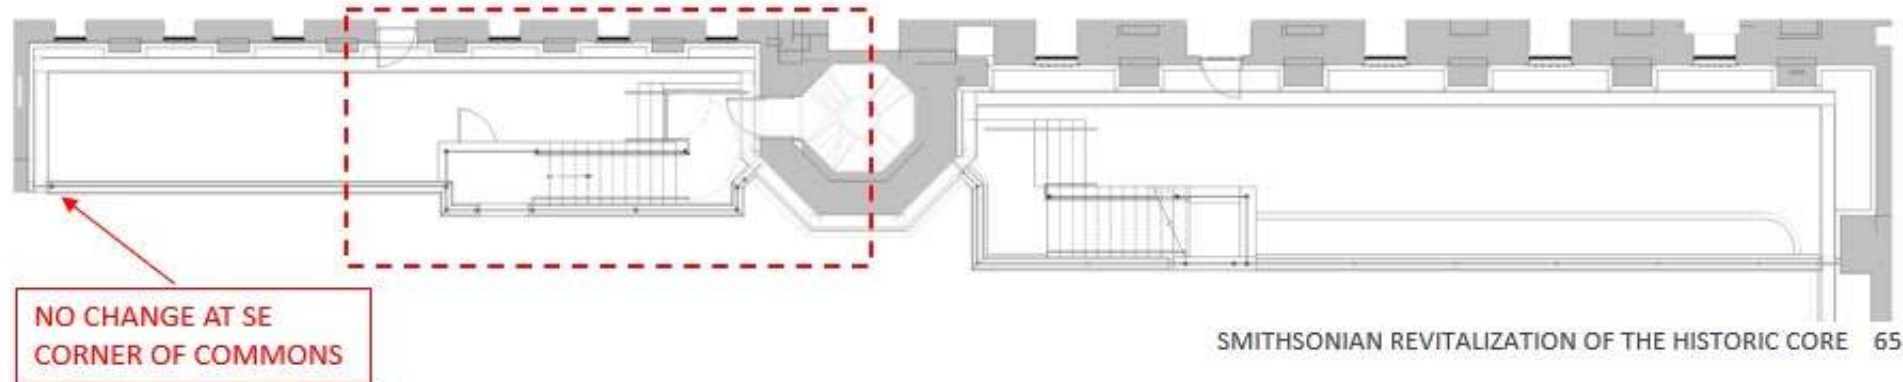
## SOUTHWEST (W) AREAWAY | MODIFICATION UPDATED PROPOSAL

- Increased space for facing material to 5"
- Retaining wall at stair shifted 22" south
- Stair landing extended 14" west

\*Retaining wall intersection at building does not change
