Smithsonian Institution

Revitalization of the Historic Core  
**CONSULTING PARTIES MEETING #13**

May 24, 2023

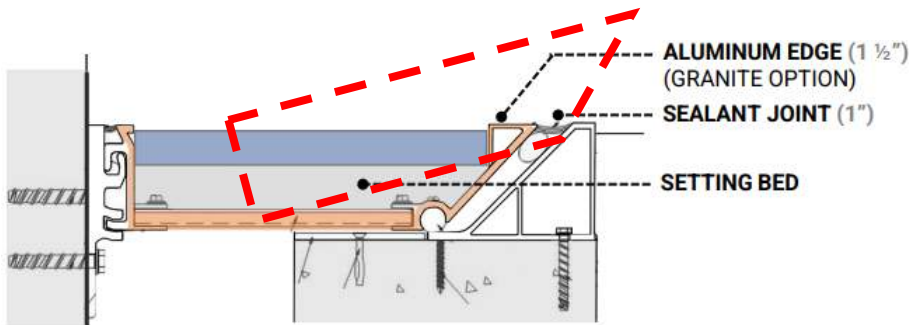
TYPICAL SEISMIC JOINT COVER

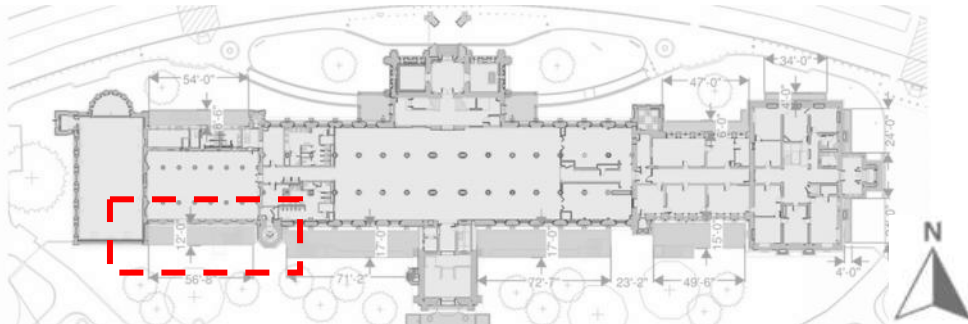
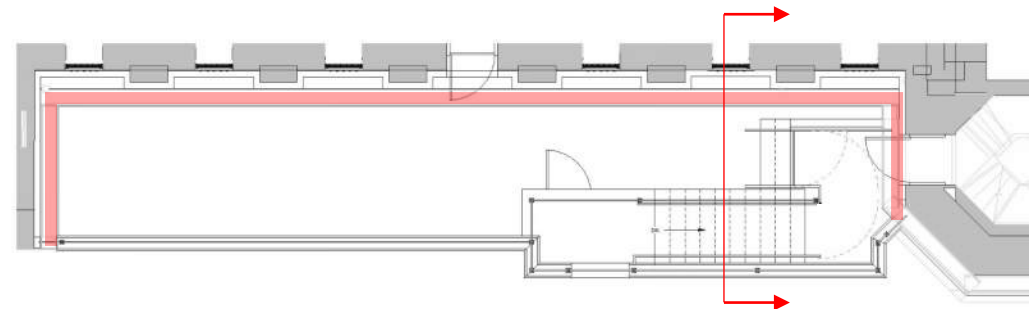
## SOUTHWEST (W) AREAWAY | MODIFICATION UPDATED PROPOSAL

- Finish materials TBD, pending future CP review
- 5" of depth allocated for finish wall material (TBD)
- Minimum 24" clearance at seismic joint
- Minimum 46" egress clearance
- Guardrail centered over structure below

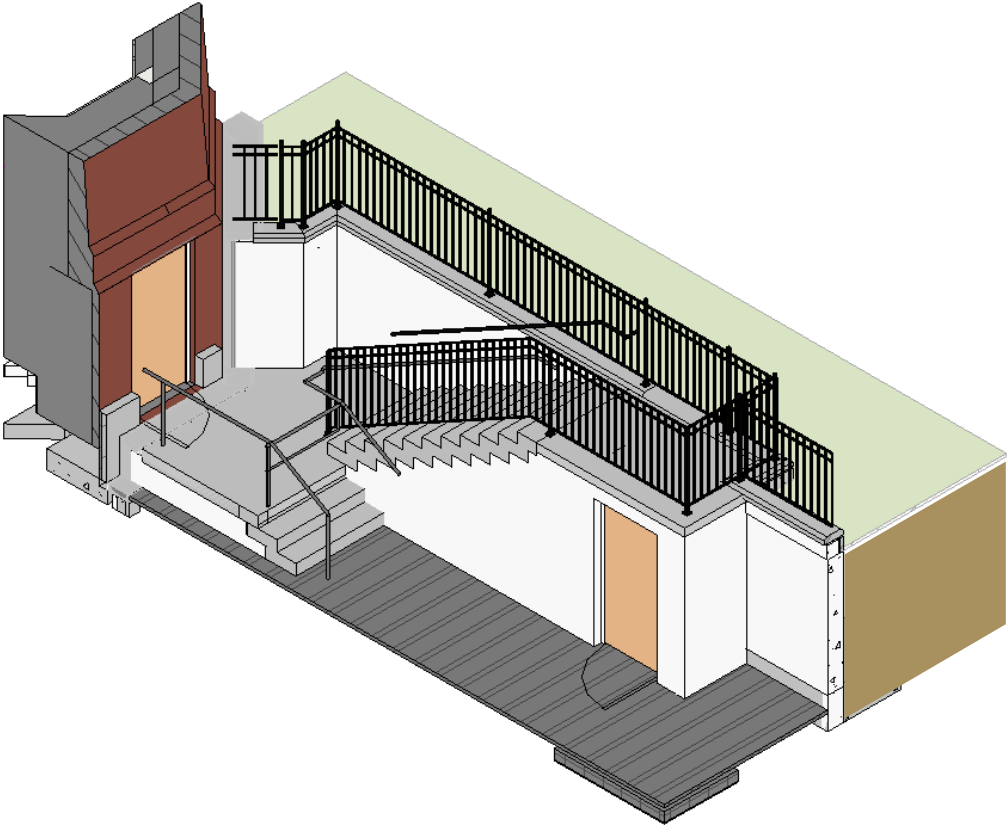
SOUTHWEST (W) AREAWAY | MODIFICATION  
UPDATED PROPOSAL

AXON (PROPOSED MODIFICATION)

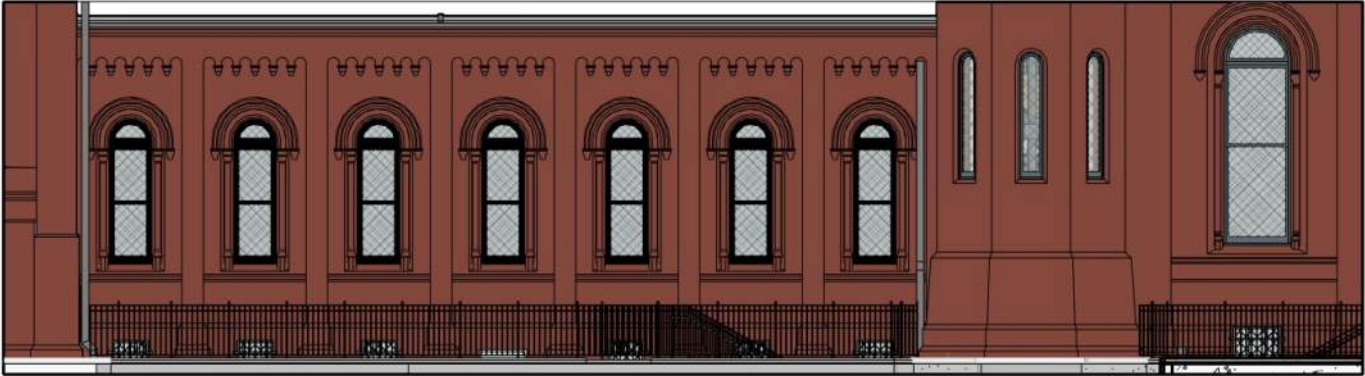
ELEVATION (CURRENT)

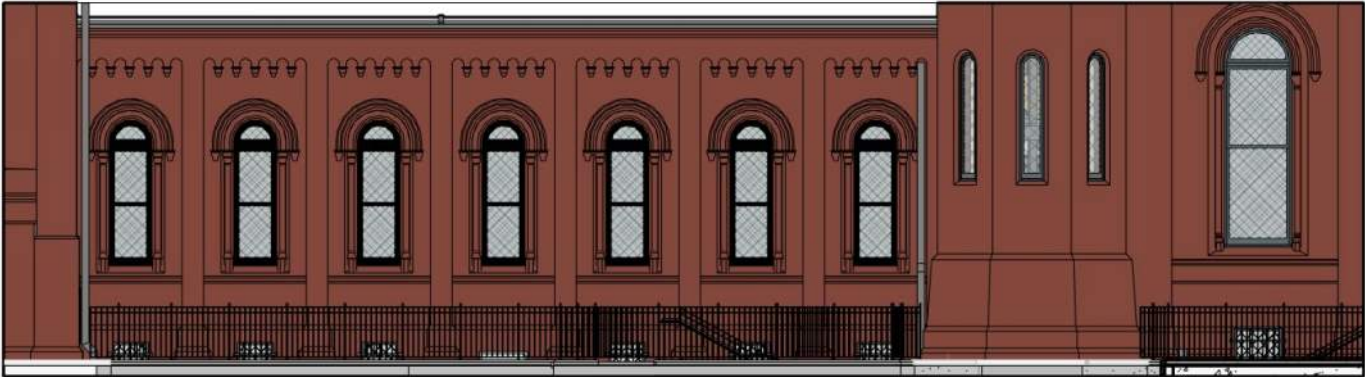
ELEVATION (PROPOSED MODIFICATION)

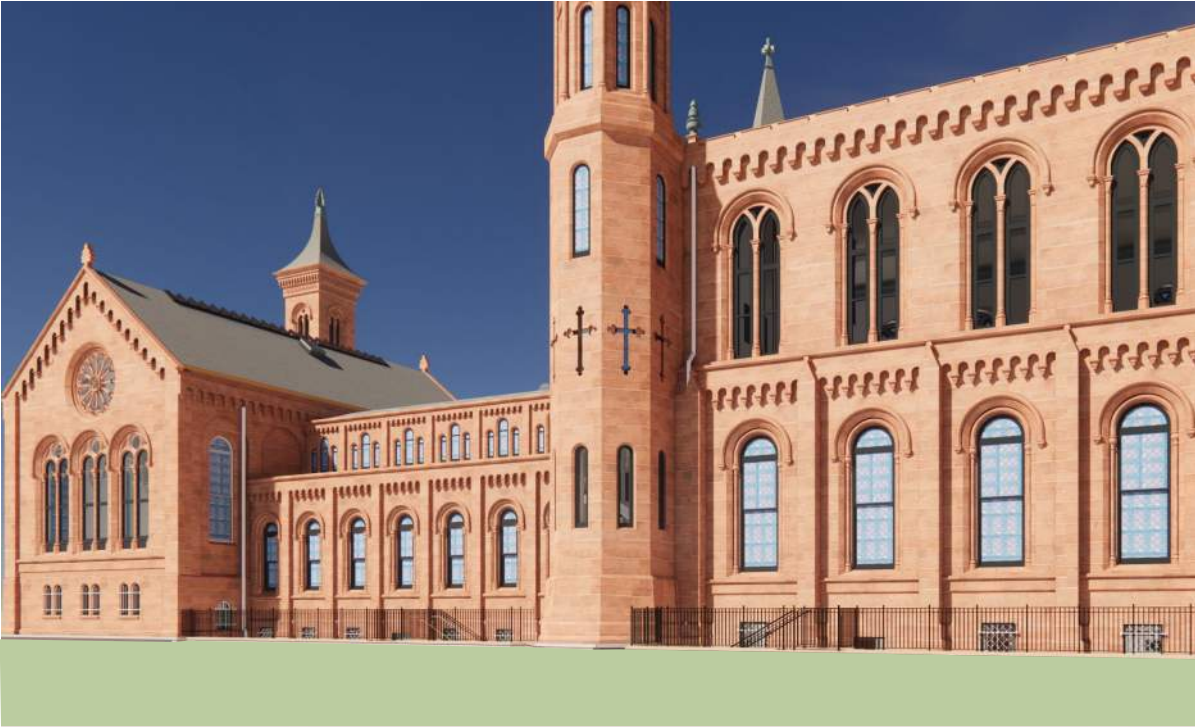
SOUTHWEST (W) AREAWAY | MODIFICATION  
VISUALIZATION (LOOKING NW)

CURRENT DESIGN

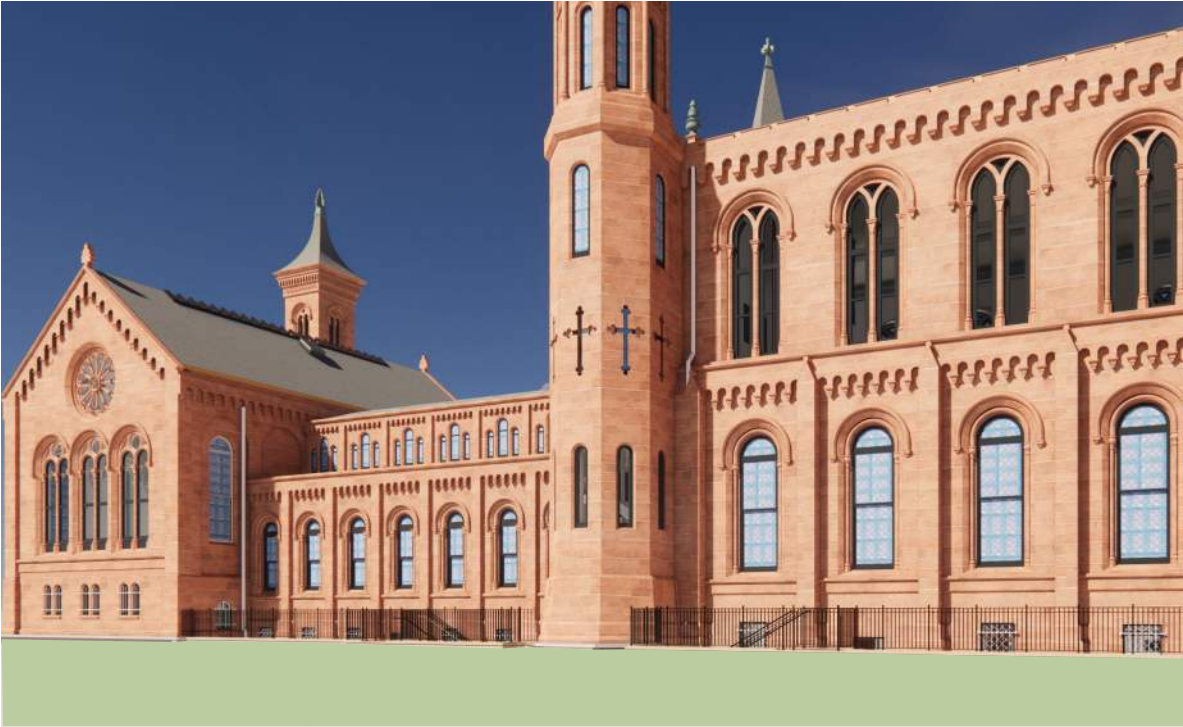
PROPOSED MODIFICATION

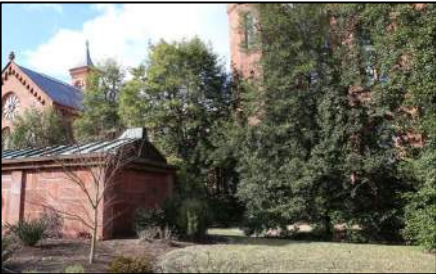
EXISTING CONDITION

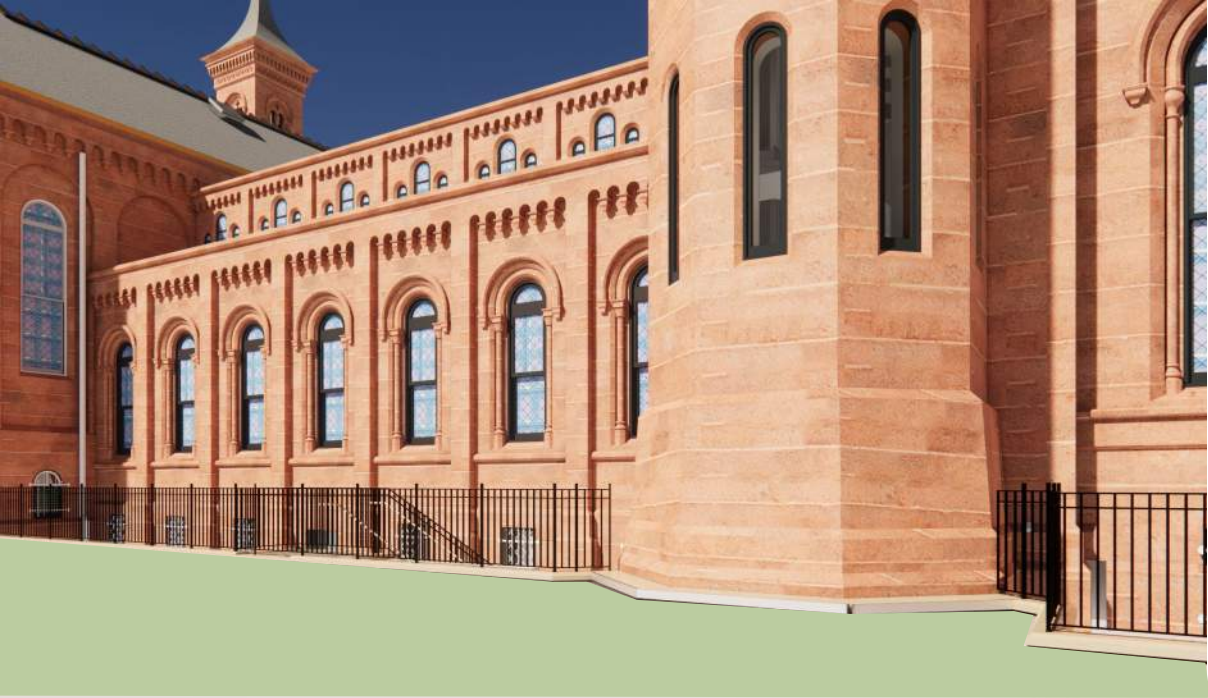
SOUTHWEST (W) AREAWAY | MODIFICATION  
VISUALIZATION (LOOKING NW)

CURRENT DESIGN

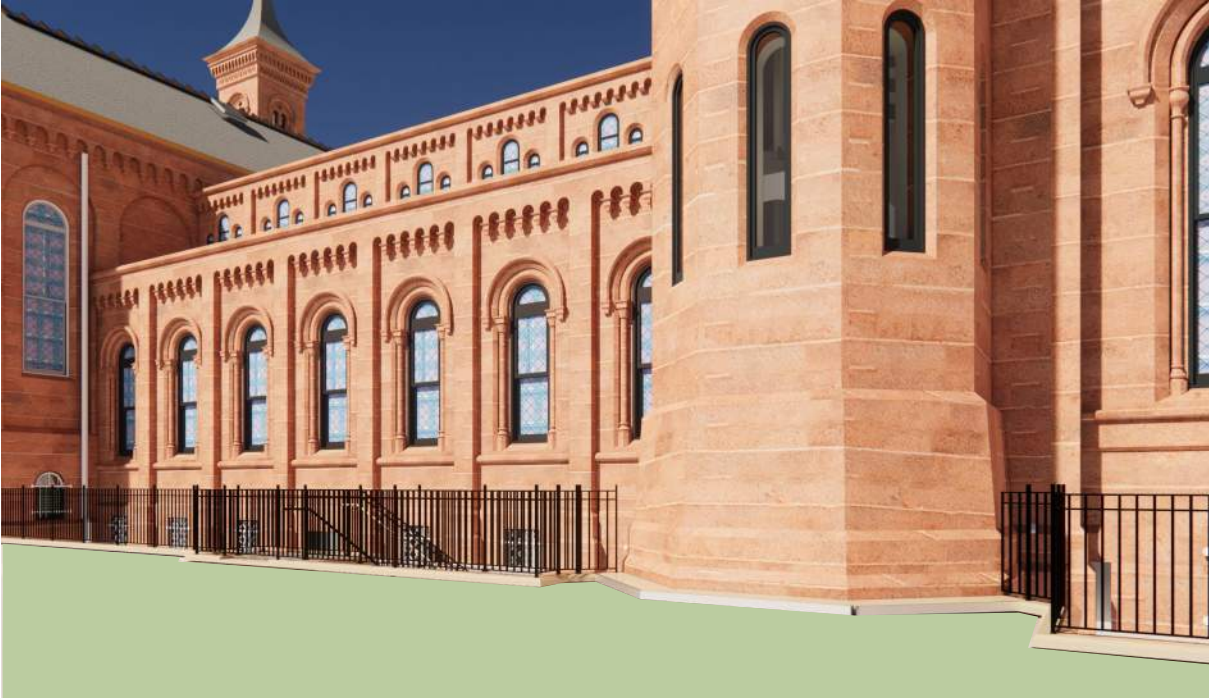
PROPOSED MODIFICATION

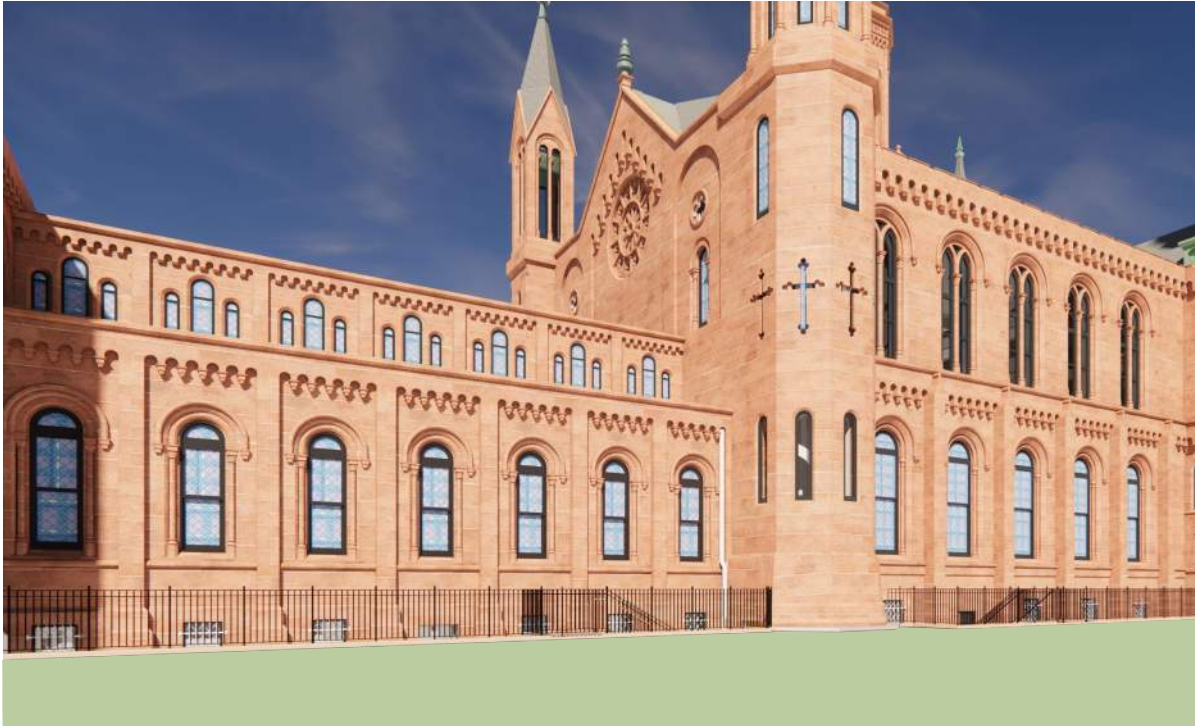
SOUTHWEST (W) AREAWAY | MODIFICATION  
VISUALIZATION (LOOKING NE)

CURRENT DESIGN

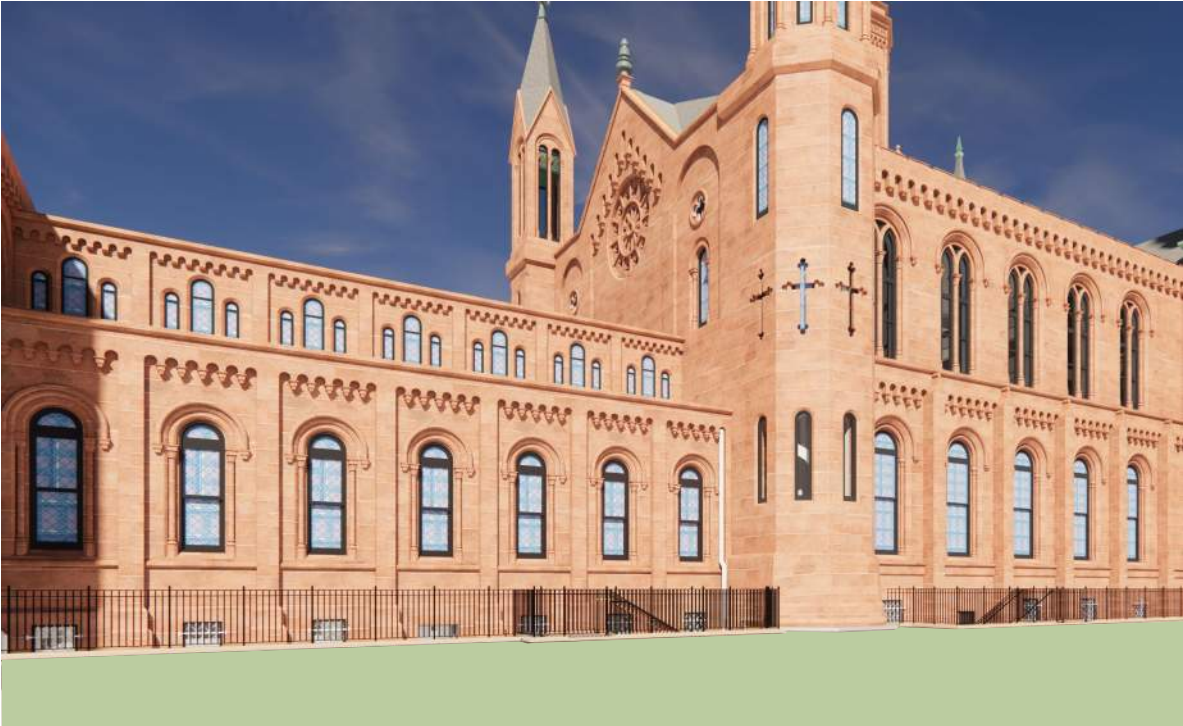
PROPOSED MODIFICATION

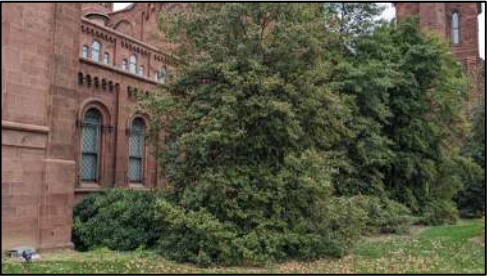
EXISTING CONDITION

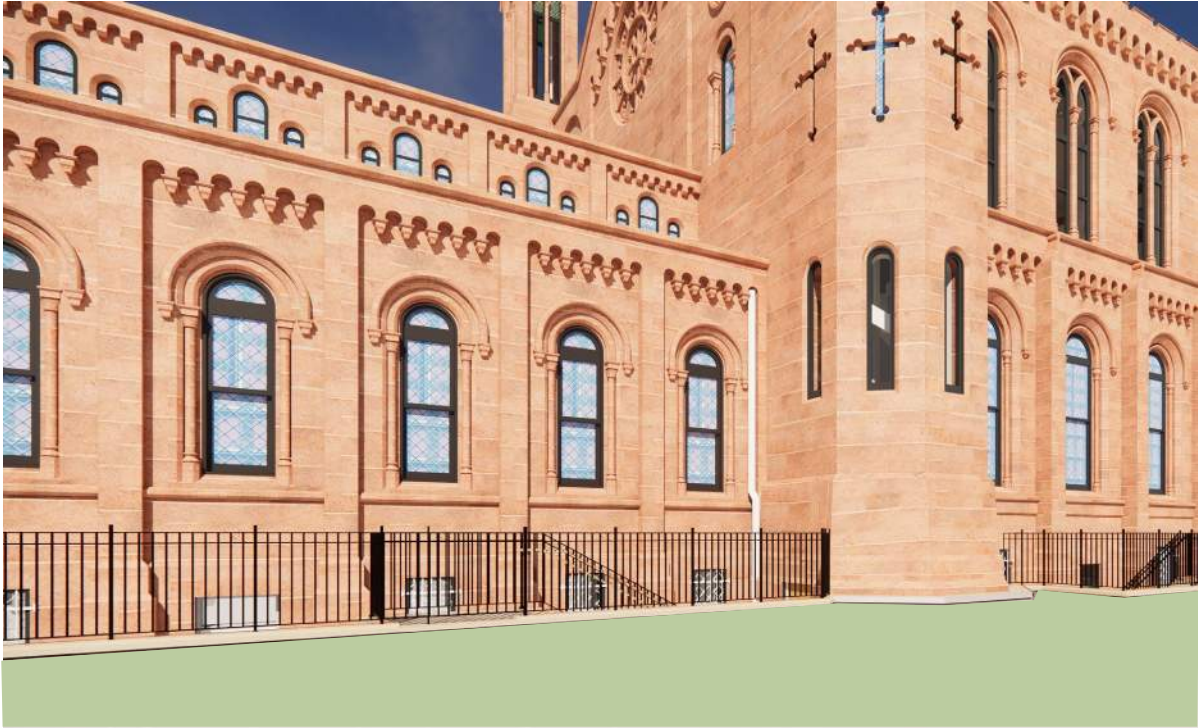
SOUTHWEST (W) AREAWAY | MODIFICATION  
VISUALIZATION (LOOKING NE)

CURRENT DESIGN

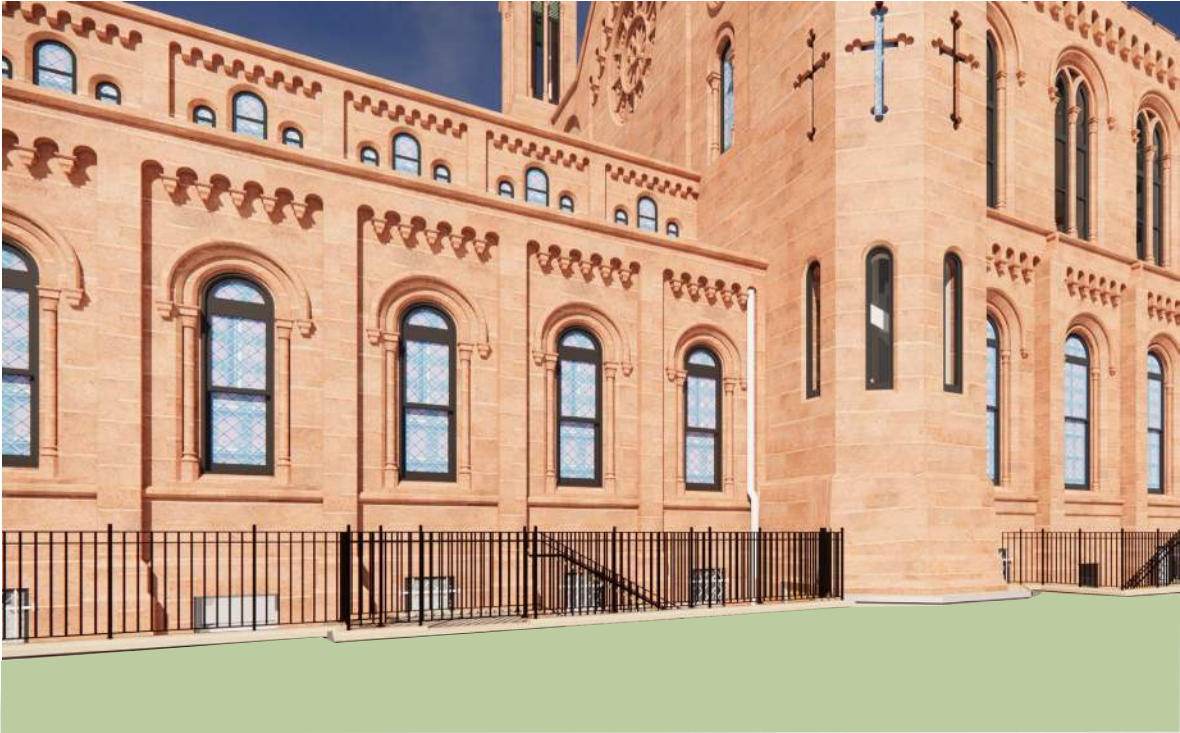
PROPOSED MODIFICATION
