## Smithsonian Institution

## Revitalization of the Historic Core **CONSULTING PARTIES MEETING #15**

July 26, 2023

## **BASEMENT WINDOWS AND DOORS**

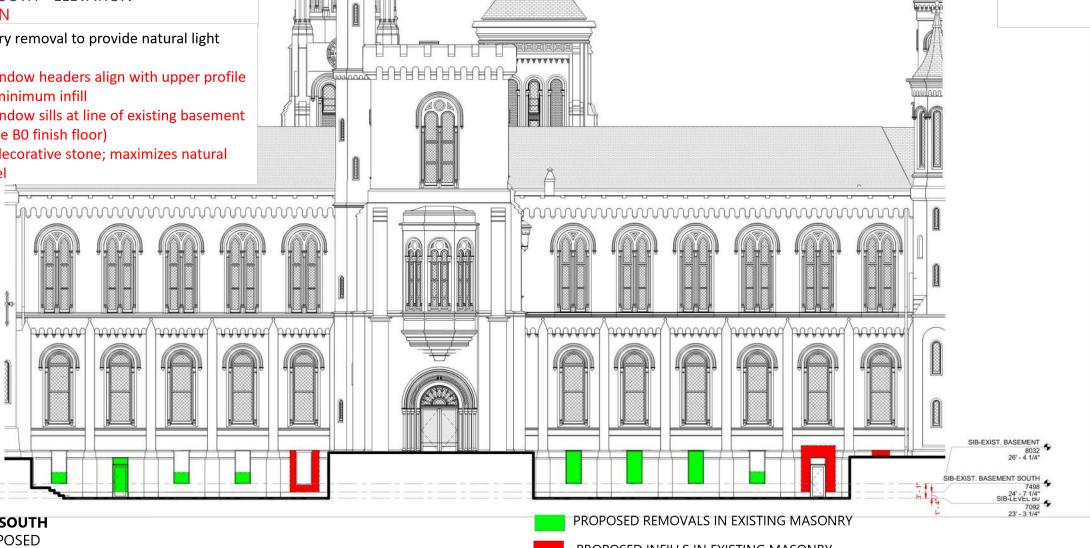
**ELEVATION - PROPOSED**

MAIN BUILDING SOUTH - ELEVATION PREFERRED OPTION

- Requires masonry removal to provide natural light into B0 level
- All basement window headers align with upper profile of water table, minimum infill
- All basement window sills at line of existing basement level (3'-1" above B0 finish floor)
- Least effect on decorative stone; maximizes natural light into B0 level

**MAIN BUILDING SOUTH**

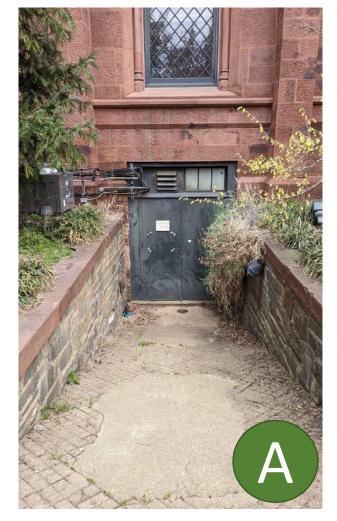
EXISTING DOOR AT SOUTHEAST OF GREAT HALL

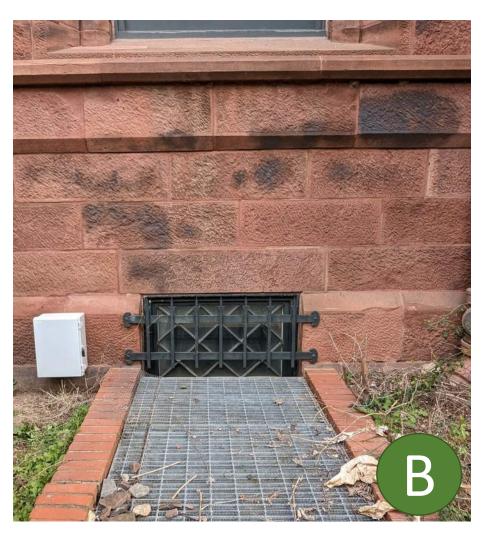
EXISTING WINDOW AT SOUTHEAST OF GREAT HALL

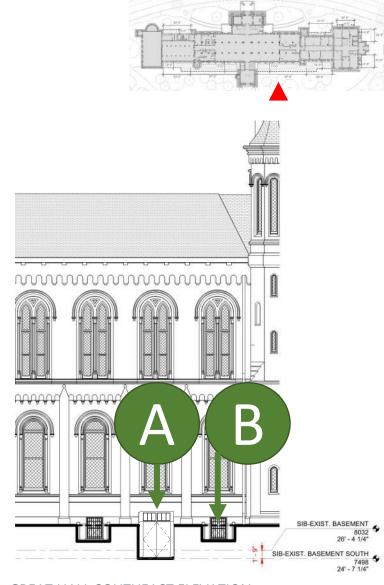
**GREAT HALL SOUTHEAST ELEVATION**

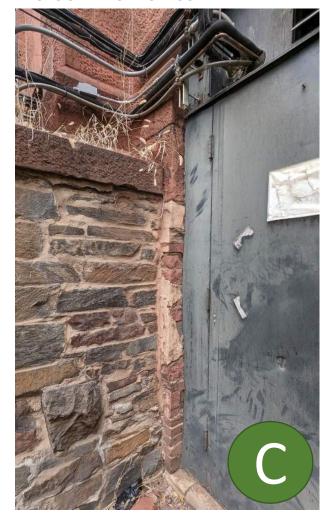
EXISTING DOOR AT SOUTHEAST OF GREAT HALL

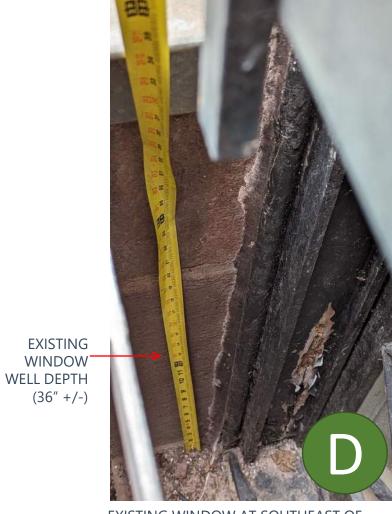
**EXISTING WINDOW AT SOUTHEAST OF GREAT HALL**

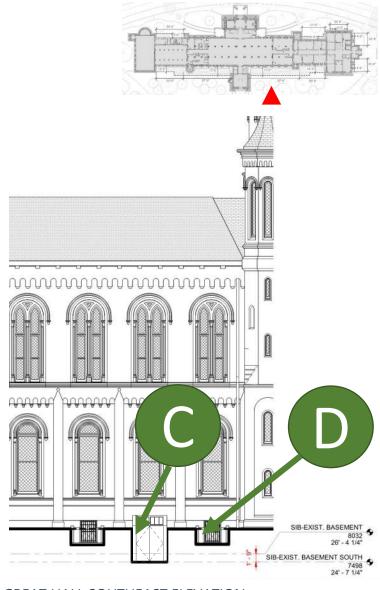
**GREAT HALL SOUTHEAST ELEVATION**

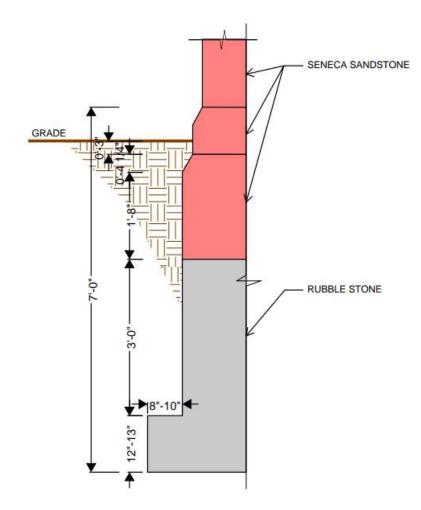
STRUCTURAL TESTPIT FINDINGS

DIAGRAM OF BELOW GRADE EXTERIOR ASSEMBLY

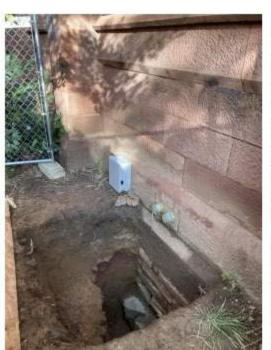
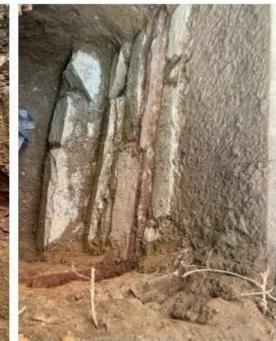
IMAGES FROM STRUCTURAL TESTPIT EXPLORATION

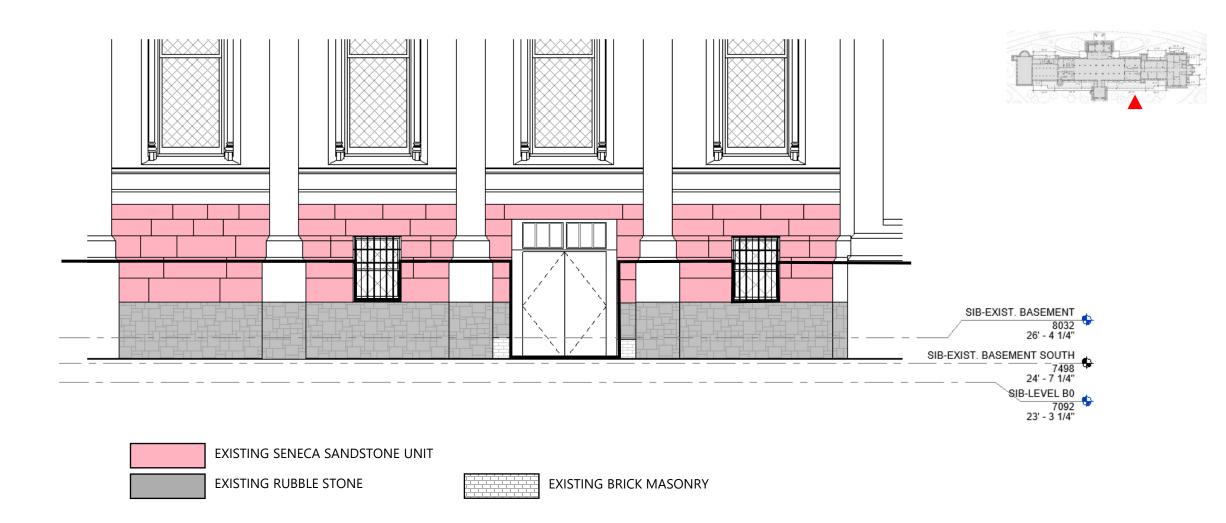
MAIN BUILDING - SOUTH (EAST) ELEVATION

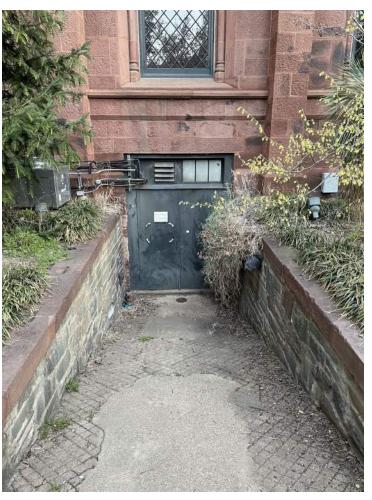
Existing ramp and door at the southeast corner of the Main Building.

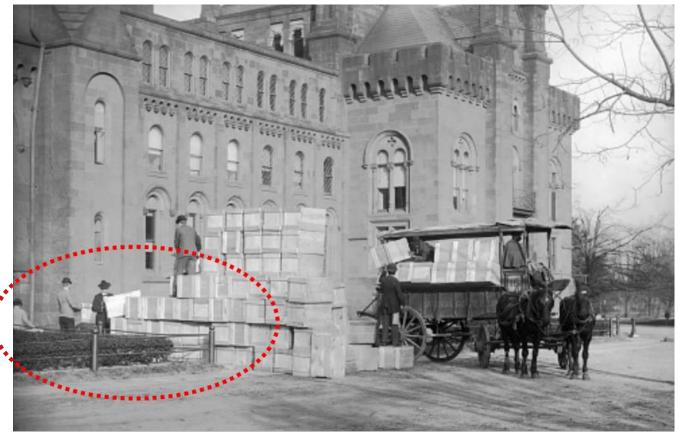
International Exchange Service Deliveries, 1910

In 1871 the loading ramp and door were installed

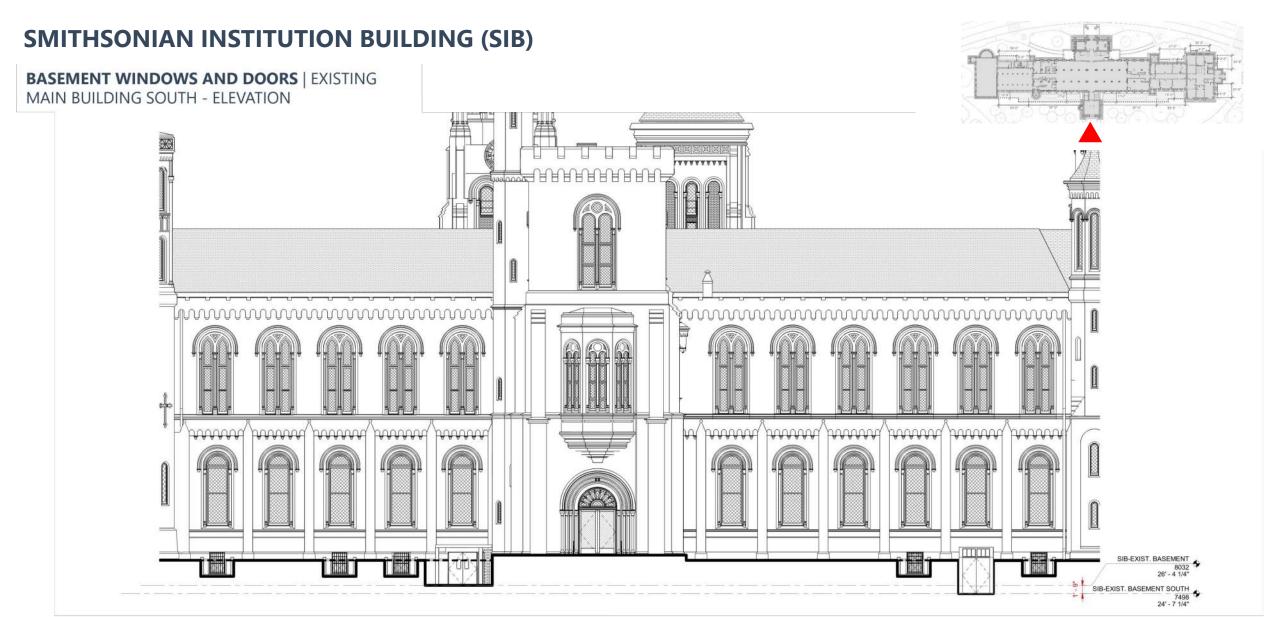
MAIN BUILDING SOUTH ELEVATION - EXISTING

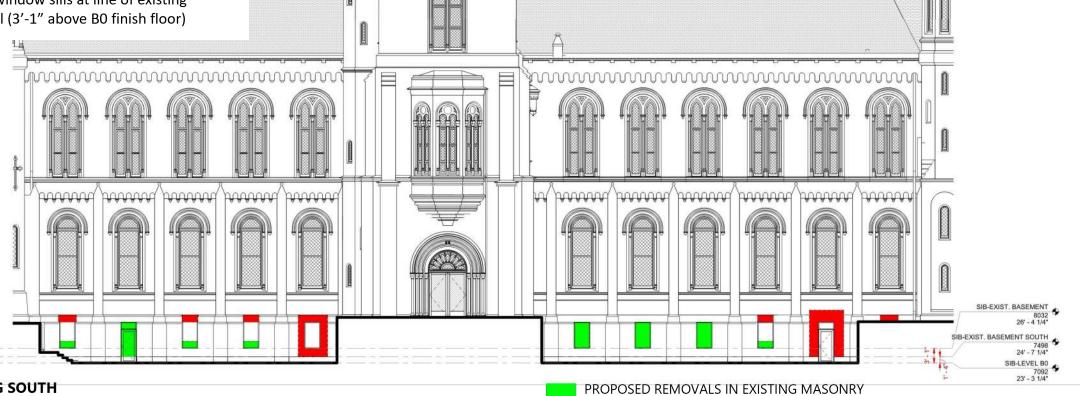
ELEVATION – PROPOSED (OPT 1)

MAIN BUILDING SOUTH - ELEVATION OPTION 1 (PREVIOUSLY PROPOSED – NOT PREFERRED)

- Requires masonry removal to provide natural light into B0 level
- All basement window headers align with lower profile of water table
- Infill above windows in water table not preferred
- All basement window sills at line of existing basement level (3'-1" above B0 finish floor)

PROPOSED INFILLS IN EXISTING MASONRY

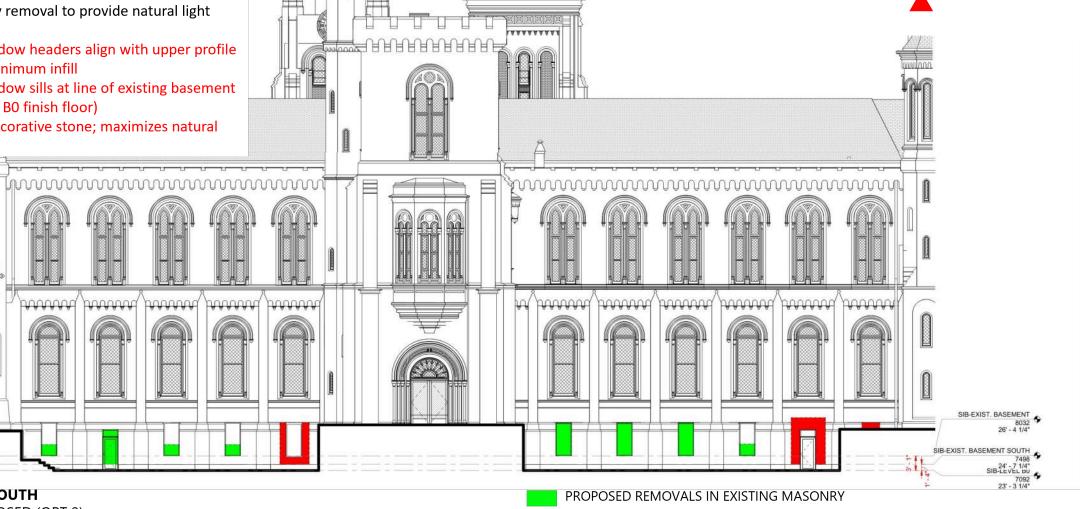
ELEVATION – PROPOSED (OPT 2)

MAIN BUILDING SOUTH - ELEVATION **OPTION 2 - PREFERRED OPTION**

- Requires masonry removal to provide natural light into B0 level
- All basement window headers align with upper profile of water table, minimum infill
- All basement window sills at line of existing basement level (3'-1" above B0 finish floor)
- Least effect on decorative stone; maximizes natural light into B0 level

PROPOSED INFILLS IN EXISTING MASONRY

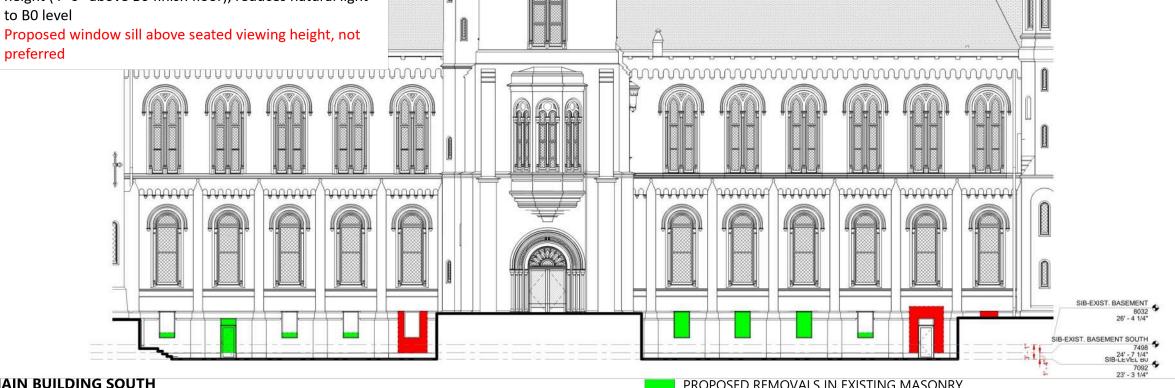
ELEVATION – PROPOSED (OPT 3)

MAIN BUILDING SOUTH - ELEVATION **OPTION 3**

- Requires masonry removal to provide natural light into B0 level
- All basement window headers align with upper profile of water table, minimizes infill
- All basement window sills at line of existing basement sill height (4'-6" above B0 finish floor), reduces natural light to B0 level
- preferred

PROPOSED REMOVALS IN EXISTING MASONRY

PROPOSED INFILLS IN EXISTING MASONRY

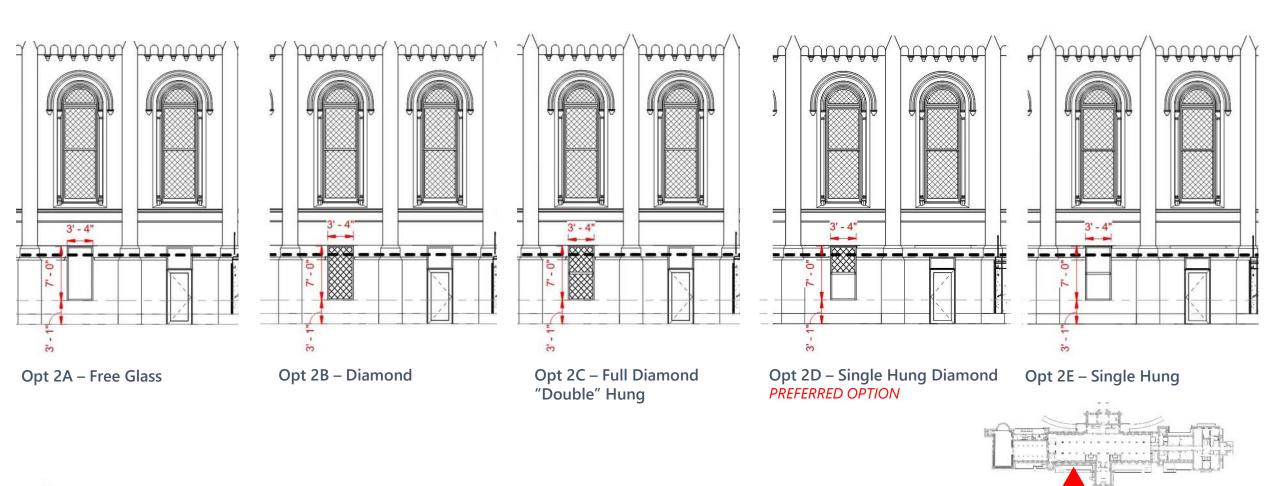
**BASEMENT WINDOWS AND DOORS** | PROPOSED MAIN BUILDING SOUTH - EXTERIOR DETAIL OPTION 2 – SASH OPTIONS

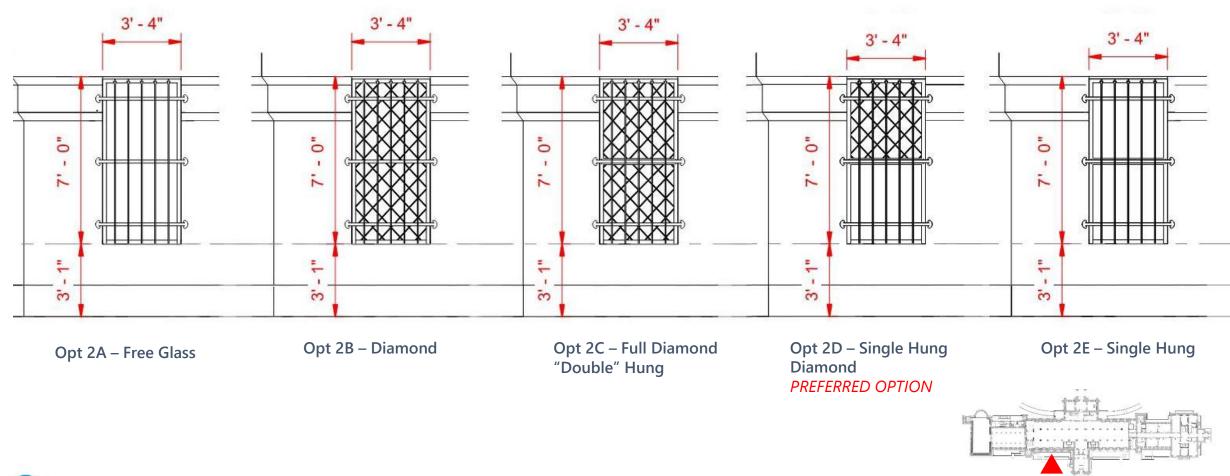
**BASEMENT WINDOWS AND DOORS** | PROPOSED MAIN BUILDING SOUTH - EXTERIOR DETAIL OPTION 2 – SASH OPTIONS WITH EXTERIOR GRILLES

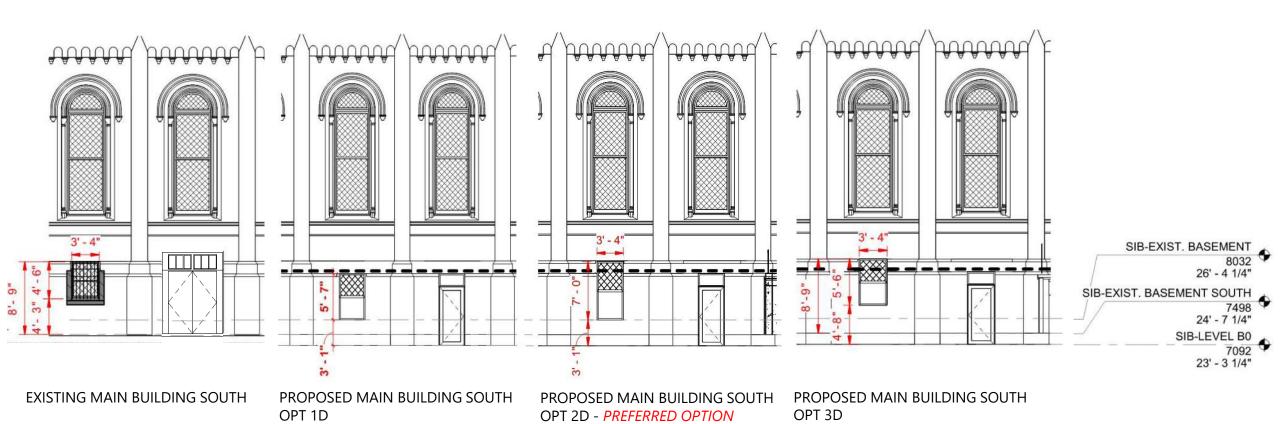
#### **BASEMENT WINDOWS AND DOORS** | PROPOSED

MAIN BUILDING SOUTH - EXTERIOR DETAIL COMPARISON OF OPTIONS

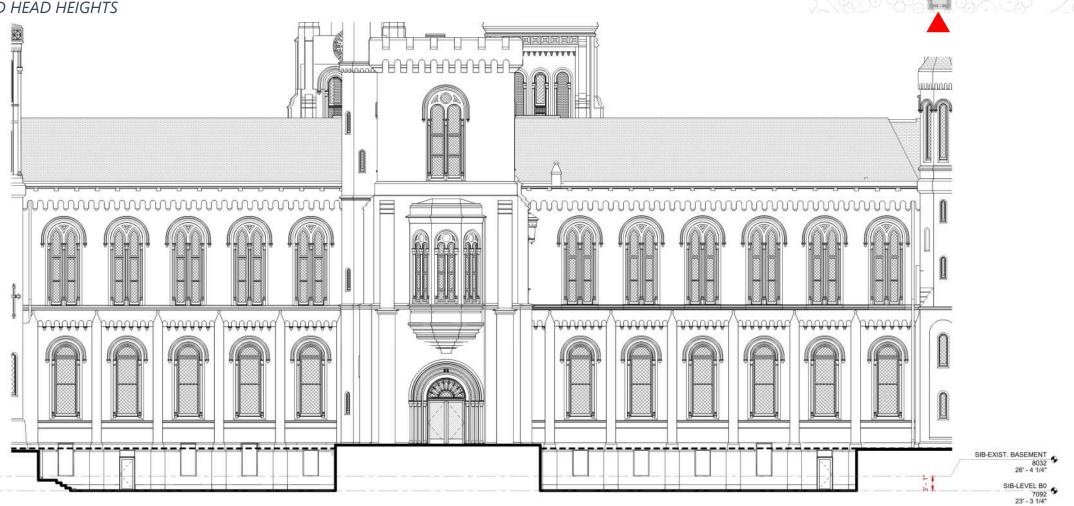
PROPOSED MAIN BUILDING SOUTH - OPTION 4

MAIN BUILDING SOUTH - ELEVATION OPTION 4 - MIXED HEAD HEIGHTS

New window opening heads aligned with grade Existing window openings increased to 7'-0" high, heads remain at existing height

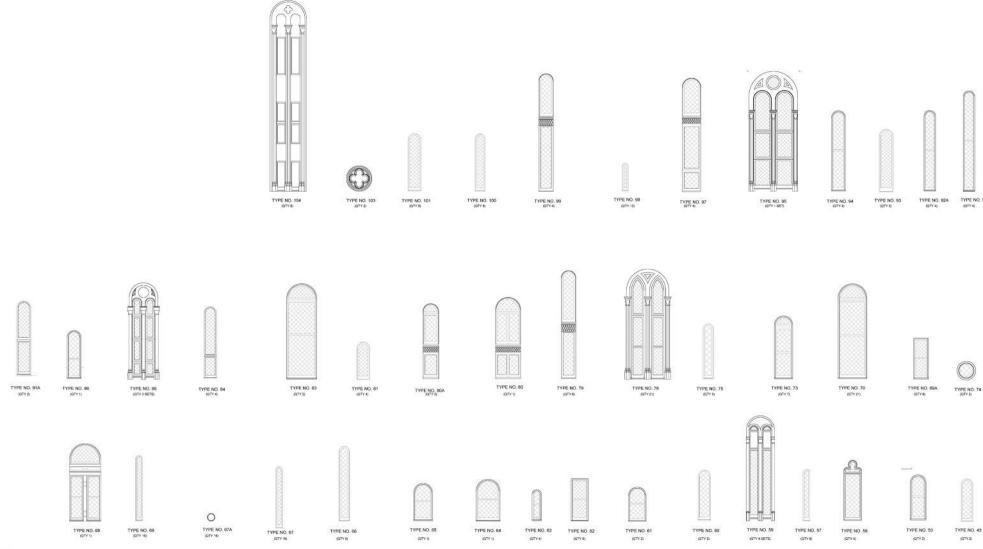
WINDOW REPLACEMENT | EXTERIOR APPEARANCE SHAPE, TYPE

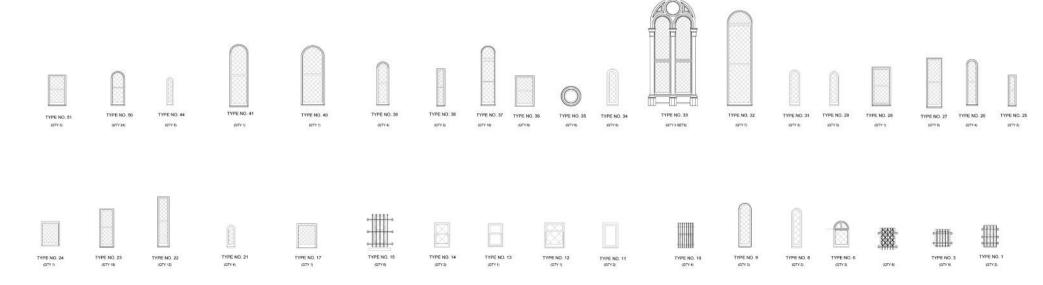
#### WINDOW REPLACEMENT | EXTERIOR APPEARANCE

SHAPE, TYPE

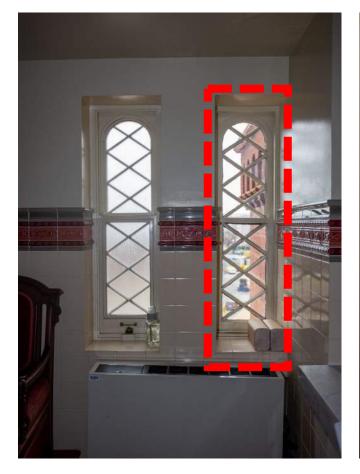
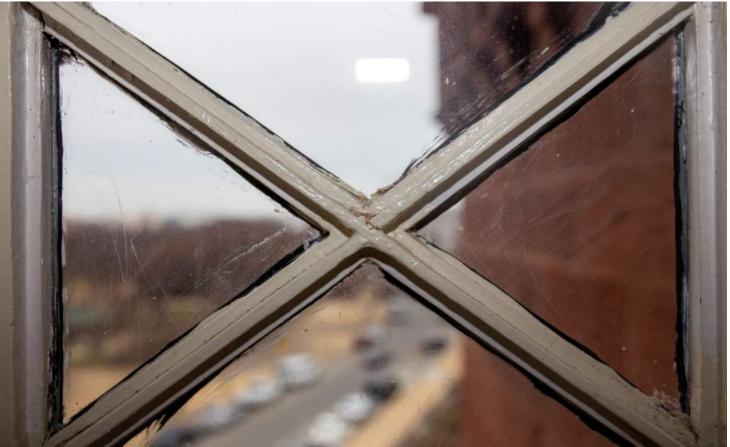
WINDOW REPLACEMENT | MUNTIN PROFILE **EXISTING**

SURVIVING HISTORIC SASH (LEVEL 4)

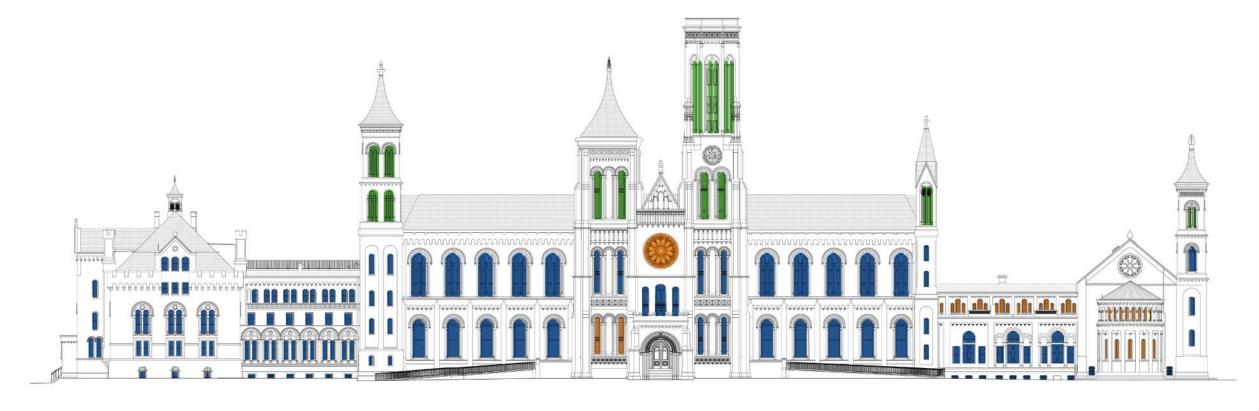
WINDOW REPLACEMENT | PROPOSED **NORTH ELEVATION**

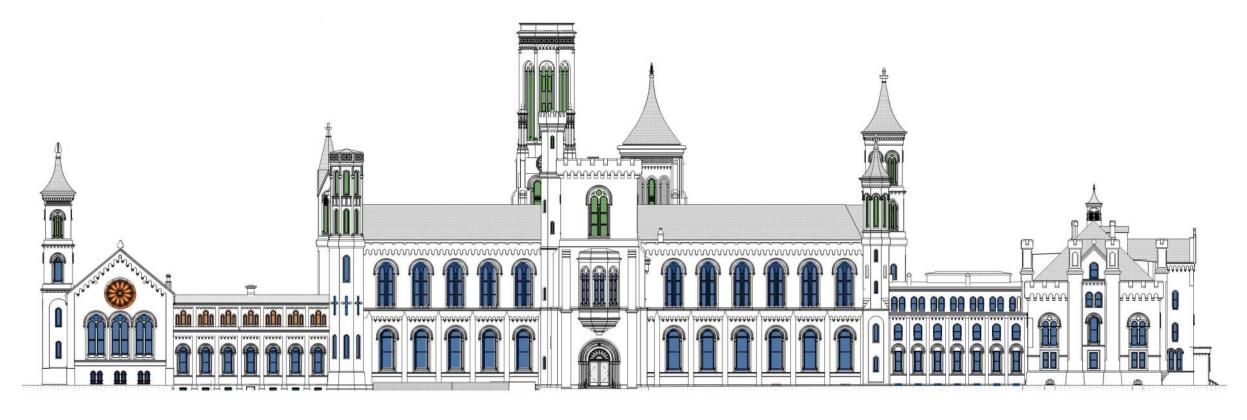
**SOUTH ELEVATION**

WINDOW REPLACEMENT | PROPOSED SOUTH ELEVATION

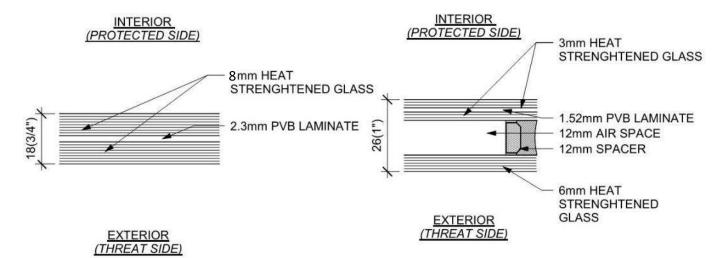
3 mm (1/8") heat strengthened glass 1.52 mm (0.060") PVB laminate 3 mm (1/8") heat strengthened glass 12 mm (1/2") air space 6 mm (1/4") heat strengthened glass

Exterior (threat) side

LAMINATED GLAZING FOR BLAST STORM PANEL

INSULATED GLAZING UNIT (IGU) FOR STEEL REPLACEMENT WINDOW

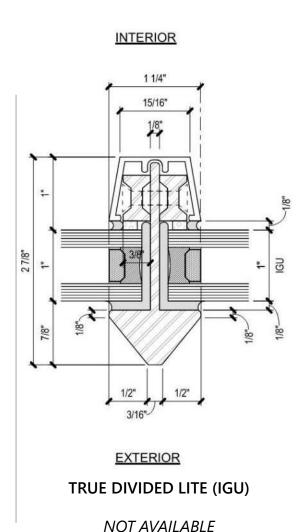
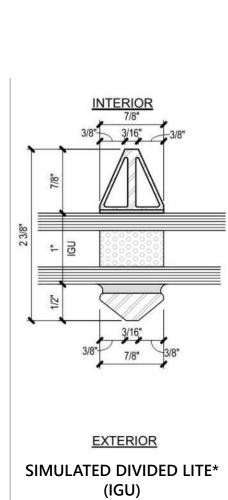
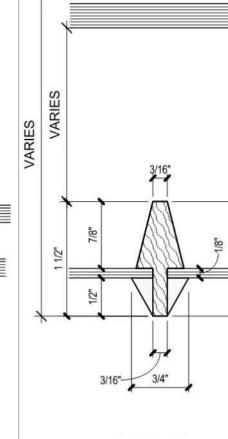
MUNTIN DETAIL COMPARISON

**EXTERIOR**

**EXISTING (AS FOUND)**

INTERIOR

**ONLY OPTION**

**HISTORIC + NEW STORM** (BLAST STORM PANEL)

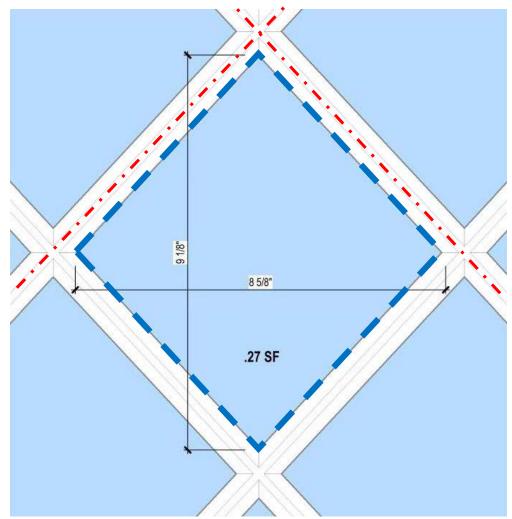
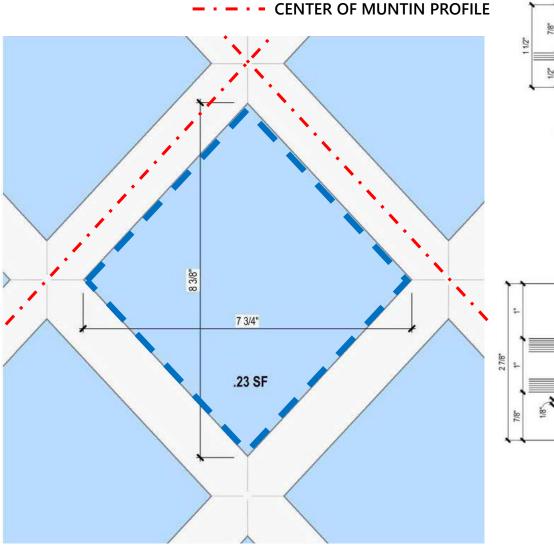
WINDOW REPLACEMENT | PROPOSED MUNTIN GLAZING COMPARISON - TRUE DIVIDED LITE

**AREA OF FREE GLASS**

**EXISTING (AS FOUND)**

TRUE DIVIDED LITE - NOT AVAILABLE

**CHANGE IN AREA OF** FREE GLASS = -15%

8 5/8"

.27 SF

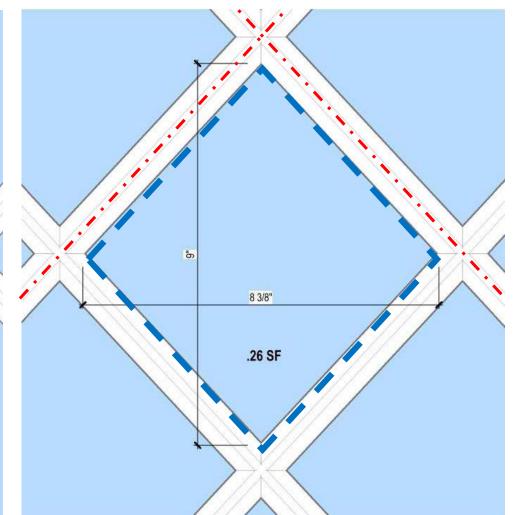
WINDOW REPLACEMENT | PROPOSED MUNTIN GLAZING COMPARISON – SIMULATED DIVIDED LITE - ONLY OPTION

**AREA OF FREE GLASS**

**CENTER OF MUNTIN PROFILE**

SIMULATED DIVIDED LITE - ONLY OPTION

**CHANGE IN AREA OF** FREE GLASS = -4%

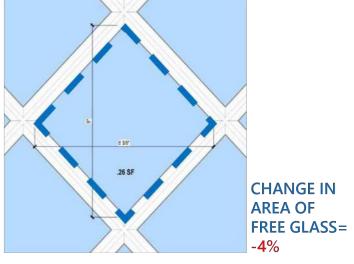
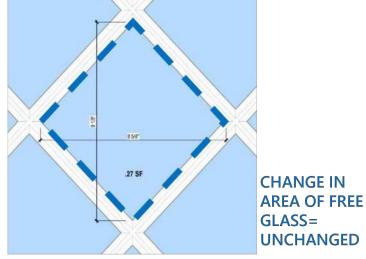
WINDOW REPLACEMENT | PROPOSED MUNTIN GLAZING COMPARISON - SUMMARY

#### AREA OF FREE GLASS

# **REPLACEMENT TYPES**

TRUE DIVIDED LITE

**CHANGE IN AREA OF FREE GLASS= -15%**

SIMULATED DIVIDED LITE

**ONLY OPTION**

**HISTORIC / NEW STEEL WINDOW** + NEW STORM (AT INTERIOR)

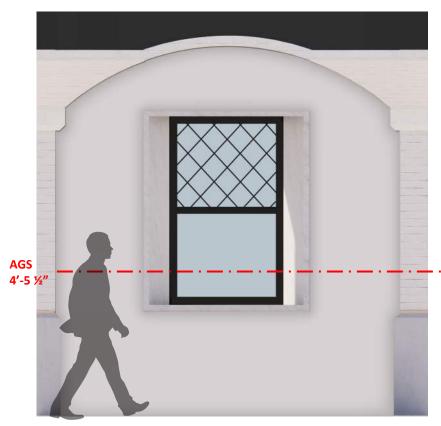
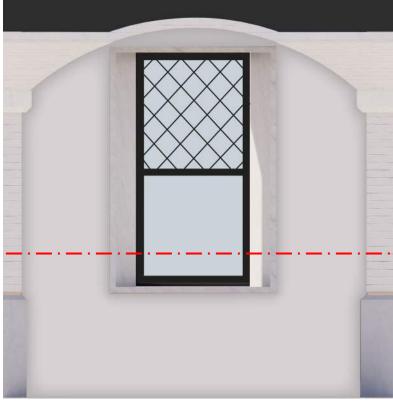
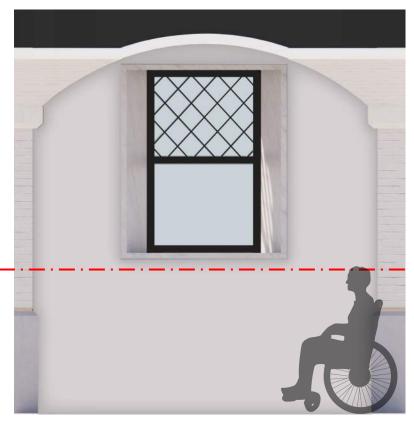
MAIN BUILDING BASEMENT - WINDOW SIZE OPTION VISUALIZATION COMPARISON

#### **FEATURES:**

#### **OPTION 1**

- 3'-4" x 5'-7"
- HEADER AT LOWER WATER LINE
- SILL AT EXISTING BASEMENT DATUM

#### **OPTION 2 – PREFERRED OPTION**

- 3'-4" x 7'-0"
- HEADER AT EXISTING HEADER HEIGHT
- SILL AT EXISTING BASEMENT DATUM

#### **OPTION 3**

- 3'-4" x 5'-7"
- HEADER AT EXISTING HEADER HEIGHT
- SILL AT 4'-7"

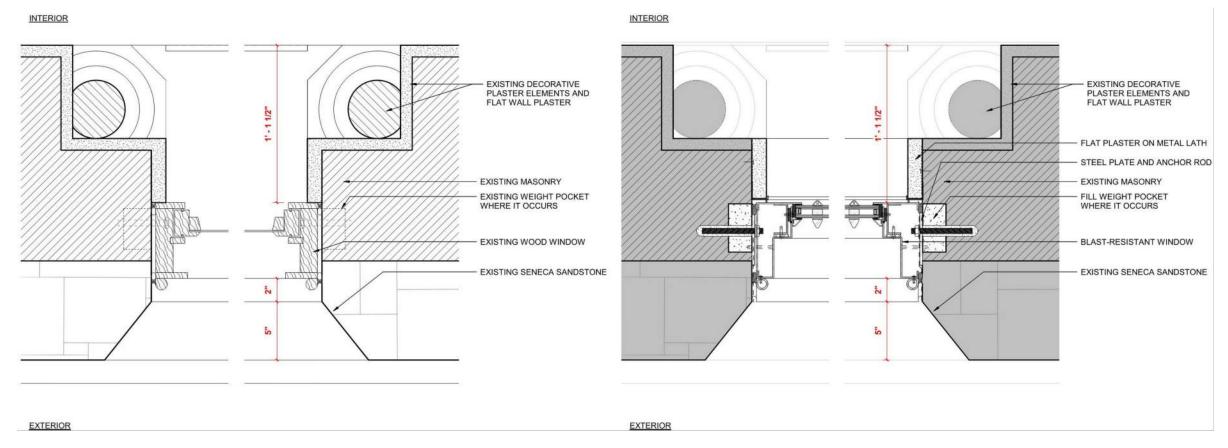
WINDOW REPLACEMENT | TYPICAL ANCHORAGE DETAIL NEW BLAST WINDOW (ADDITIONAL STRENGTHENING WHERE REQUIRED)

**EXISTING WINDOW PLAN DETAIL**

#### PROPOSED WINDOW PLAN DETAIL

\* WHERE STRENGTHENING IS REQUIRED, STEEL PLATE FOR STRENGTHENING IS WITHIN WINDOW FRAME DEPTH

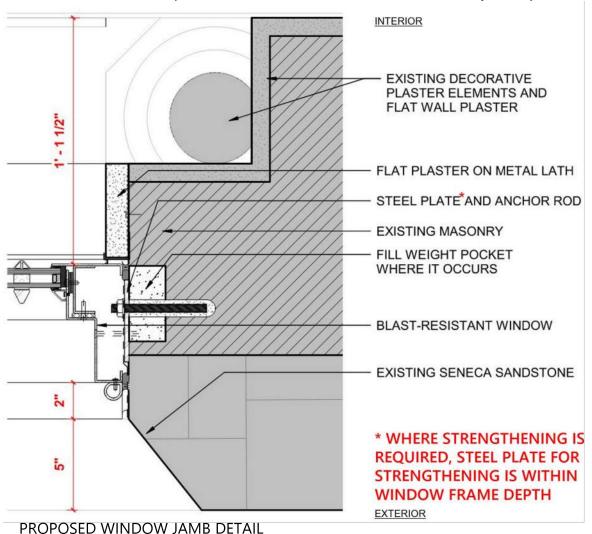
WINDOW REPLACEMENT | TYPICAL ANCHORAGE JAMB DETAIL NEW BLAST WINDOW (ADDITIONAL STRENGTHENING WHERE REQUIRED)

- Typical blast window placed at same location as existing.
- Window anchorage concealed within window frame depth.
- Where strengthening is required steel plate is concealed within window frame depth.
- Minimal plaster removal required to remove existing window as plaster turns into existing wood frame.

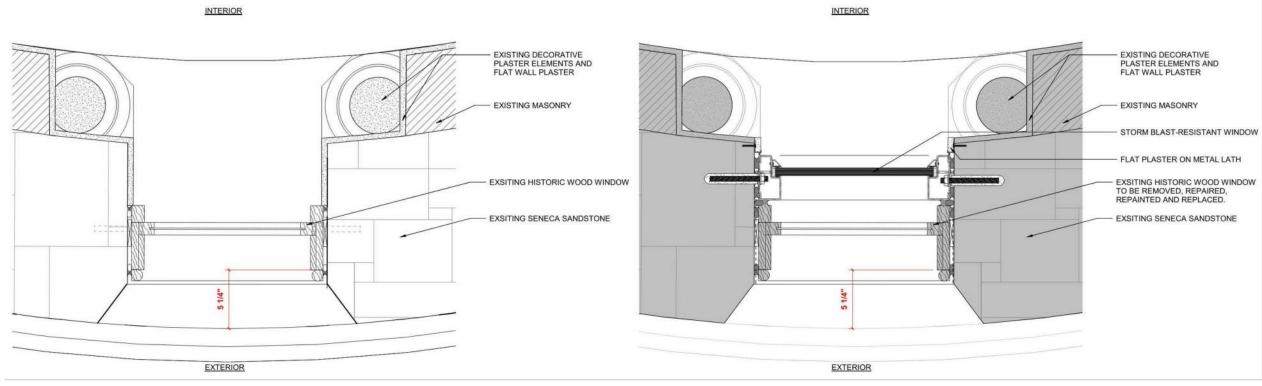
**WINDOW REPLACEMENT** | TYPICAL ANCHORAGE DETAIL NEW INTERIOR STORM WINDOW

**EXISTING WINDOW PLAN DETAIL**

PROPOSED WINDOW PLAN DETAIL

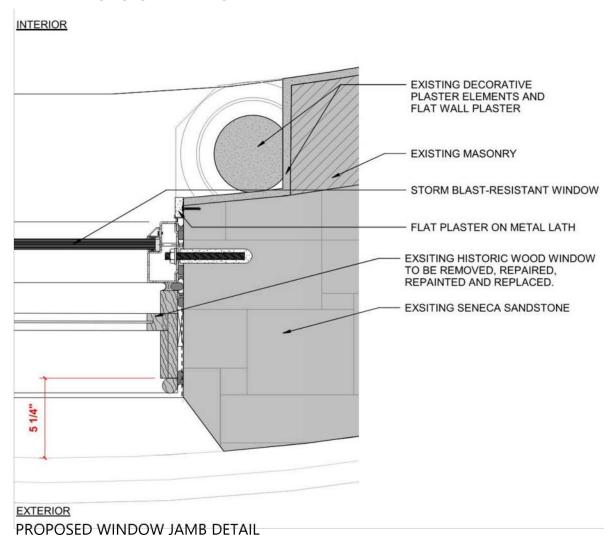
WINDOW REPLACEMENT | TYPICAL ANCHORAGE JAMB DETAIL **NEW INTERIOR STORM WINDOW**

- Typical interior storm blast window placed behind existing window.
- Window anchorage concealed within window frame depth.
- Minimal plaster removal required to remove existing window for repairs as plaster turns into existing wood frame.

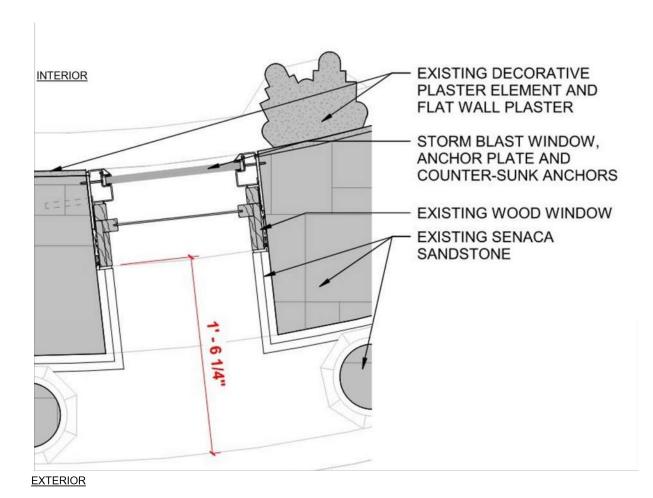
**WINDOW REPLACEMENT** | TYPICAL ANCHORAGE DETAIL NEW INTERIOR STORM WINDOW + WALL STRENGTHENING

#### **INTERIOR INTERIOR** EXISTING DECORATIVE EXISTING DECORATIVE PLASTER ELEMENT AND PLASTER ELEMENT AND FLAT WALL PLASTER FLAT WALL PLASTER STORM BLAST WINDOW, ANCHOR PLATE AND EXISTING WOOD WINDOW COUNTER-SUNK ANCHORS EXISTING WOOD WINDOW EXISTING SENACA **EXISTING SENACA** SANDSTONE SANDSTONE **EXTERIOR EXTERIOR**

PROPOSED WINDOW JAMB DETAIL

- Typical interior storm blast window placed behind existing window.
- Window anchorage concealed within window frame depth.
- Steel plate required for strengthening concealed within window frame depth.
- Minimal plaster removal required to remove existing window as plaster turns into existing wood frame.

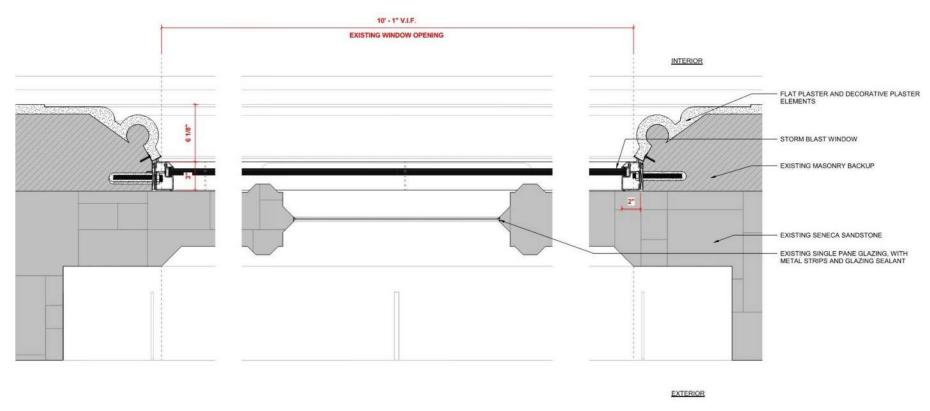
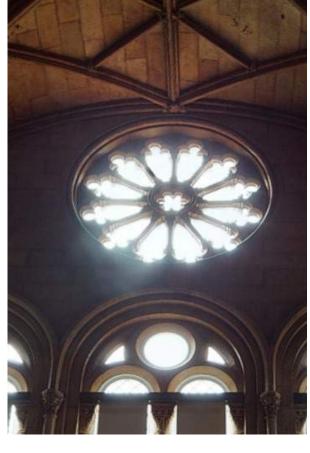
WINDOW REPLACEMENT | TYPICAL ANCHORAGE DETAIL NEW INTERIOR STORM ROSE WINDOW – COMMONS (SINGLE PANE GLAZING)

#### **EXISTING WINDOW ELEVATION**

- Interior storm blast window placed behind existing window with single pane glazing.
- Window anchorage and strengthening concealed within window frame depth.
- Minimal plaster removal required to attach frame to masonry.

PROPOSED WINDOW PLAN DETAIL

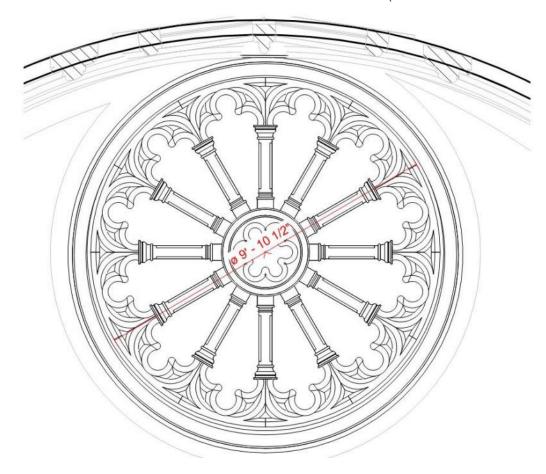
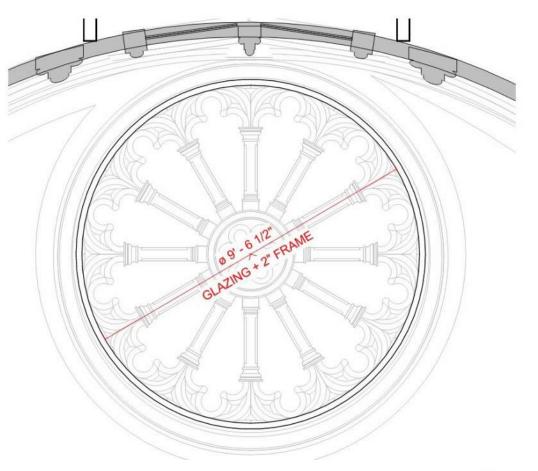
WINDOW REPLACEMENT | TYPICAL ANCHORAGE DETAIL NEW INTERIOR STORM ROSE WINDOW – COMMONS (SINGLE PANE GLAZING)

**EXISTING WINDOW INTERIOR ELEVATION**

PROPOSED WINDOW INTERIOR ELEVATION

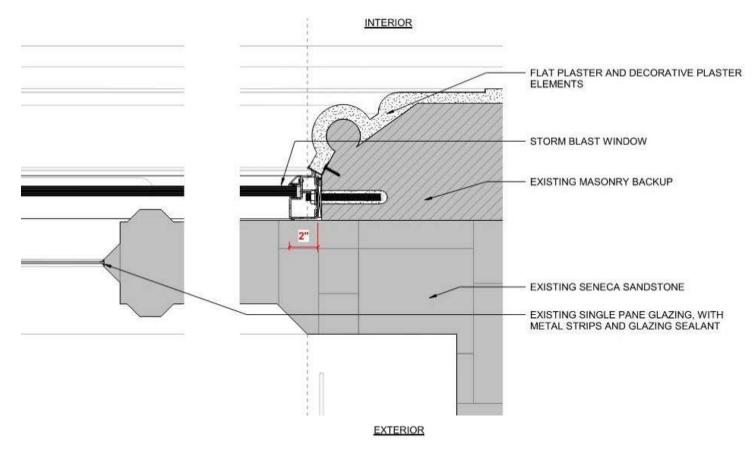
WINDOW REPLACEMENT | TYPICAL ANCHORAGE JAMB DETAIL NEW INTERIOR STORM ROSE WINDOW – COMMONS (SINGLE PANE GLAZING)

PROPOSED WINDOW JAMB DETAIL

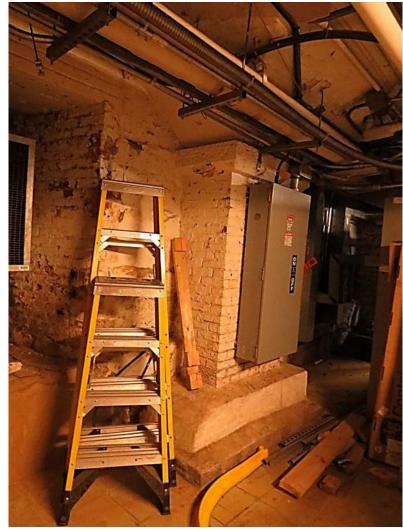
**BO VISITOR AMENITIES** | EXTENSION OF BO PIER ELEVATION

**EXISTING PIER AT SOUTH ELEVATION**

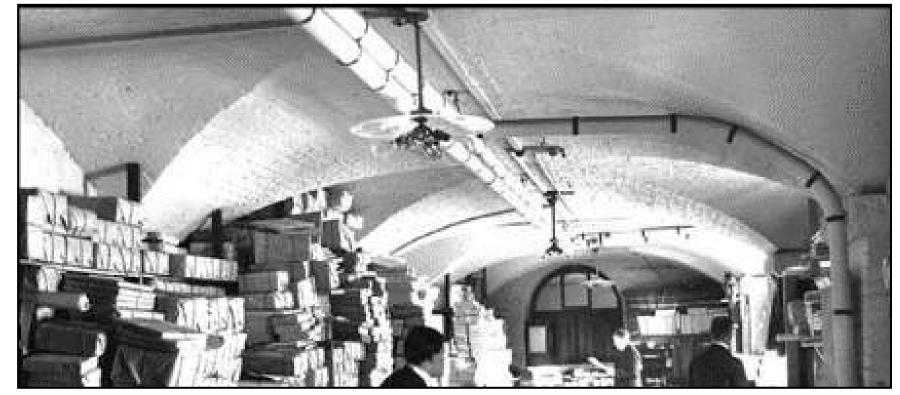
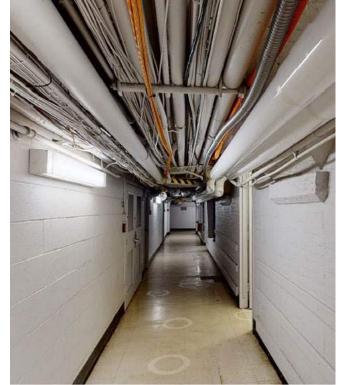
**BO VISITOR AMENITIES** | HISTORIC BASEMENT IMAGE

**BASEMENT CEILING PAINTED WHITE**

EXISTING VISIBILITY OF BASEMENT CEILING

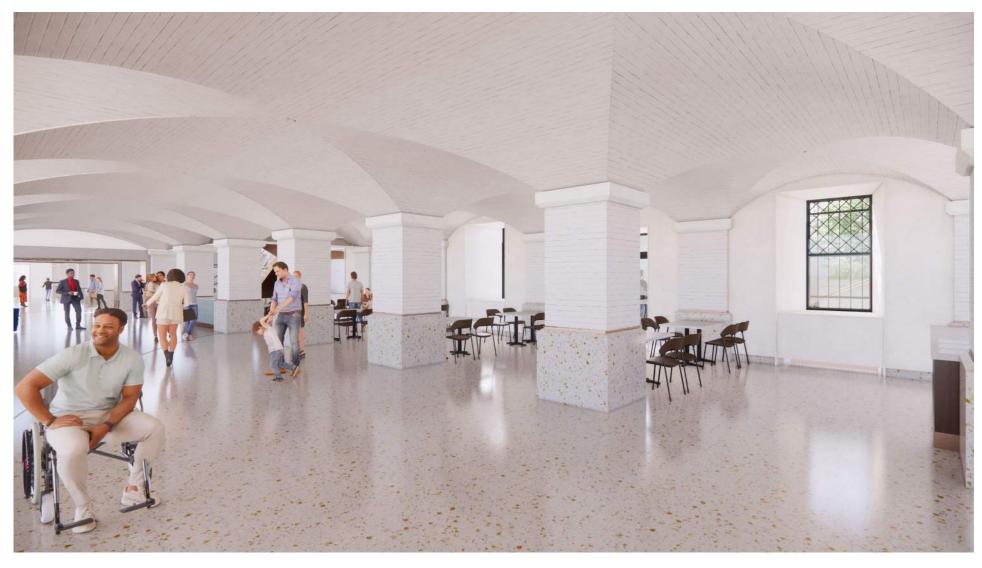
**BO VISITOR AMENITIES** | OPTION 1 PIER EXTENSION AND FLOORING

**COLUMN EXTENSION** TERRAZZO OPTION #1

FLOOR TERRAZZO 01

FLOOR TERRAZZO 02

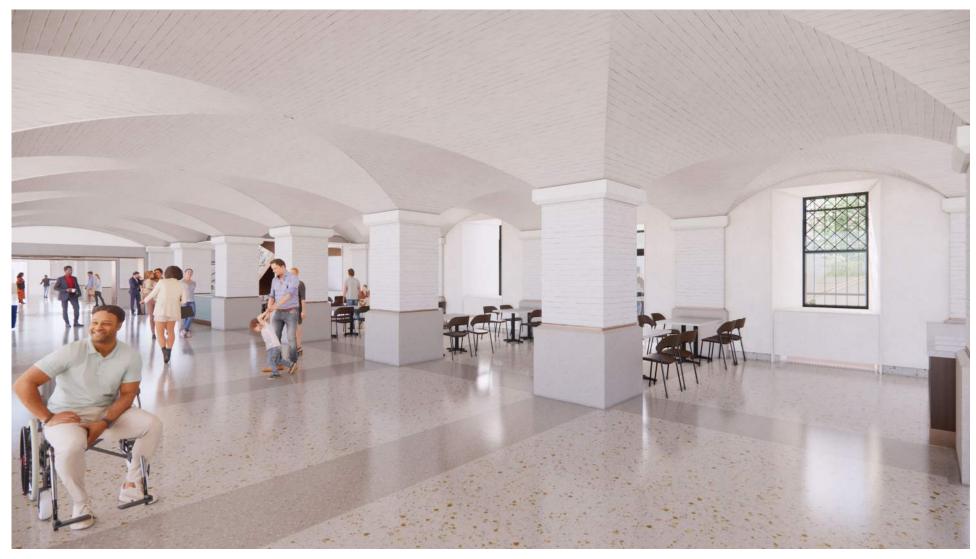
**BO VISITOR AMENITIES** | OPTION 2 PIER EXTENSION AND FLOORING

**COLUMN EXTENSION** PARGE MATERIAL OPTION #2

FLOOR TERRAZZO 01

FLOOR TERRAZZO 02

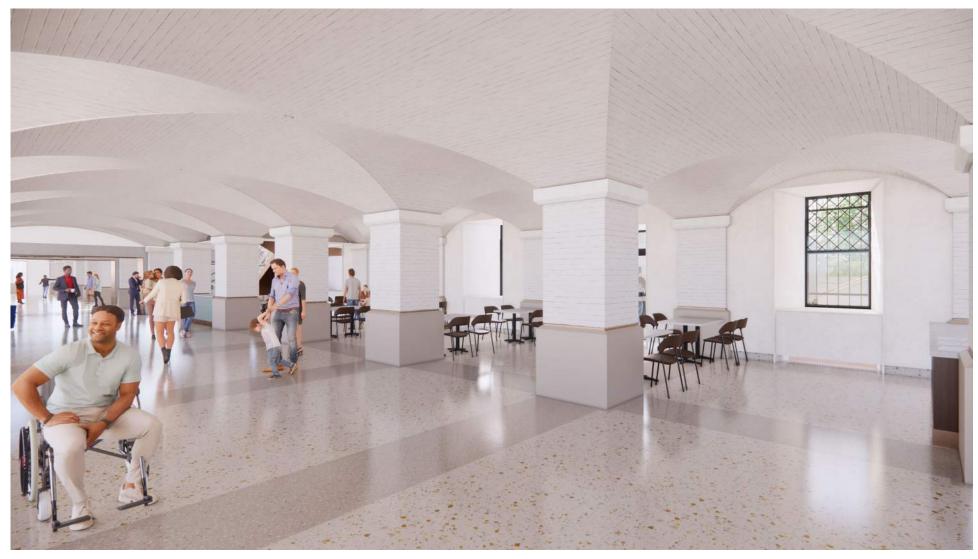
**BO VISITOR AMENITIES** | OPTION 3 PIER EXTENSION AND FLOORING

**COLUMN EXTENSION** STONE OPTION #3 Indiana Limestone - Sandblasted

FLOOR TERRAZZO 01

FLOOR TERRAZZO 02

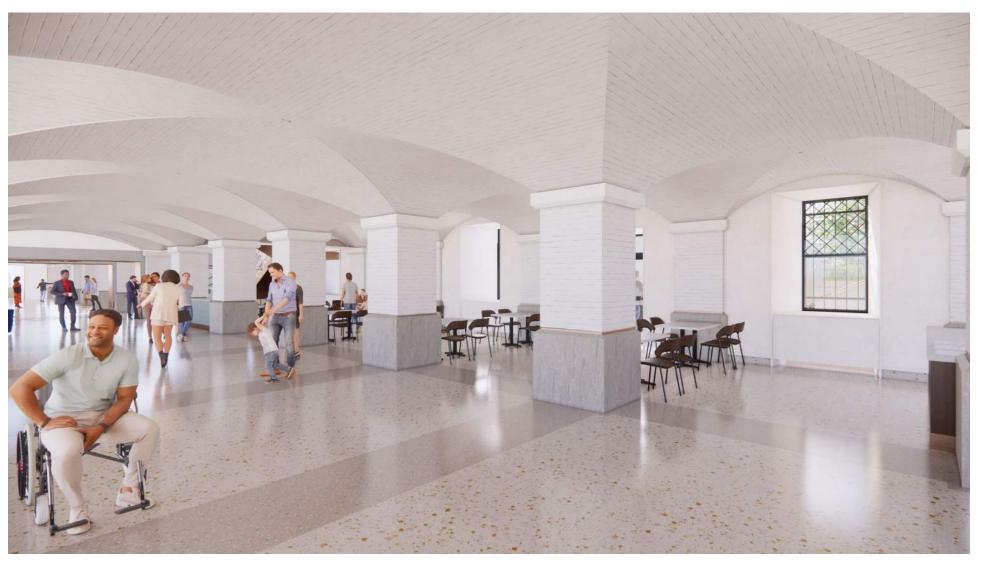
**BO VISITOR AMENITIES** | OPTION 4 - PREFERRED PIER EXTENSION AND FLOORING

**COLUMN EXTENSION** STONE OPTION #4 St. Clair Limestone

FLOOR TERRAZZO 01

FLOOR TERRAZZO 02

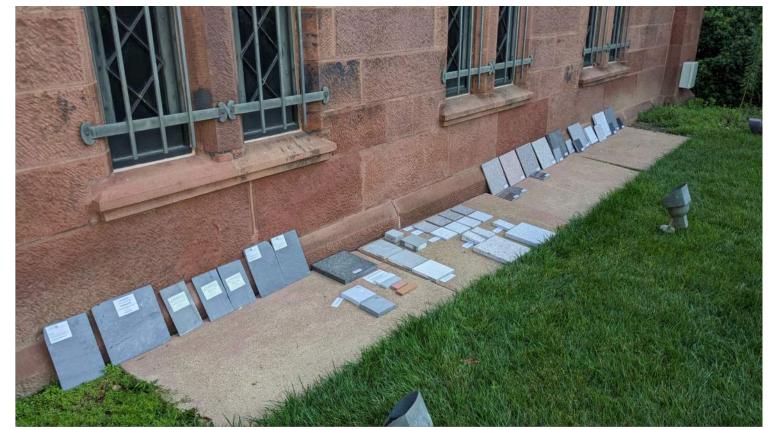
- Materials reviewed for:
  - Perimeter Security Hardened Elements (North Entry)
  - Areaway Finishes (Granite, UHPC, Pavers, Precast Treads)
  - Roof slate

LEFT TO RIGHT: ROOF SLATE, AREAWAY MATERIALS, PERIMETER SECURITY MATERIALS

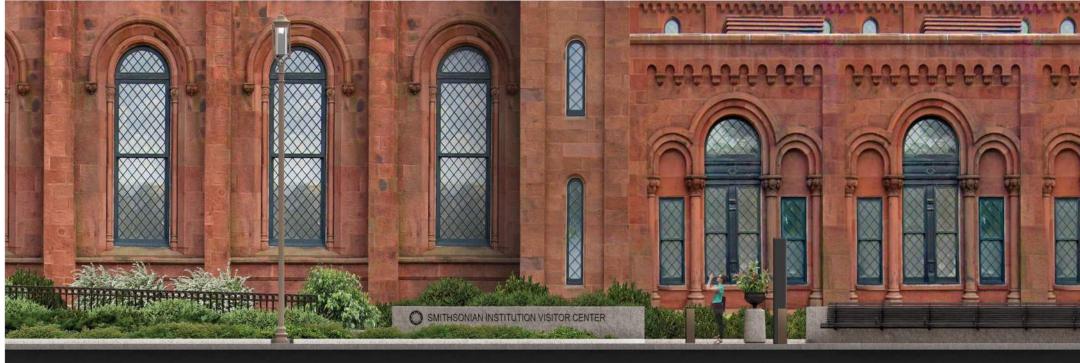
PERIMETER SECURITY HARDENED ELEMENTS STONE OPTIONS – PRAIRIE BROWN

PRAIRIE BROWN (FINISH TBD)

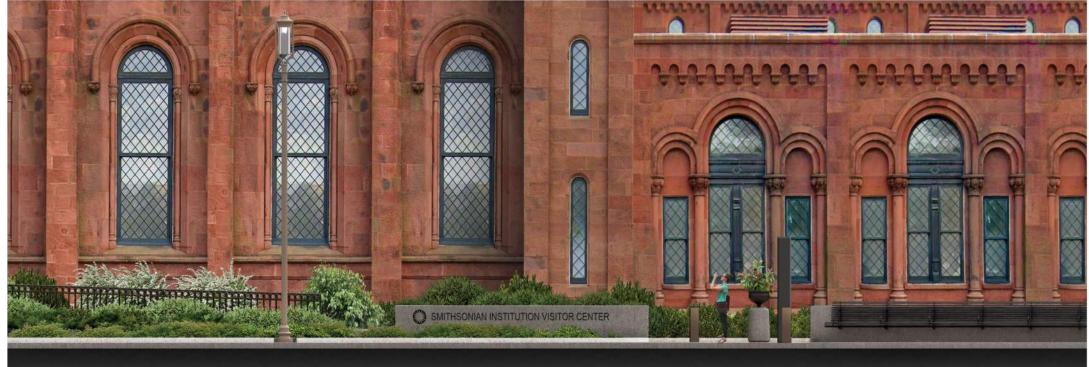
PERIMETER SECURITY HARDENED ELEMENTS STONE OPTIONS – OLYMPIC BLACK

OLYMPIC BLACK - SANDBLAST FINISH

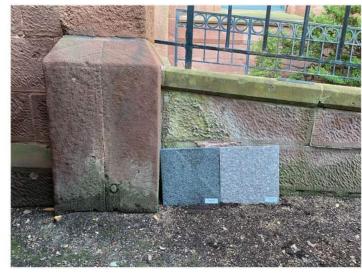
EXISTING CONDITIONS: SANDSTONE BLOCKS WITH STONE COPING

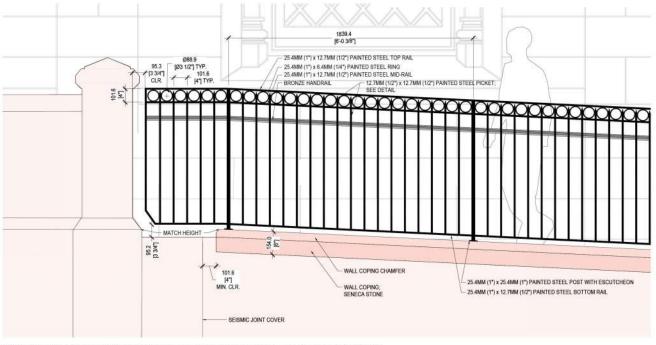
OLYMPIC BLACK (LEFT) SEISMIC JOINT COVER STONE AND PRAIRIE BROWN

PREFERRED OPTION: SENECA SANDSTONE MATCH FOR RAMP WALL (VENEER) AND COPING
