## Smithsonian Institution

## Revitalization of the Historic Core **CONSULTING PARTIES MEETING #15**

July 26, 2023

## **BASEMENT WINDOWS AND DOORS**

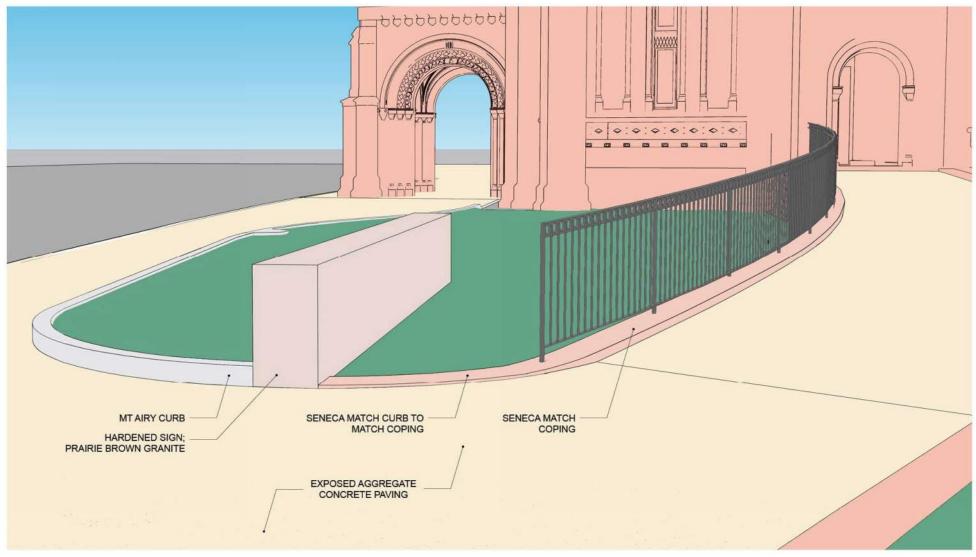
**SLOPED SIDEWALK FROM JEFFERSON DRIVE – WEST** | PROPOSED

OPTION 1 – PRAIRIE BROWN

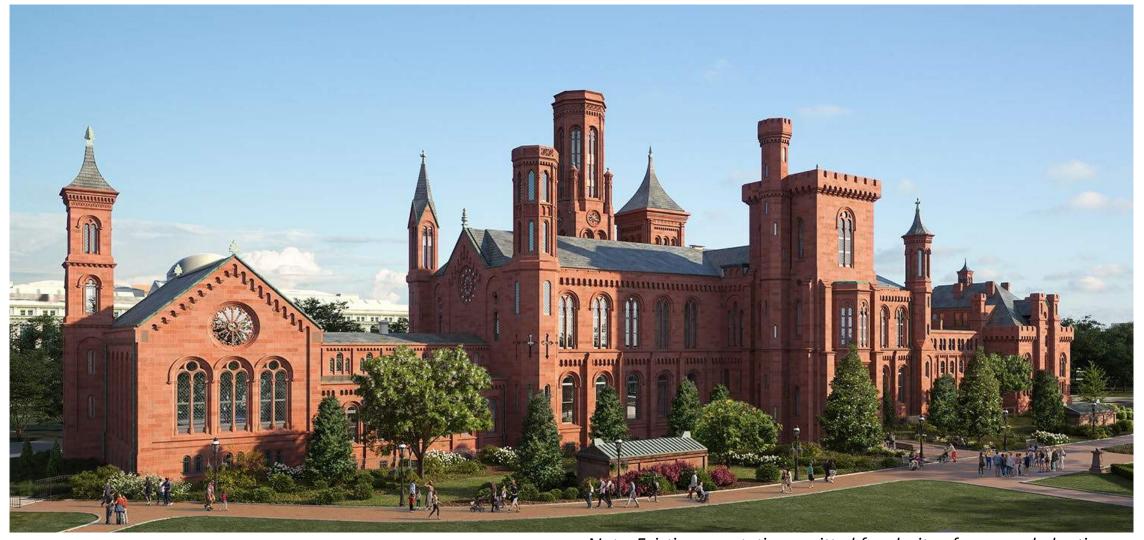
PLANTING PLAN | RENDERED VIEW: CASTLE SOUTH SIDE LOOKING NORTHEAST

Note: Existing vegetation omitted for clarity of proposed plantings.

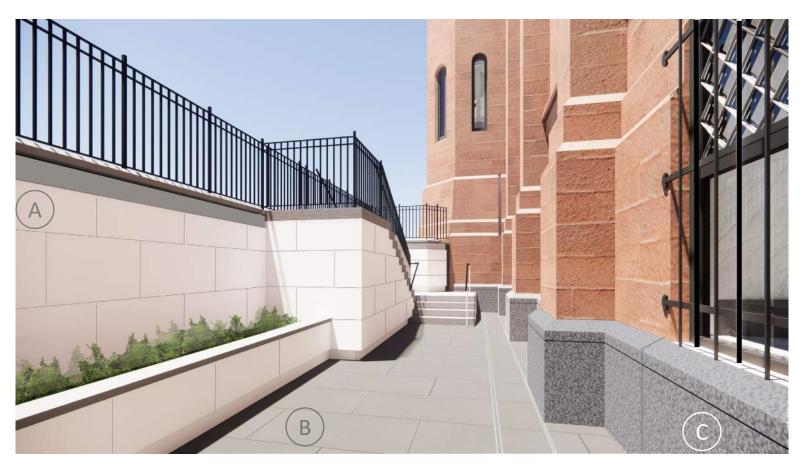
A) WALL – UHPC (CUSTOM MIX BASED ON PORCELAIN PAVER)

B) PORCELAIN PEDESTAL PAVER - NANTUCKET

C) UNDERPINNING – OLYMPIC BLACK (SANDBLAST)

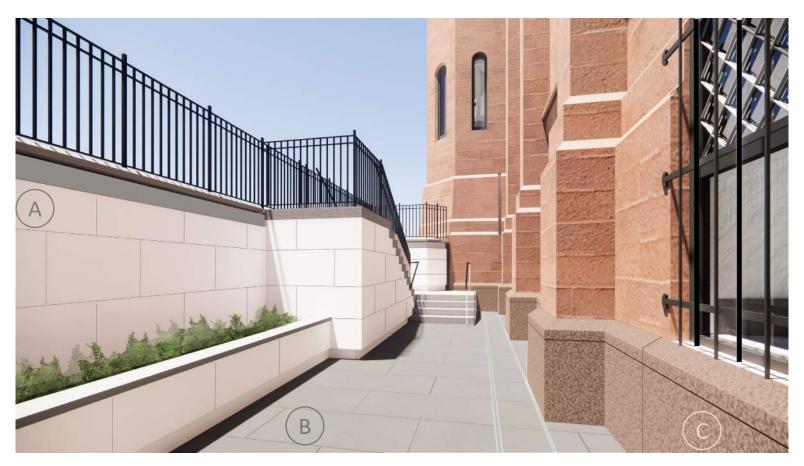
A) WALL – UHPC (CUSTOM MIX BASED ON PORCELAIN PAVER)

B) PORCELAIN PEDESTAL PAVER - NANTUCKET

C) UNDERPINNING – CARNELIAN

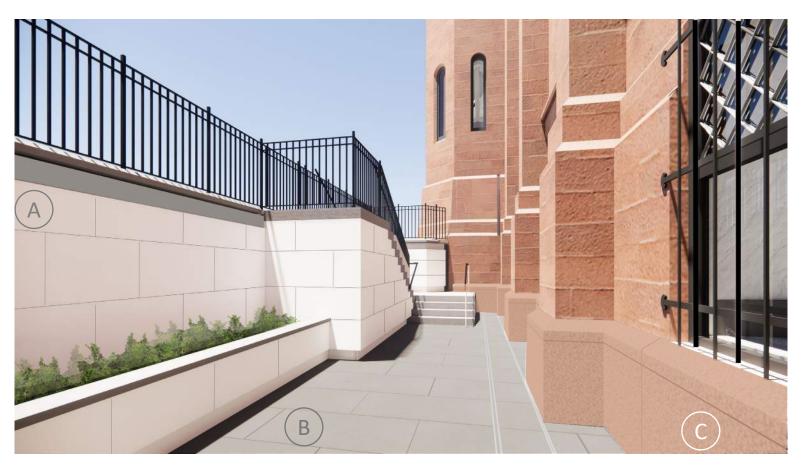
A) WALL – UHPC (CUSTOM MIX BASED ON PORCELAIN PAVER)

B) PORCELAIN PEDESTAL PAVER - NANTUCKET

C) PARGE – TINTED (LIGHTER)

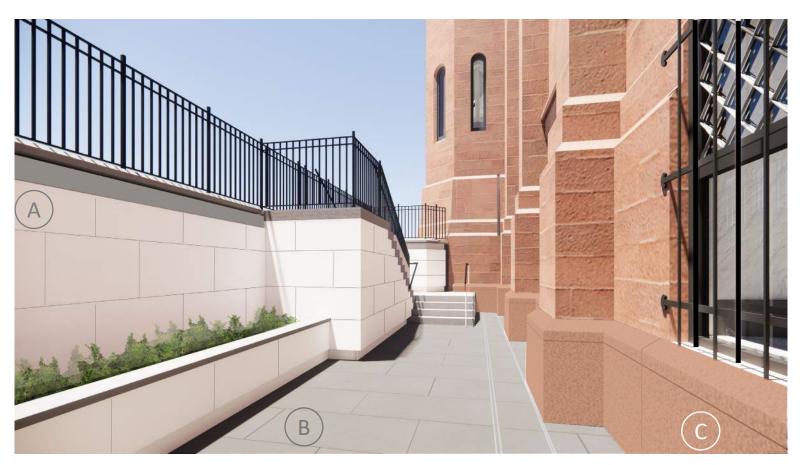
A) WALL – UHPC (CUSTOM MIX BASED ON PORCELAIN PAVER)

B) PORCELAIN PEDESTAL PAVER - NANTUCKET

C) PARGE – TINTED (DARKER)

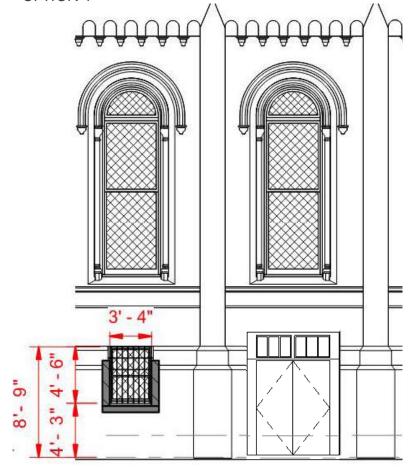
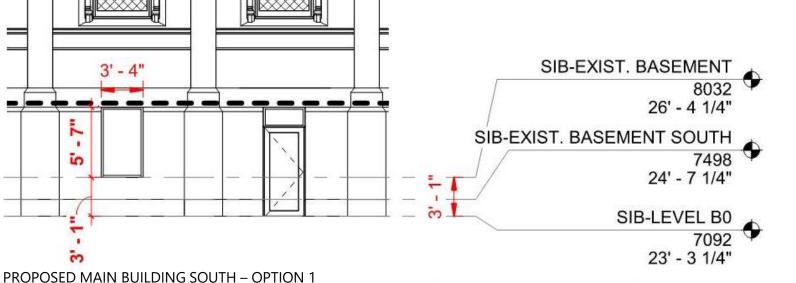
MAIN BUILDING SOUTH - EXTERIOR DETAIL **OPTION 1**

- 3'-4" wide x 4'-6" high
- **Diamond Muntin Pattern**
- Single-Hung

- 3'-4" wide x 5'-7" high
- Sill dropped to existing basement level
- · Window head aligned with grade

**EXISTING MAIN BUILDING SOUTH**

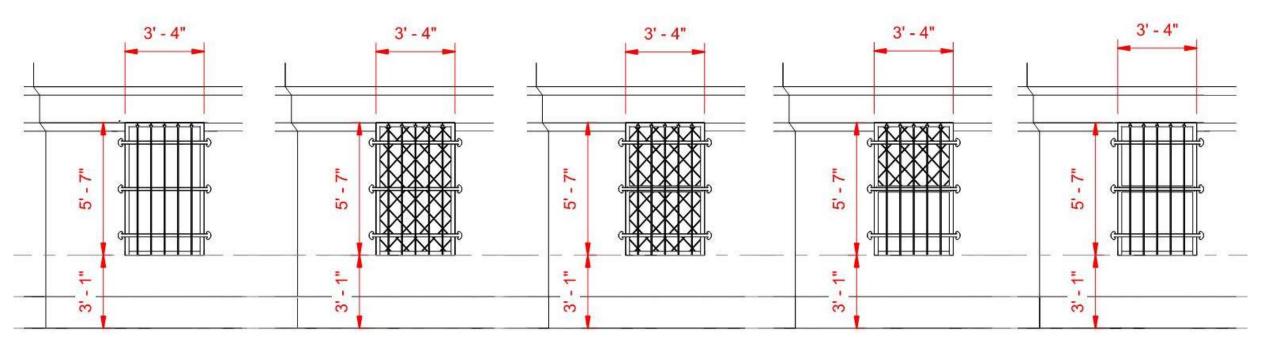
**BASEMENT WINDOWS AND DOORS** | PROPOSED MAIN BUILDING SOUTH - EXTERIOR DETAIL OPTION 1 – SASH OPTIONS WITH EXTERIOR GRILLES

Opt 1A – Free Glass

Opt 1B – Diamond

Opt 1C – Full Diamond "Double" Hung

Opt 1D – Single Hung Diamond

Opt 1E – Single Hung

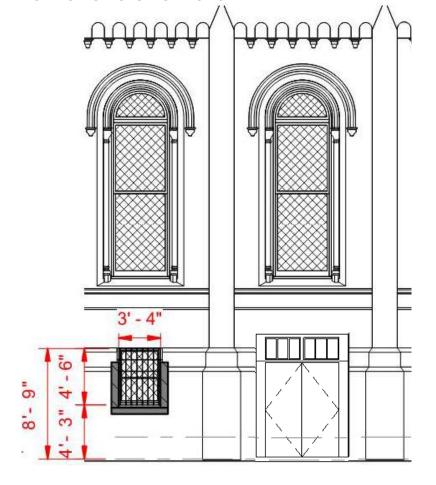
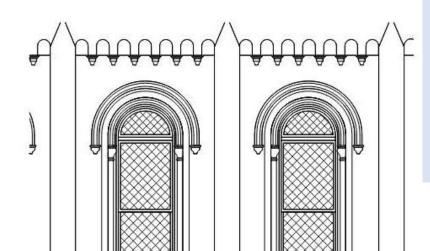
MAIN BUILDING SOUTH - EXTERIOR DETAIL OPTION 3 – SASH OPTIONS

- 3'-4" wide x 4'-6" high
- · Diamond Muntin Pattern
- Single-Hung

- 3'-4" wide x 5'-6" high
- Head at existing location- top of watertable
- Window heads above grade

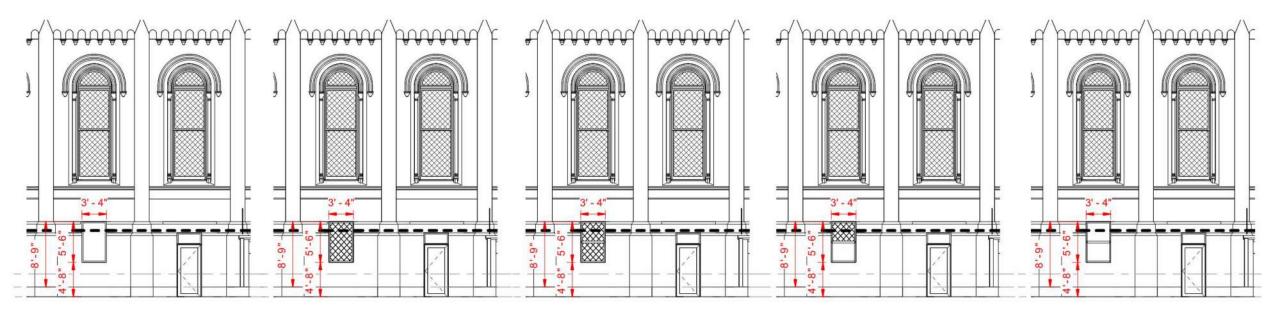
**BASEMENT WINDOWS AND DOORS** | PROPOSED MAIN BUILDING SOUTH - EXTERIOR DETAIL **OPTION 3 – SASH OPTIONS**

Opt 3A – Free Glass

Opt 3B – Diamond

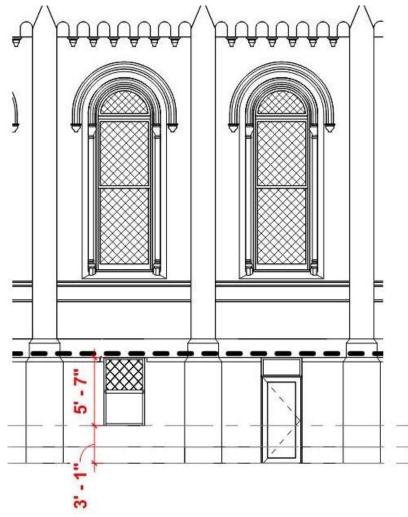
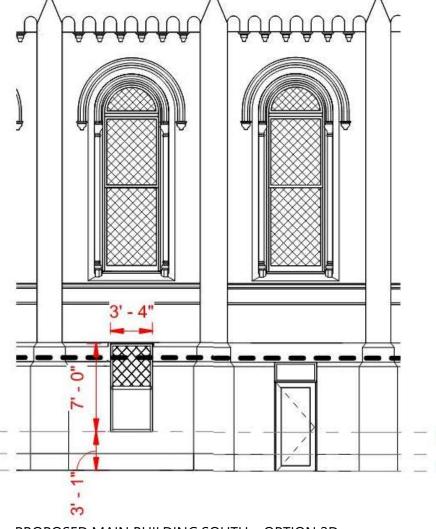
# **BASEMENT WINDOWS AND DOORS** | PROPOSED MAIN BUILDING SOUTH - EXTERIOR DETAIL

COMPARISON OF OPTION 1D & 2D
