Criteria of Adverse Effect

This report provides an assessment of effects on historic resources associated with the Revitalization of the Historic Core (RoHC) Revitalize Castle project. Effect assessments are based on the criteria of adverse effect as defined in the implementing regulations of Section 106 of the National Historic Preservation Act (36 CFR Part 800). The criteria of adverse effect are defined as follows:

Project Background and Section 106 Compliance

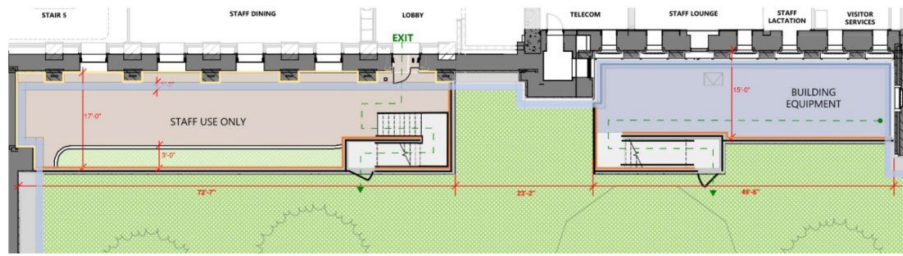
Detail plan of the Castle's proposed southeast areaway.

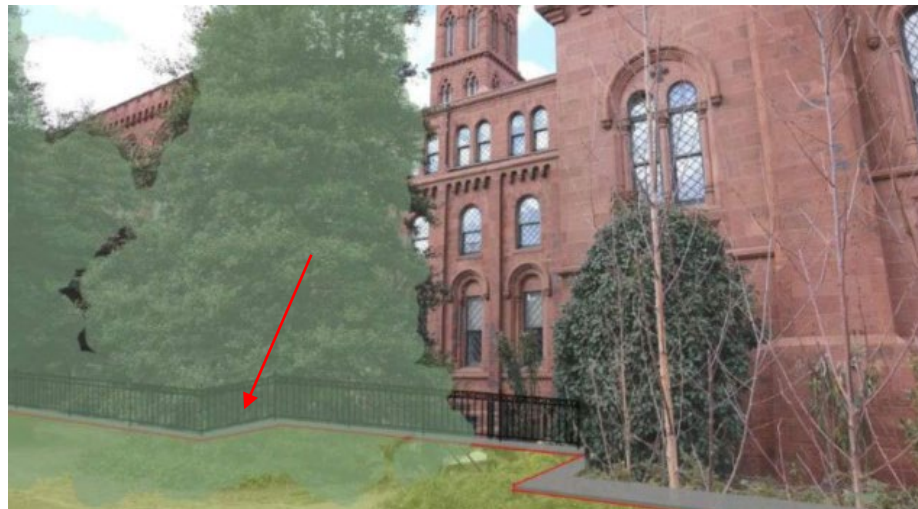
Rendering of the visibility of the Castle's proposed southeast areaway, taken from the Haupt Garden hardscape path. The fall protection railing and plantings will be finalized in Phase 2 of Section 106 consultation. Egress stair gate location is noted with a red arrow.

- Options for exposed foundation surface treatments and materials to minimize adverse effect, are pending mock-ups and further development in Phase 2 of 106 consultation.

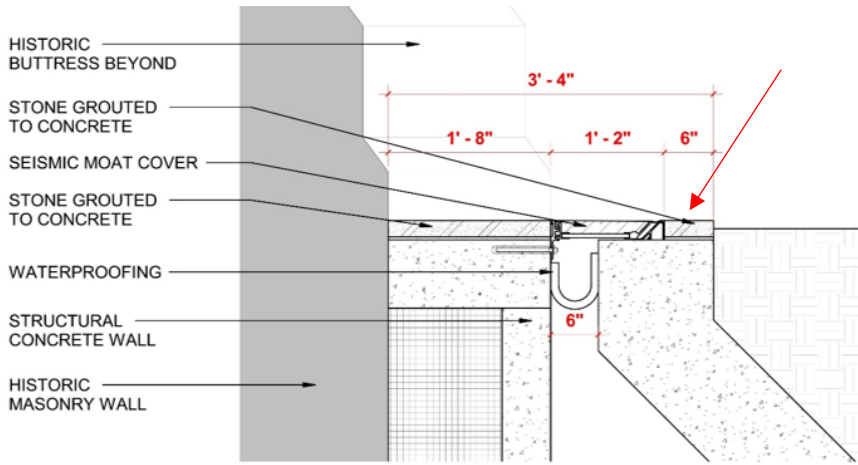
SEISMIC JOINT COVER WITH STONE EDGING

Note the dimension of the seismic moat cover width of 1'2". This option includes a 6" stone edge finish treatment, noted with a red arrow.

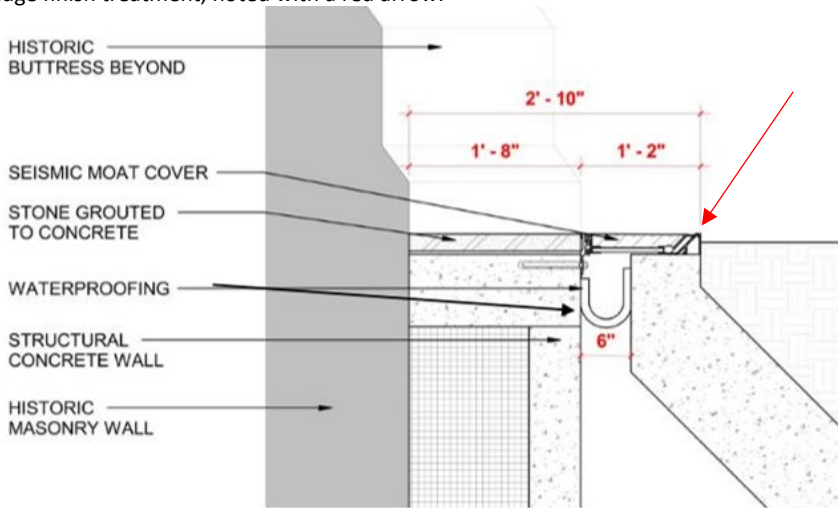
SEISMIC JOINT COVER WITH FINISHED METAL EDGE

Note the dimension of the seismic moat cover width of 1'2". This option lacks a stone edge, with the finished metal of the cover plate terminating the above-grade assembly, noted with a red arrow.

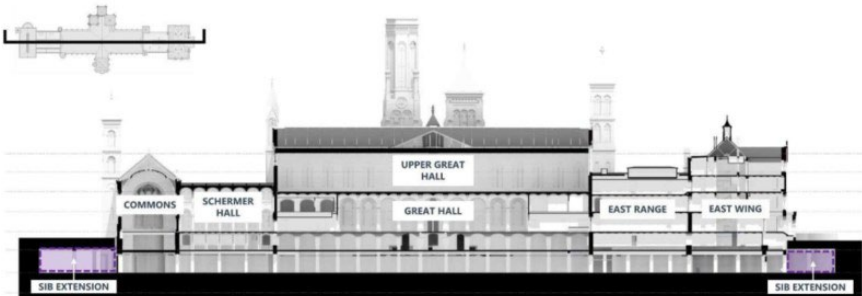
<p>Proposed longitudinal section.</p>	<ul style="list-style-type: none"> - SIB Extension will allow for the majority of service functions and infrastructure to be placed outside the Castle footprint, prioritizing the historic interiors for public programming and use. - There is the potential for construction related adverse effects from excavation or building vibration. - Excavation for this project is connected to Stipulation 7.C (Monitoring of Adjacent Historic Properties) of the South Mall Master Plan Programmatic Agreement which requires monitoring adjacent to historic properties. - Adverse effects of excavation adjacent to the Castle will be mitigated and remedied provided the following conditions are met: <ol style="list-style-type: none"> 1. Pre-construction monitoring is carried out to establish a baseline for movement

- and vibrations (Note: this monitoring started in October 2022);
2. A Monitoring Plan will be prepared to identify safe vibration limits based upon the pre-construction monitoring prior to starting construction;

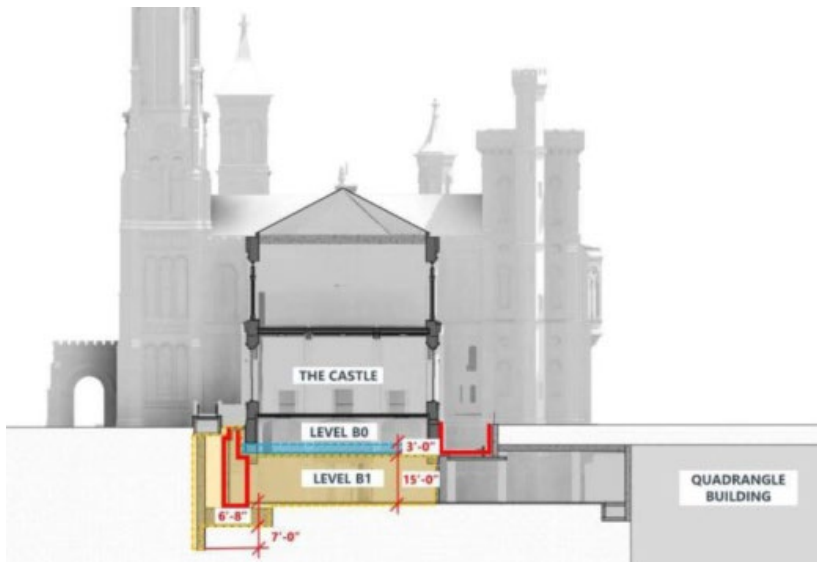
<p>Proposed transverse section through the Castle showing the depths of excavation. Lowered basement is shaded blue. Mechanical distribution level is shaded yellow.</p>	<ul style="list-style-type: none"> - Castle is an unreinforced masonry building, with a long and narrow profile, and complex building massing. - Castle is at risk for significant seismic related damage, experienced during the 2011 earthquake. - Base isolation separates the building from the ground motion, achieved by creating a plane of separation between the superstructure and the foundations. - Proposed mechanical distribution level reduces the impact of new systems on the exterior or historic interior. - Mechanical distribution level is proposed at 15’ for sufficient space for equipment operations and maintenance. - Excavation of the B0 and B1 levels has the potential to adversely affect historic fabric such as the existing floor material and the “reverse arch” construction that may exist below grade, and by altering the historic character of the existing basement. Consideration of these interior alterations, which do not have independent utility, will be part of Phase 2 of 106 consultation. - There is the potential for construction related adverse effects from excavation or building vibration.

- Excavation for this project is connected to Stipulation 7.C (Monitoring of Adjacent Historic Properties) of the South Mall Master Plan Programmatic Agreement which requires monitoring adjacent to historic properties.

- Adverse effect of excavation beneath the Castle will be remedied provided the following conditions are met:
 1. Pre-construction monitoring is carried out to establish a baseline for movement and vibrations (Note: this monitoring started in October 2022);

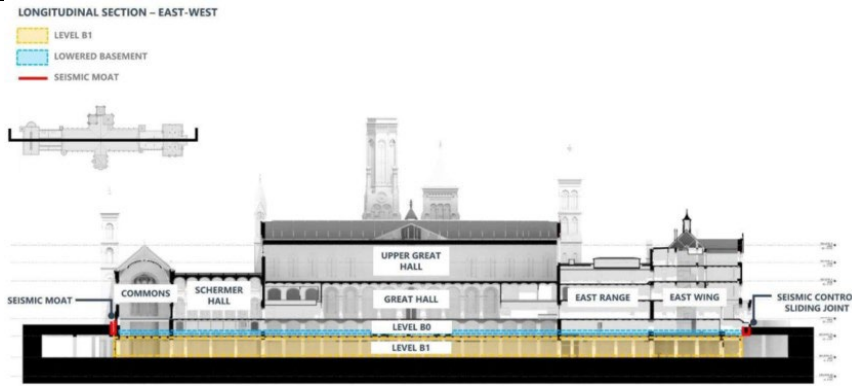
Proposed longitudinal section.

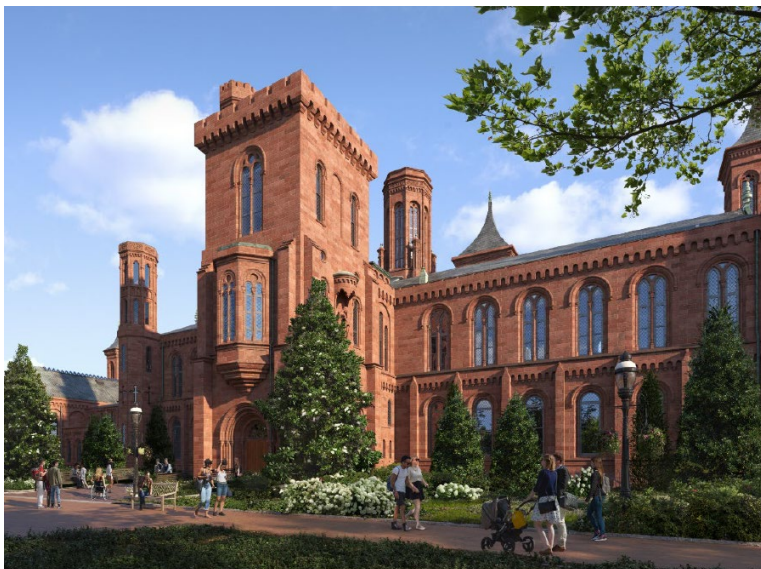
Rendering of the proposed planting plan.

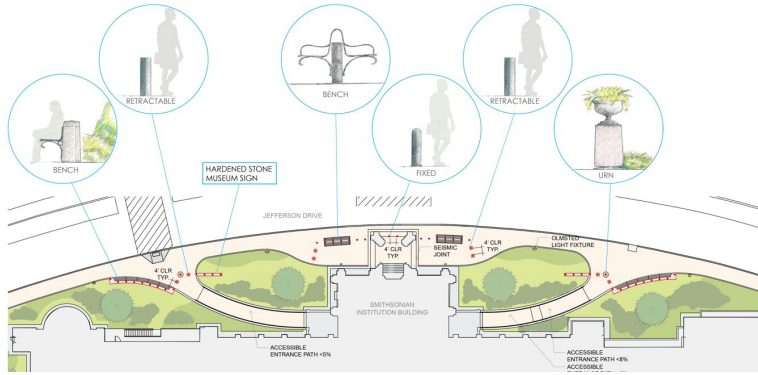
<p>Proposed perimeter security elements at north entry along Jefferson Drive.</p>

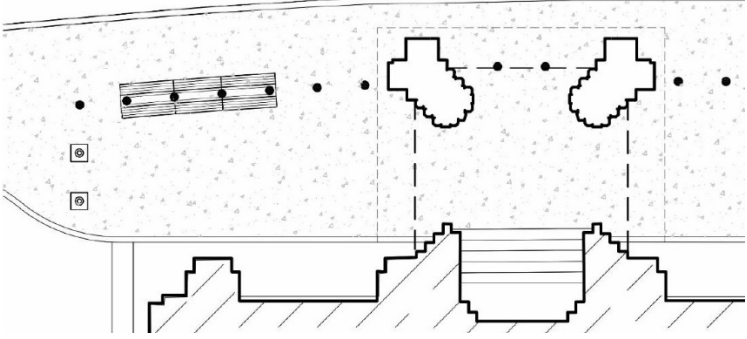
<p>Partial site plan at the porte cochere.</p>	<ul style="list-style-type: none"> - Design is a combination of hardened metal bollards (fixed and retractable), urns, wall signage, and benches. - Fixed and retractable bollards measure 30" in height and 7" in diameter for visual continuity between the two types. - Bollards will have a decorative bronze cover with the Smithsonian logo at the top and bush hammered detail mid-level on the shaft. - Two fixed bollards will be placed between the porte cochere piers aligned with the second colonnette. - Two (2) double-sided open metal slat benches are proposed on each side of the porte cochere. - At the north entrance accessible walkways, perimeter security is accomplished through bollards, hardened urn pedestals, engraved signage walls, and hardened benches. - Perimeter security stone components will use a gray-brown granite.

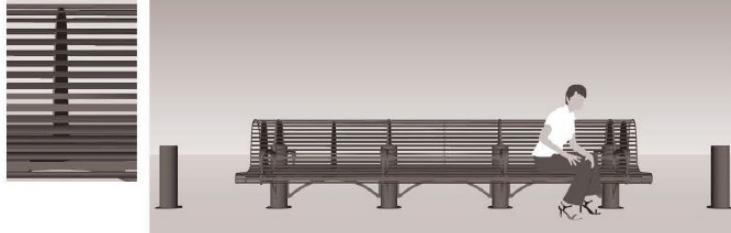
<p>Detail elevations of the double-sided metal slat bench at the porte cochere.</p>

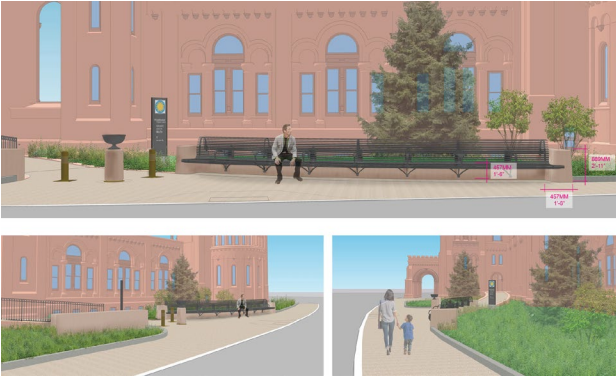
<p>Context renderings of the perimeter security on Jefferson Drive.</p>	<ul style="list-style-type: none"> - Setting is a character defining feature. - Perimeter security alters the Castle's setting. - Castle porte cochere is less than 4 feet from the roadbed curb. - At the beginning of consultation, perimeter security proposed a continuous line of bollards and site walls to create a barrier along the Jefferson Drive curb. This design had significant adverse effects on the Castle and National Mall settings and was revised to focus on three building entrance/exit locations on Jefferson Drive to minimize adverse effects. - Phase 1 of Section 106 consultation considered various combinations of hardened metal bollards (fixed and retractable), landscape wall features, and benches. There was consensus for the length, size, and placement of the integral bollard benches adjacent to the porte cochere; and for the length of benches adjacent to the accessible walkway entrances.

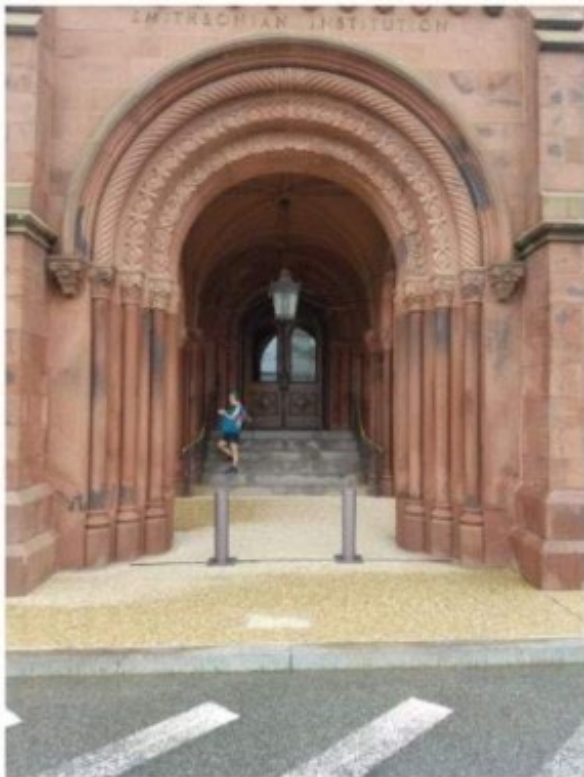
Bollard mock-up inside the porte cochere for Consulting Parties review.

- Double-sided metal open slat benches incorporate four (4) bollards each adjacent to the porte cochere. Bench design is a contemporary take on existing wood slat benches and metal filigree benches currently around the Castle's setting. Bench design minimizes adverse effect by concealing bollards in a traditional type of street furniture.

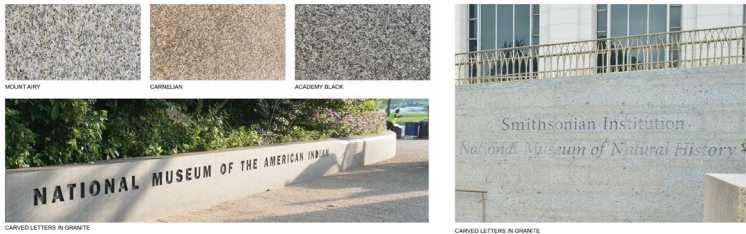
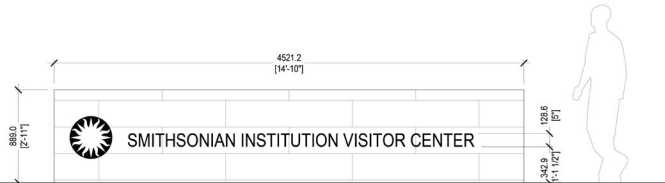
<p>Elevation drawing of the hardened wall with engraved signage, and other National Mall precedents.</p>	<ul style="list-style-type: none"> - Proposed new directional signage type is approximately half of the width of the existing signage pylons. - Proposed signage program results in an overall reduction in the amount of SI signage adjacent to the Castle. - Signage pylons will be bronze with a granite base in keeping with the SI National Mall wide standard. - There is established precedent for engraved building signage on the National Mall. - Proposed signage program will not detract from the Castle's or the National Mall settings. - Refer to "Perimeter Security" for related changes.

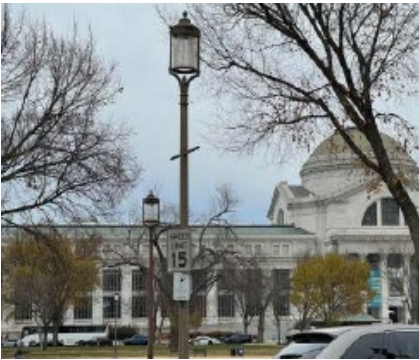
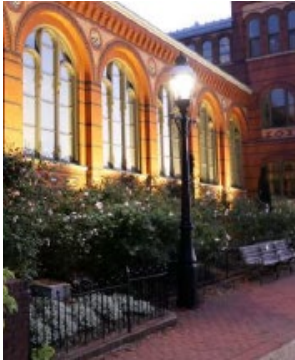
</div> <p>Existing Mall Olmsted light post. Existing Victorian light post.</p>	<ul style="list-style-type: none"> - Olmsted light posts are proposed along the south side of Jefferson Drive in keeping with the historic context and National Mall existing light posts. - Olmsted posts are 24 feet high, placed in a radial pattern to transition from the Mall placement and the curve of Jefferson Drive. - Victorian light posts are 12 feet high, placed along the main pedestrian path south of the Castle, in keeping with the existing lighting of the Haupt Garden.
Images	Additional Information
<ul style="list-style-type: none"> • The proposed Olmsted Pole location runs in relation to the natural curve of Jefferson Drive. • Maintains formality of mall <div style="display: flex; align-items: center;">

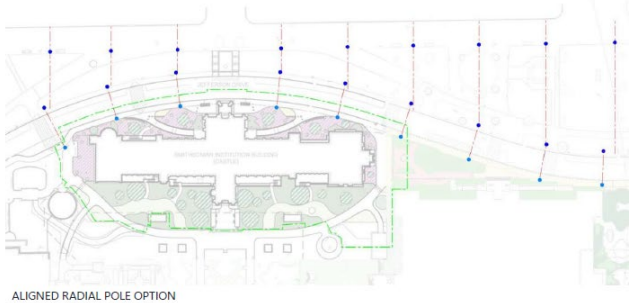
</div> <p>ALIGNED RADIAL POLE OPTION</p> <p>Proposed placement of the Olmsted light posts on the south side of Jefferson Drive, aligning radially with the existing National Mall Olmsted posts.</p> <div style="display: flex; align-items: center;">

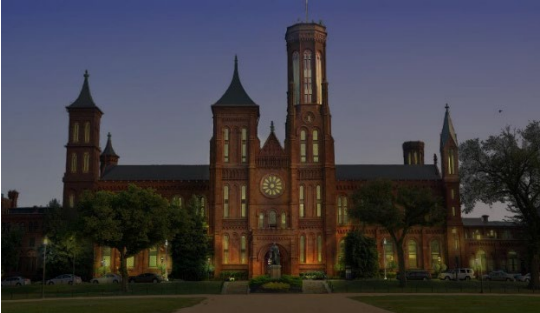
<p>Rendered night view of the Castle's north elevation and Jefferson Drive.</p>

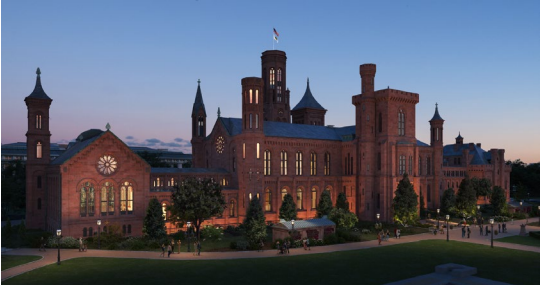
<p>Rendered night view of the Castle's south elevation and Haupt Garden paths.</p>	<ul style="list-style-type: none"> - Proposed façade lighting scheme is in keeping with other lighting on monumental buildings within the National Mall setting. - Proposed façade lighting scheme does not detract from the Castle or National Mall settings. - Light fixtures attached to the Castle will be in non-visible locations and readily reversible.

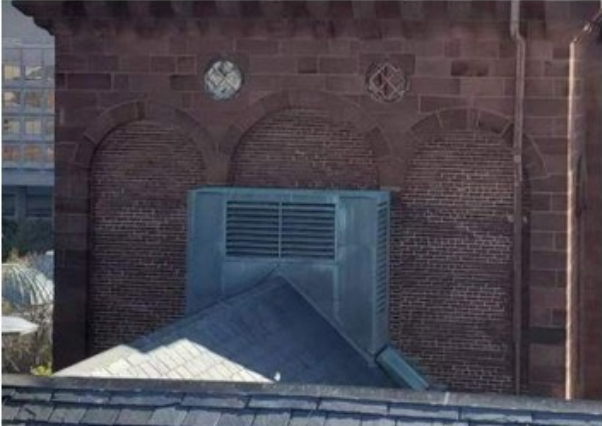
<p>Existing condition of the South Tower peaked roof and mechanical bulkhead to be removed, and the blind arches infilled with brick masonry.</p>	<ul style="list-style-type: none"> - Two (2) new elevators replace an existing non-code compliant elevator and stair in the Castle’s South Tower. - Proposed elevators are accessible and code compliant and will be the primary vertical circulation for the public for all levels of the Castle. - Each new elevator requires a visible overrun. Overruns are 3’7” above the parapet, with a hipped roof, arched detailing, and copper cladding. - Mechanical relief is accomplished with through wall louvers at blind arches at the north elevation of the South Tower. Louvers will require the removal of historic brick. Louvers will be finished to match the brick. Louvers cannot be centered within the blind arches due to an existing stair and proposed ductwork.

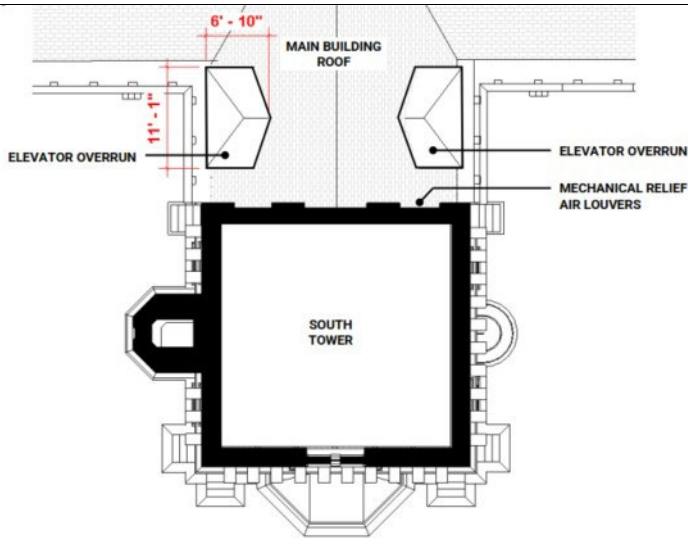
Proposed roof plan noting locations of the elevator overruns and through wall louvers.

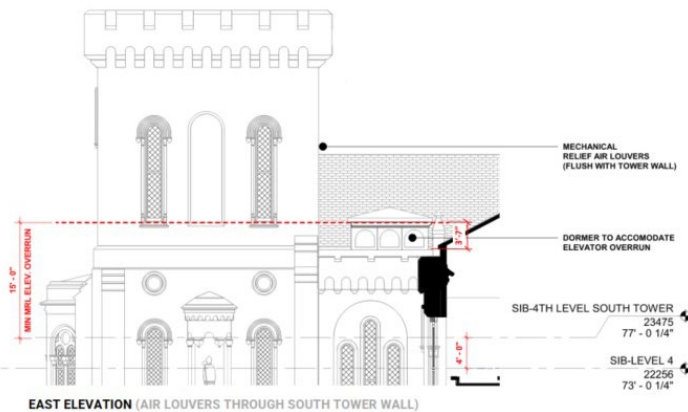
East elevation of the South Tower, depicting the preferred hipped roof and detailing of the overrun.

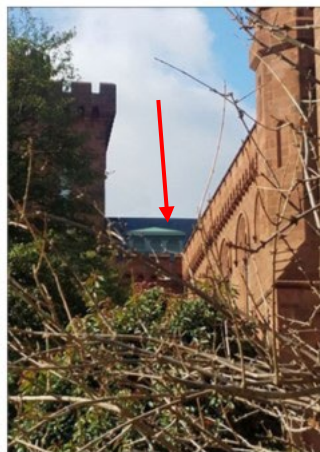
PROPOSED VIEW FROM GRADE – LOOKING NW

Location of the southeast elevator overrun noted with a red arrow.

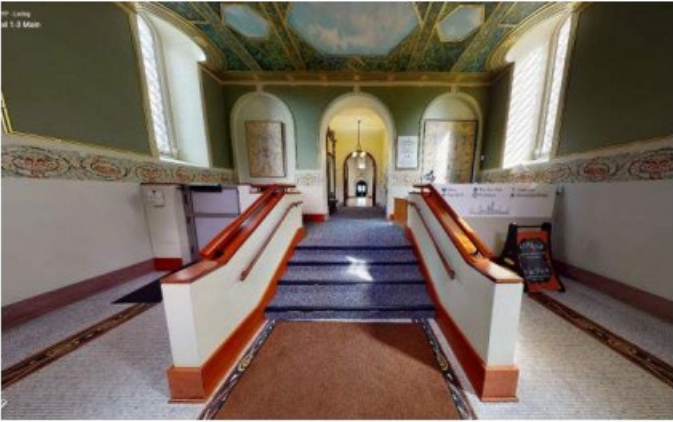
<ul style="list-style-type: none"> - South Tower elevators have associated interior alterations to accommodate the shafts and access the elevators. - West elevator replaces a non-historic elevator. East elevator replaces a non-historic circulation stair. - Elevator cabs in all spaces will be bronze with minimal frames. - Proposed arched openings in historic blind arches provide access to the elevators in the first floor Children’s Room. - Historic circulation corridors must narrow 1’6” at the first floor and 1’5” at the third floor. Alterations to the corridors at these levels impacts historic fabric.
Images	Additional Information

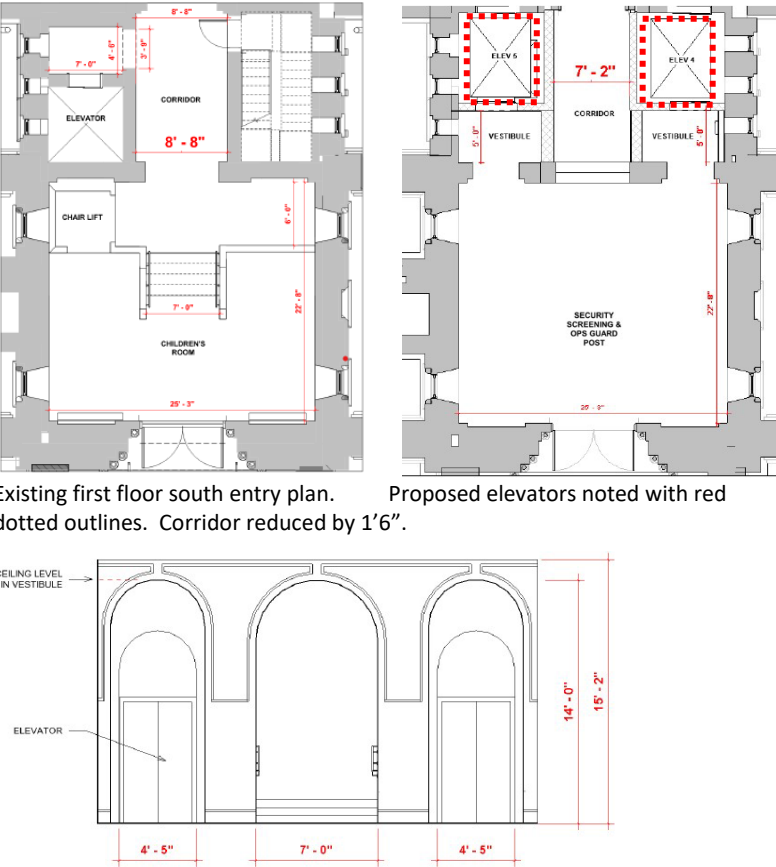
<p>Existing first floor south entry plan. Proposed elevators noted with red dotted outlines. Corridor reduced by 1’6”.</p> <p>Proposed north elevation of the Children’s Room. The center existing opening leads to the Great Hall with the historic stone stairs exposed. New arched openings within the historic blind arches lead to the elevator cabs, centered on the openings.</p>	<ul style="list-style-type: none"> - Interior alterations for the South Tower elevators lack independent utility and are subject to Section 106 consultation. - Alternate locations for these public elevators cannot be considered to avoid adverse effects to the South Tower exterior and interior. This is because the Adolf Cluss modifications inserted additional levels creating quarter level height differences between the finish floors of the South Tower and the Main Building. - Elevators are double-sided to address floor level changes between the South Tower and the Main Building. For example, for the first floor the elevator has a stop at-grade in the Children’s Room, and a quarter level up for access to the Great Hall. - Proposed elevators permit the restoration of the Children’s Room, currently half occupied by non-historic stairs, accessible lift, and platform. - Historic Tennessee Pink marble stairs are present beneath the non-historic accessible lift platform in the Children’s Room. The stairs will be exposed and restored.

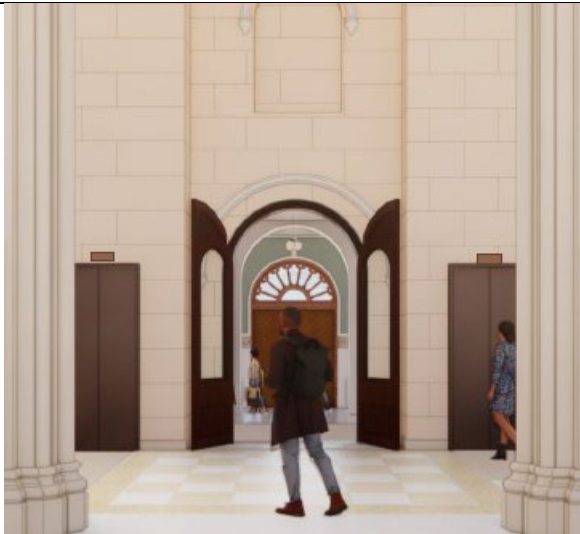
Rendered view from the Great Hall looking into the Children's Room. New bronze elevator doors flank the historic center arched opening.

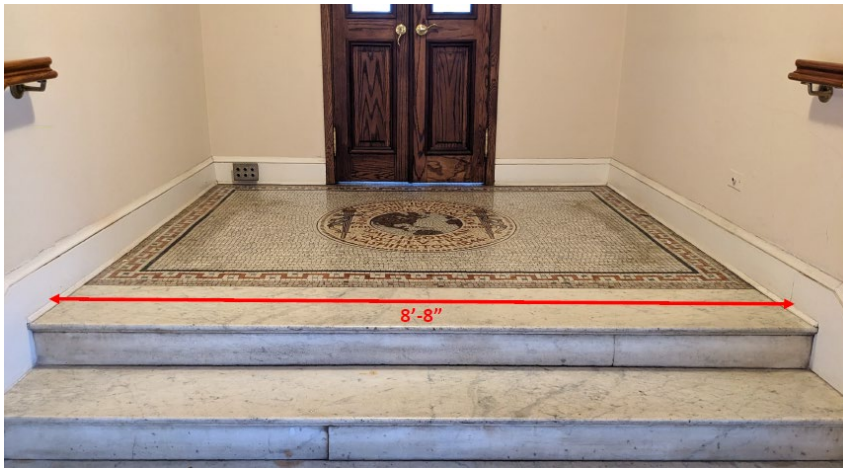
Existing upper mosaic at corridor of third level Regent's Room.

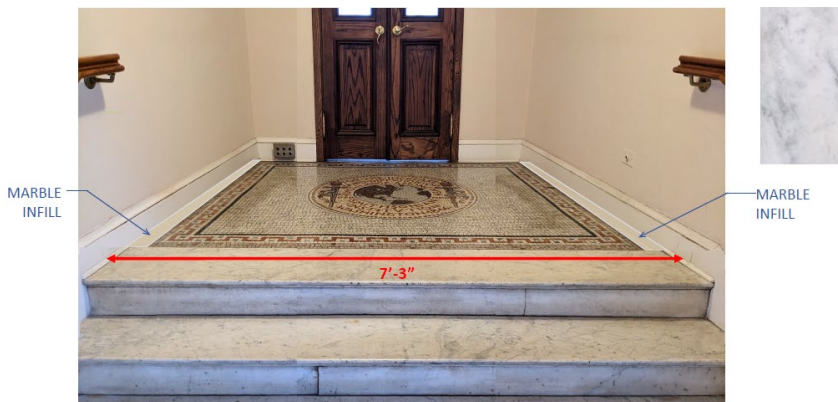
Proposed modification to the mosaics from narrowing the corridor 1'5" to accommodate the elevator shafts.

- Arched openings are used for many historic door openings in public areas of the Castle.
- Interior alterations associated with the elevators have an adverse effect on historic fabric and interiors.

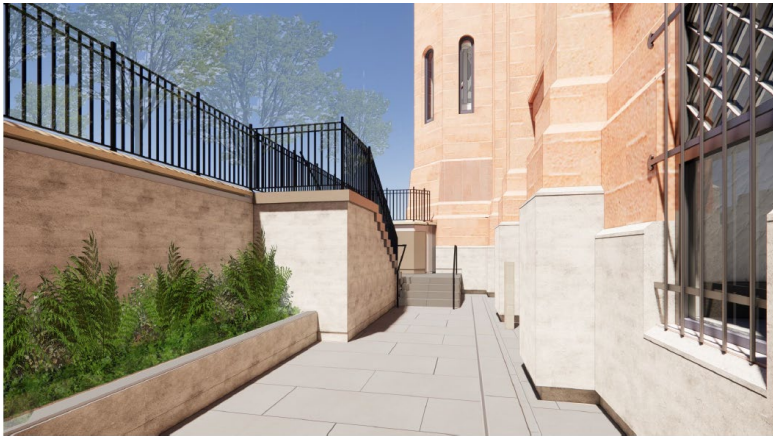
<p>Rendering of finishes at the southwest areaway.</p>

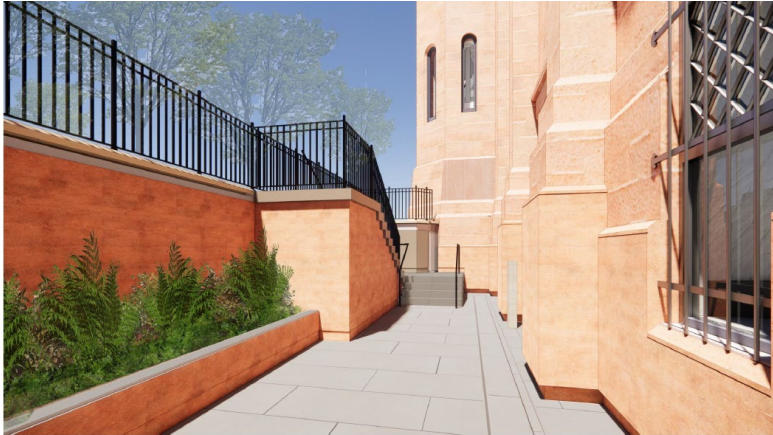
<p>Rendering of finishes at the southwest areaway.</p>	<ul style="list-style-type: none"> - Setting is a character defining feature. - Castle currently has 393 linear feet of areaway (recessed well), and 220 existing linear feet of apron (paving at grade). - Phase 1 determined that the Areaways and Window Wells (Locations and Dimensions) adversely affect the Castle’s Setting and relationship with the ground plane. - Areaways, egress stairs, window wells, and their fall protection railings will be visible at the base of the Castle, and adversely affect the Setting. - Proposed finishes are intended to be neutral and utilitarian, and to not call undue attention to the new work. - Proposed finishes will not intensify the adverse effect. - Section 106 agreement document will include measures for consultation on physical mock-up to select the stucco finish colors.

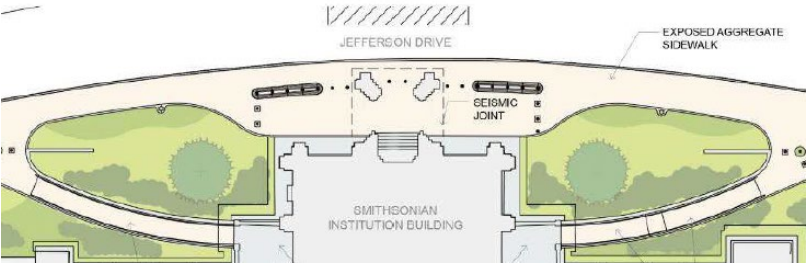
<p>Partial site plan noting the seismic joint line location at the porte cochere.</p>	<ul style="list-style-type: none"> - Setting is a character defining feature. - Phase 1 determined that the visibility of the Seismic Control Joint has an adverse effect on the Castle and National Mall settings. - Phase 1 determined that the Seismic Control Joint (Location and Width) overall assembly width will be the minimum dimension possible to minimize visual impact. - Seismic control joint will be incorporated into the recessed areaways and under projecting building elements such as the porte cochere and east entrance stairs. - Olympic Black granite was selected as the preferred neutral option, to differentiate from the Castle's sandstone and for its ability to recede in the landscape context. - Use of Olympic Black granite minimizes visibility of the seismic control joint and minimizes the adverse effect from the seismic control joint installation. - Anodized metal appears neutral to the variety of materials in the Castle's setting. - Refer to "Installation of Seismic Control Joints Around the Castle Perimeter (Location and Width)" for more information from Phase 1 of consultation.

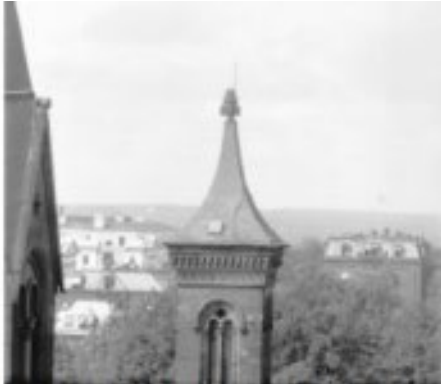
</div> <p data-bbox="110 732 509 787">Historic image c. 1930 of the West Tower with lightning protection.</p> <div data-bbox="581 407 979 730">

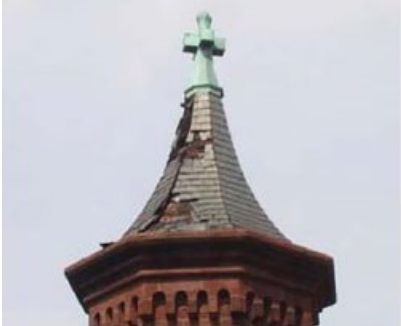
</div> <p data-bbox="581 732 964 787">Octagon Tower damaged by a lightning strike in 2005.</p>	<ul style="list-style-type: none"> - Lighting protection system will be installed on the perimeter of the Castle roof. - Air terminals (metal rod) project 10 inches above rooftop features, placed at the perimeter of the Towers and peak of the East Wing roof. - Air terminals will be clamped to existing features, with grounding cables held in place using metal brackets attached at mortar joints. Some cables will require adhesive mounting at the roof edges.
Images	Additional Information

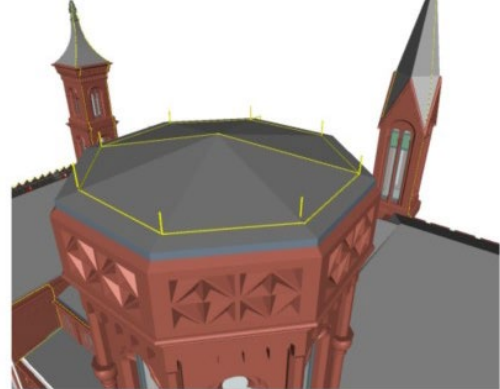
</div> <p data-bbox="110 1845 597 1875">Proposed Octagon Tower air terminals and cables.</p>	<ul style="list-style-type: none"> - Lighting protection was implemented in the original Castle design with wrought iron lighting rods on the Perimeter Towers, originally 10' taller than the various Tower roofs. - In 2005 the Southeast Tower roof was damaged from a lightning strike and restored. - Proposed lighting protection system is in keeping with systems found on historic buildings and buildings on the National Mall. - Air terminals will have minimal visibility and the grounding cables will be installed in building recesses or the least obtrusive locations. - Lighting protection system will not damage historic fabric and is fully reversible.

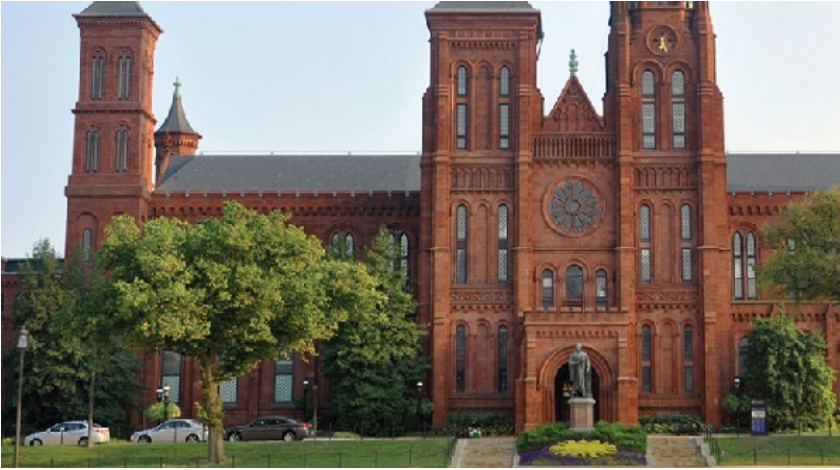
<p>Rendered view of the fall protection system looking south to the Castle.</p>	<ul style="list-style-type: none"> - Life safety fall protection system will be installed at the Castle roof to allow maintenance. - Fall protection system consists of low metal cables and stanchions at the roof ridges. - Low metal stanchion redirects in select locations off the ridges connect different sections of fall protection system.
Images	Additional Information

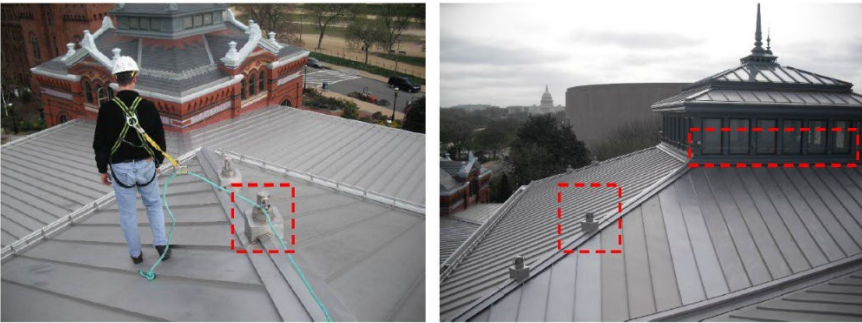
<p>EXAMPLE OF REDIRECT STANCHION EXAMPLE OF REDIRECT STANCHION AND HORIZONTAL LIFELINE</p> <p>Similar fall protection system installed on the Arts & Industries Building.</p>	<ul style="list-style-type: none"> - Roof Profile is a character defining feature. - Providing fall protection on the roof of the Castle cannot be avoided. - Proposed minimal cable and stanchion system avoids requiring a guardrail around the entire roof perimeter, and significant adverse effect. - Redirect stanchions connect sections of cables and reduce the visual impact of the system. - Fall protection system will be visible on the Castle's roof, and adversely effects the roof profile. - Moving the stanchions and system off the ridge was considered to minimize adverse effect. Placing the stanchions at the metal ridge gap reduces challenging waterproofing details and opportunities for water intrusion in the long-term. - Contributes to cumulative adverse effects on Roof Profile and Building Massing, and overall visual effects.

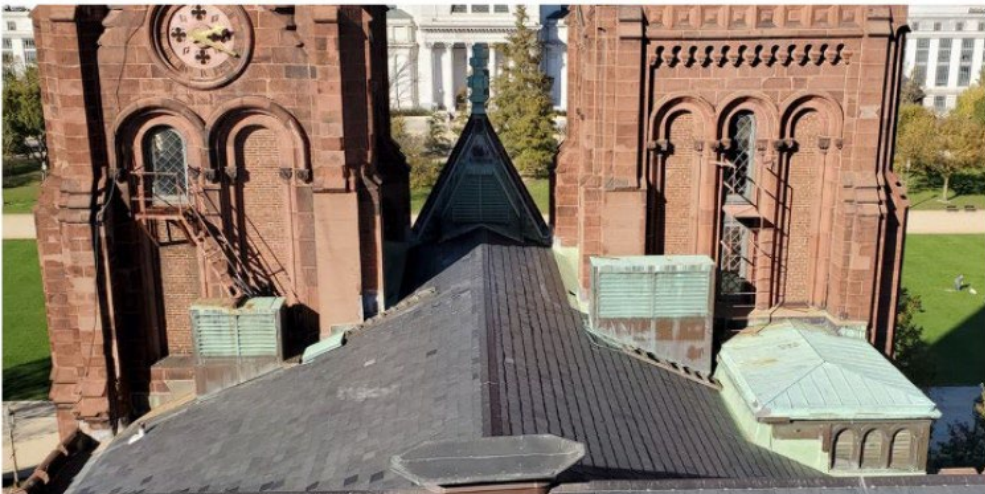
<p>Existing conditions of roof access ladder and stairs at the south elevations of the Flag and North Towers.</p>	<ul style="list-style-type: none"> - Roof access hatch proposed on the peaked roof between the Flag and North Towers. - Access hatch provides direct access to the cable fall protection system. - Permits the removal of unsightly non-historic access stairs at the south sides of the Flag and North Towers.
Images	Additional Information

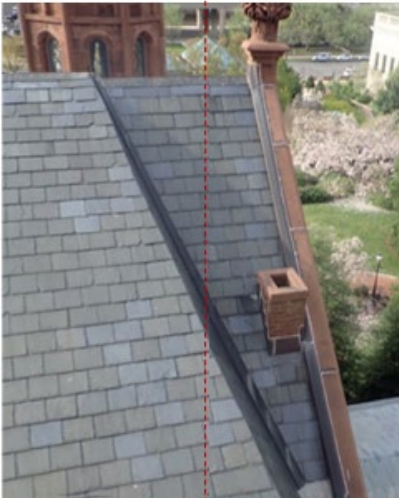
<p>PROPOSED (+1.25" – 4.75") EXISTING</p> <p>Proposed and existing montage demonstrating the dimensional roof change over the Main Building.</p>

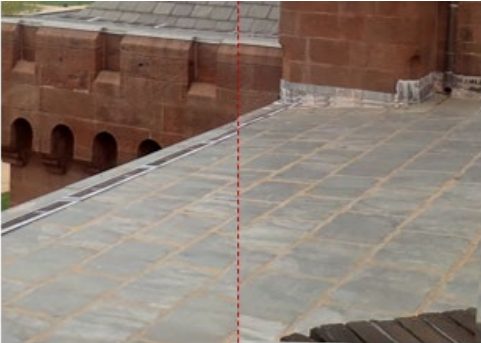
<p>EXISTING PROPOSED (TAPER TO +5.25")</p> <p>Proposed and existing montage demonstrating the dimensional roof change over the East Range.</p>	<ul style="list-style-type: none"> - Roof Materials and Profiles are character defining features. - Existing roof system includes little to no insulation. - Addition of rigid insulation beneath the slate and zinc-tin cladding improves the Castle's energy performance. - Majority of the Castle's roof edges are behind crenellated parapets and other architectural features and are at least 30' above grade. - Proposed work will not result in discernible impacts at the roof edges and ridgelines from grade or at distances around the Castle. - Dimensional changes are not proposed in visible locations to avoid adverse effect. - Roof dimensional change at the flat metal areas tapers to the roof edge to keep the alteration non-visible and to avoid adverse effect.

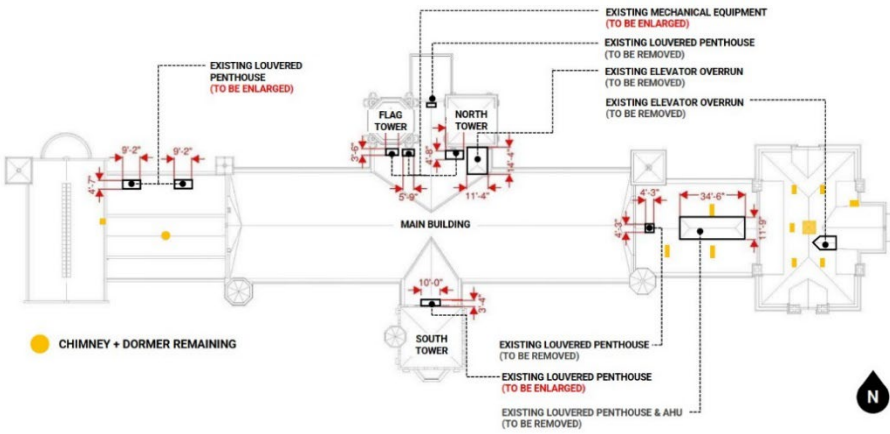
<p>Existing roof plan. Existing rooftop features with all black text in the tags will be removed.</p>	<ul style="list-style-type: none"> - West Range has two (2) visible mechanical penthouses that will be expanded. Location and height remain the same, and only the width expands. - One (1) visible elevator mechanical penthouse and two (2) mechanical penthouses will be removed from the North Entry Hyphen. - One (1) visible non-historic mechanical penthouse on the East Wing will be removed for the 4th Floor Egress Path. - Two (2) visible mechanical penthouses are proposed behind the Flag and North Towers at the North Entry Hyphen.
Images	Additional Information

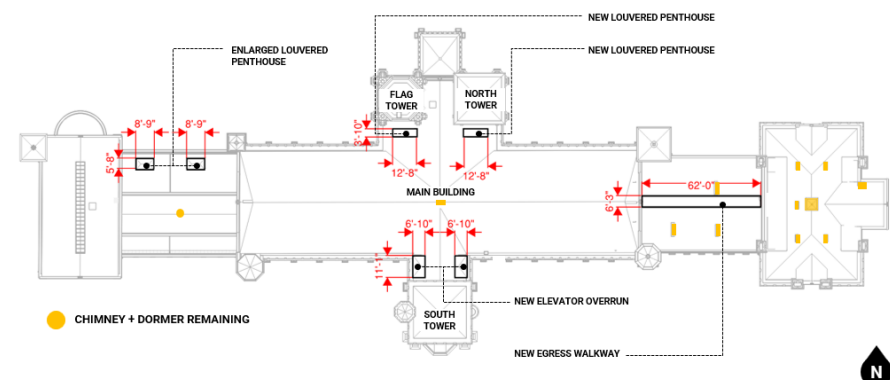
<p>Proposed roof plan. Historic chimneys and dormers that will be retained are noted in yellow.</p>	<ul style="list-style-type: none"> - Roof Profile and Building Massing are character defining features. - Historic visible chimneys, dormers, and historic ventilators will be retained, noted with yellow on the plans at left. - Existing historic cupola with louvers at the East Wing will be re-used without expansion. - Majority of the associated mechanical modifications occur within the interior attic space. There will not be additional rooftop mechanical features beyond the penthouses. - During Phase 2 of consultation multiple design alternatives were developed to minimize visibility of the North Entry Hyphen penthouses. Visibility of the penthouses cannot be eliminated to avoid adverse effect. - The preferred option is the narrowest width and as close to the ridge as possible to reduce visibility and minimize adverse effect. The penthouses will be clad in copper and feature an arched louver at the east and west sides in keeping with detailing found on the Castle's stone and other rooftop additions.

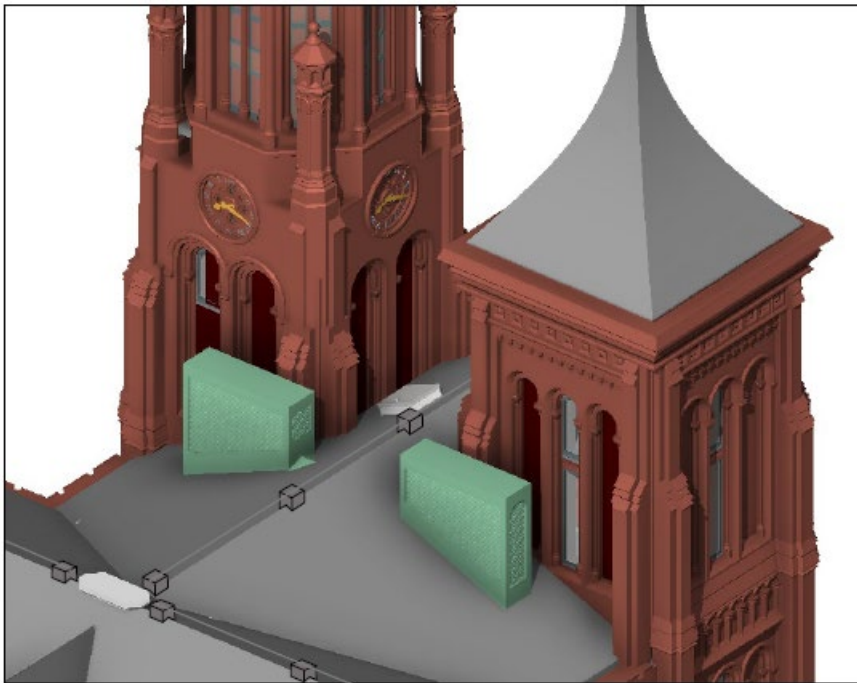
Axon view of the proposed North Entry Hyphen mechanical penthouses.

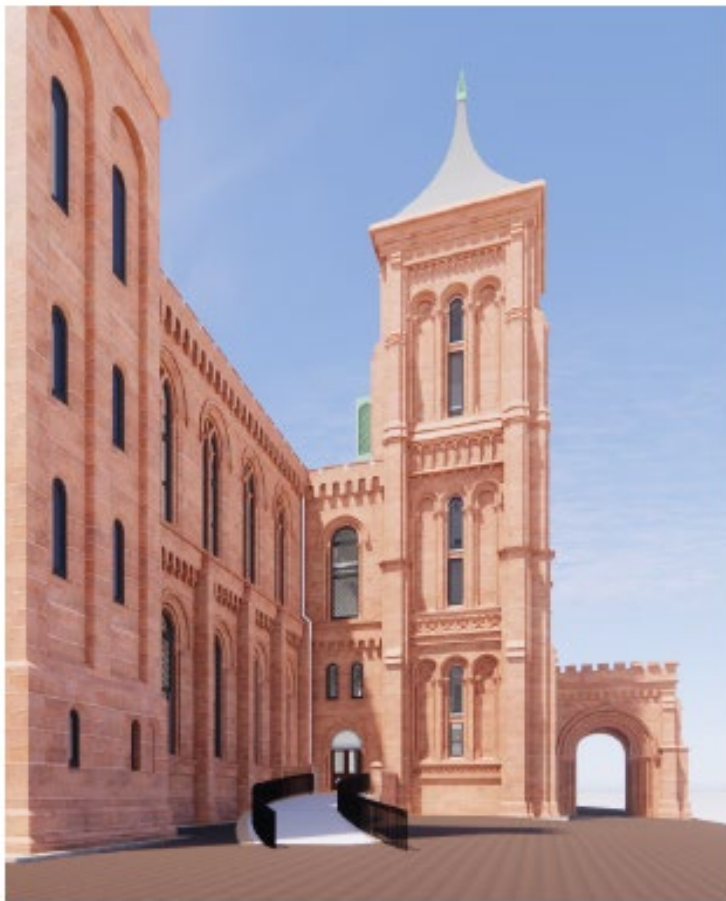
Rendered view of visibility of the east penthouse at the North Entry Hyphen from Jefferson Drive.

- The east North Entry penthouse is visible for a limited distance on Jefferson Drive. The west penthouse is minimally visible due to the historic buttressing of the Flag Tower.
- During Phase 2 of consultation a visible mechanical penthouse to support the South Tower elevators was revised to non-visible through wall louvers, avoiding adverse effect.
- Visibility of the West Range and North Entry mechanical penthouses adversely effects the Roof Profile and Building Massing, character defining features of the Castle.
- Refer to "South Tower Elevators – Exterior Alterations" for related changes.

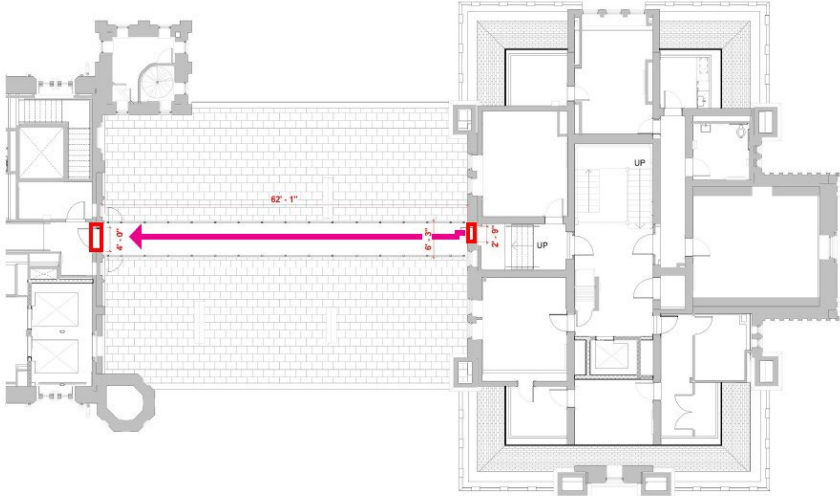
<p>Plan of the proposed egress path from the East Wing across the East Range roof to the Main Building.</p>	<ul style="list-style-type: none"> - Installation of an exterior egress pathway at the East Range roof provides a second means of egress from the East Wing. - Exterior egress pathway will be unenclosed with fall protection railings. - Non-historic window sash will be removed from two openings to accommodate egress doors. Egress doors will not require alterations to the masonry openings. - Egress path fall protection railings will be a simple metal picket with a black finish.
Images	Additional Information

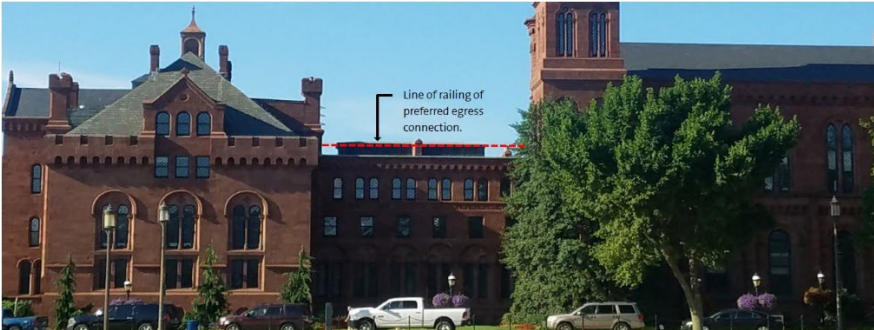
<p>Photograph of the East Range and the visibility of the 1973 mechanical penthouse. Red dotted line indicates the height of the 42" guardrail.</p>

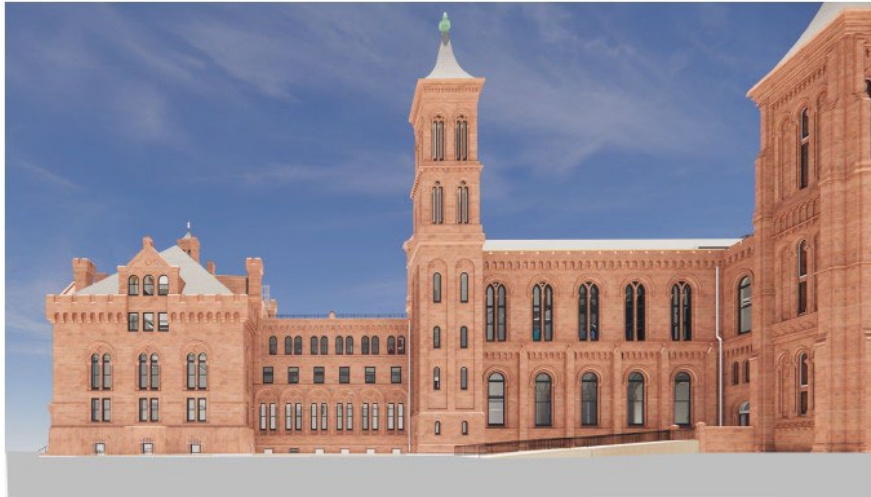
Walkway railing visibility from the middle of the National Mall.

- Use of a simple metal picket railing that meets the code requirement minimums, minimizes undue attention to this change and adverse effect.
- Contributes to cumulative adverse effects on Roof Profile and Building Massing, and overall visual effects.

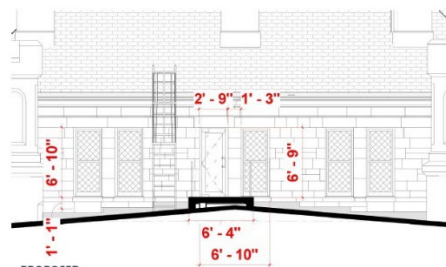
EXISTING

EXISTING SENECA SANDSTONE UNIT

4th Level East Wing, west elevation. Non-historic window sash will be replaced with a metal and glass egress door.

PROPOSED

*NO ALTERATION TO HISTORIC SANDSTONE

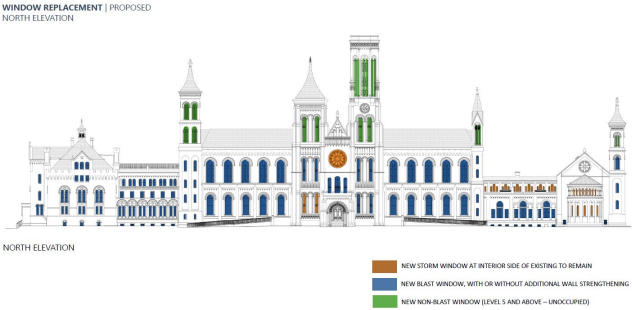
<p>Proposed Castle north elevation with window replacement types noted.</p>	<ul style="list-style-type: none"> - Building-wide window replacement of the non-historic window sash with blast resistant windows. - Historic windows c. 1915 that are present in the West Range Clerestory, West Wing Apse, Smithson Crypt, rose windows, and West Wing skylights will be restored and retained in-place. Blast resistant storm windows will be installed on the building interior to maintain the exterior appearance. - Replacement windows will restore the red-brown historic finish color. - Replacement windows will be steel and simulated divided light. Diamond muntin pattern size will vary proportionally based on the window type and size.
Images	Additional Information

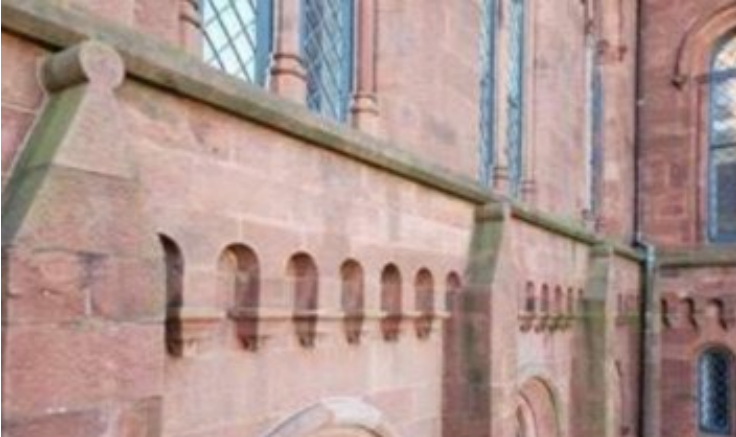
<p>Seneca sandstone with biological growth staining.</p>

Smithsonian Institution Building	
Feature/Action	Design Details
Exterior Masonry Restoration	<ul style="list-style-type: none"> - Exterior red Seneca sandstone will be restored, including façade cleaning, and pointing. - Maximum amount of sound sandstone will be preserved. - Stone repairs include resetting of displaced masonry, Dutchmen repairs, and select full replacement stones. - A red sandstone (St. Bees) was selected through consultation as the alternative stone to use for restoration repairs after Seneca sandstone reserves are exhausted.
Images	Additional Information

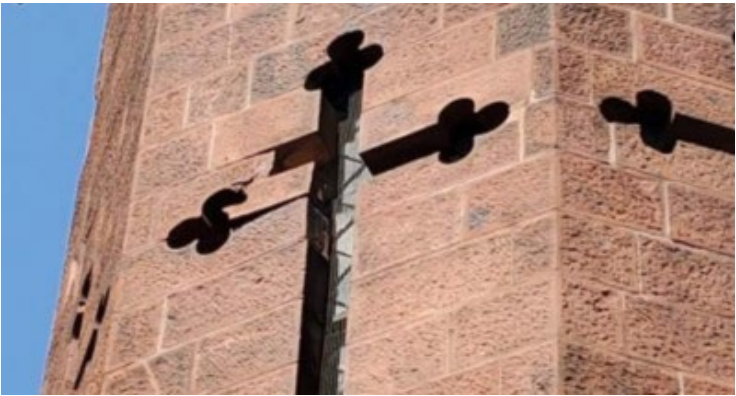
<p>Displaced Seneca sandstone masonry at the Octagon Tower.</p>	<ul style="list-style-type: none"> - Seneca sandstone exterior is a character defining feature. - Seneca sandstone is no longer quarried, and the SI retains a significant stockpile at a Smithsonian storage facility that will be used for the restoration work. - Stone replacement pieces will be in-kind, with hand tooling and finishing to maintain consistency with the stone color ranges, texture, and detailing. - Stone restoration will be consistent with the <i>Secretary of the Interior's Standards</i> Preservation approach. - Seneca stone reserves will be prioritized for highly visible repairs, and limit any alternative sandstone for repairs in less visible areas.
