Criteria of Adverse Effect

This report provides an assessment of effects on historic resources associated with the Revitalization of the Historic Core (RoHC) Revitalize Castle project. Effect assessments are based on the criteria of adverse effect as defined in the implementing regulations of Section 106 of the National Historic Preservation Act (36 CFR Part 800). The criteria of adverse effect are defined as follows:

Project Background and Section 106 Compliance

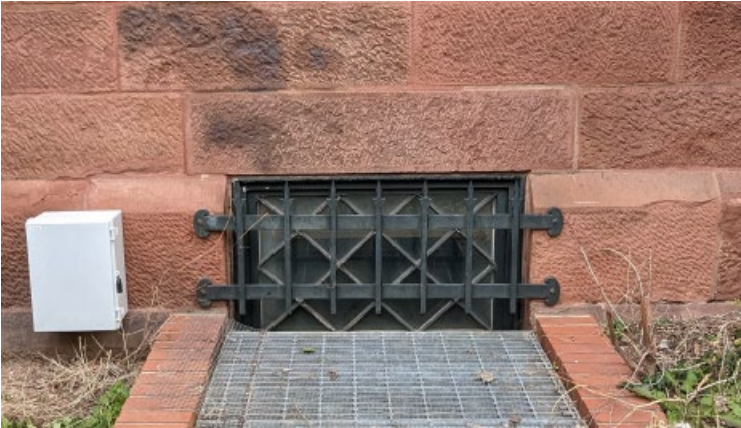
<p>Photograph of existing basement window at the southeast side of the Main Building. Note the metal window security grille.</p>	<ul style="list-style-type: none"> - New basement windows are proposed within the basement level areaways below-grade on the Castle south elevation. - Castle south elevation at the basement level contains some window openings. Proposed work will enlarge existing window openings and create new masonry openings. - Existing basement windows are cut into a water table with a chamfered top edge. Existing windows are 3'-4" wide and 4'-6" tall. - The preferred option maintains the existing window header and width and lowers the sill to an overall window height of 7'. New window openings match the altered window openings. - Proposed window sash within the openings is fixed double-hung, with a diamond pane muntin at the upper sash and a single lite lower sash. - Basement window openings will have an applied metal security grille, matching the design of the existing grilles, with wider horizontal bars and thin verticals with finials.

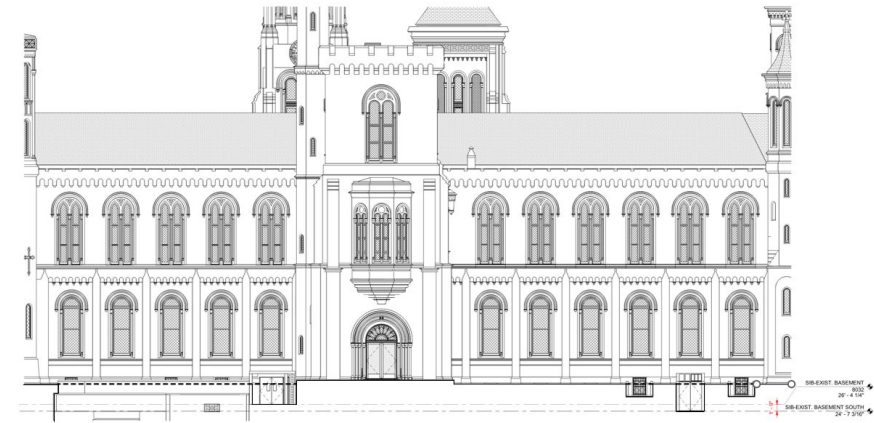
<p>Existing south elevation</p>	<ul style="list-style-type: none"> - Proposed windows increase natural light to newly occupied public basement spaces utilizing existing window openings and creating new masonry openings. - Proposed window fenestration is subtly differentiated from the historic windows consistent with the <i>Secretary of the Interior's Standards</i>. - Historic door opening size installed c. 1871 at the southeast end of the Main Building will be retained with new door infill. - Exterior metal grilles are required for security. - Proposed work requires the removal and alteration of sandstone masonry. Masonry blocks will be removed, cut,

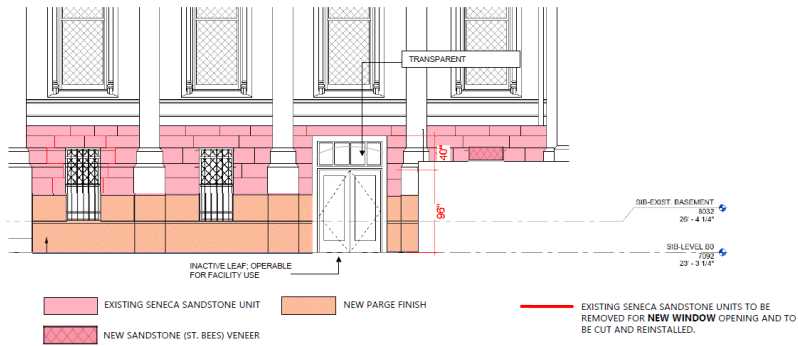
Detail elevation at the southeast basement level.

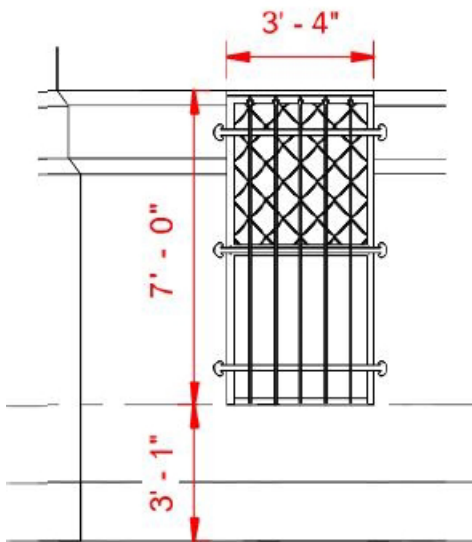
Detail elevation of proposed basement window dimensions. Elevation depicts the proposed sash configuration and security grille.

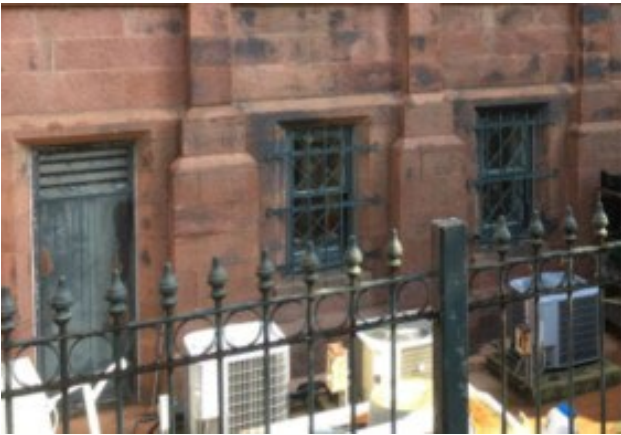
<p>Existing egress door at the East Range south areaway.</p>	<ul style="list-style-type: none"> - On the Castle’s south elevation, two existing doors (East and West Range areaways) will be modified and re-used. One (1) new doors opening will be created (Main Building southwest areaway). - On the Castle’s north, one (1) new egress door opening will be created (West Range areaway). - Egress doors will be metal, full glazing, single light. - On the Castle’s south elevation at the Main Building southeast areaway, the historic masonry opening from a c. 1871 door will be maintained. Proposed infill will be paired single-light metal doors with a four-light transom.
Images	Additional Information

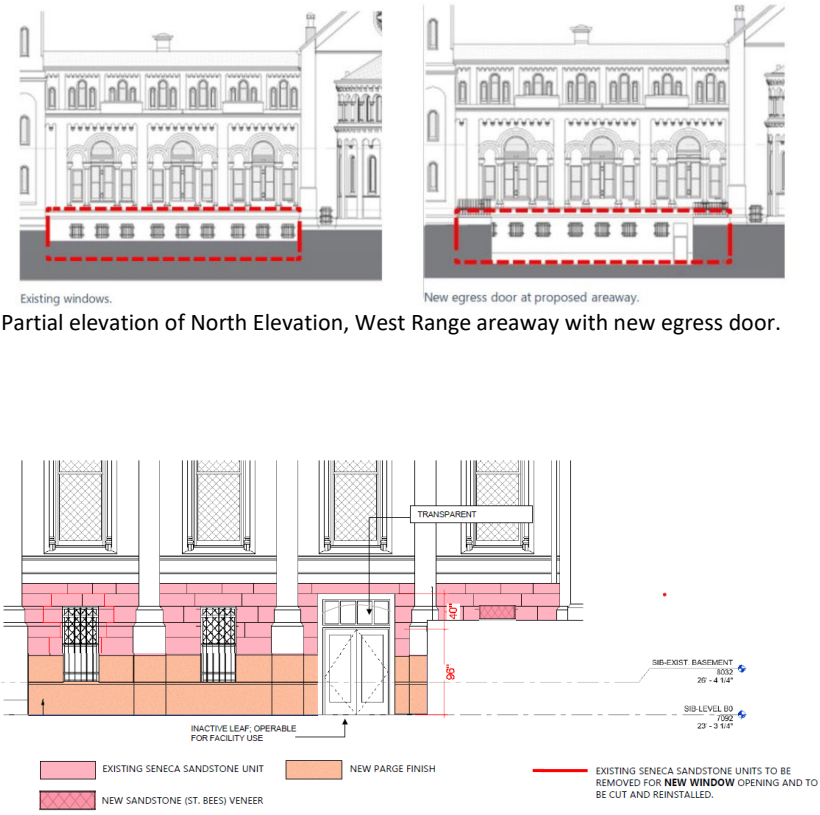
<p>Existing windows.</p> <p>New egress door at proposed areaway.</p> <p>Partial elevation of North Elevation, West Range areaway with new egress door.</p> <p>Detail elevation at the southeast basement level with the c. 1871 historic door opening and proposed egress infill.</p>	<ul style="list-style-type: none"> - Additional egress doors are required for life safety based on the increased building population. - All egress doors will be located at the Castle basement level within below-grade areaways. - Proposed work requires the removal and alteration of sandstone masonry. Masonry blocks will be removed, cut, dressed, and re-installed to create the masonry openings. - Egress doors will have some visibility within the setting and Haupt Garden. - Existing sidewalks and pedestrian paths in the Haupt Garden will be maintained, which restricts some visibility in combination with the landscaped setting and minimizes adverse effect. - The c. 1871 large door opening on the south elevation was added during the period of significance. Retaining this opening size and insertion of paired egress doors minimizes adverse effect. - Contributes to cumulative adverse effects on the Castle’s Setting.

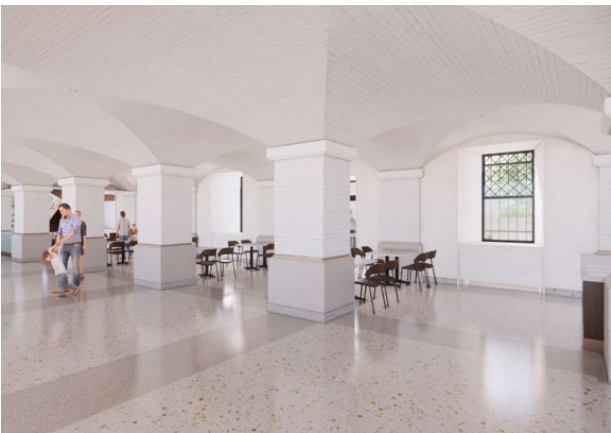
<p>Rendering of the Basement interior.</p> </div>	<ul style="list-style-type: none"> - These alterations to the basement level historic finishes lack independent utility without the associated exterior alterations, and are subject to Section 106 consultation. - Where grade is changed and underpinning is added to the historic piers, existing and new construction will be integrated but differentiated in appearance consistent with the <i>Secretary of the Interior’s Standards</i>. - Altered basement windows maintain the existing header height. - Excavation of the B0 and B1 levels has the potential to adversely affect historic fabric such as the existing floor material and the “reverse arch” construction that may exist below grade, and by altering the historic character of the existing volume of the basement space. - If unanticipated historic fabric is discovered during excavation, these features will be considered for recordation, potential salvage, possible preservation in place of select features. - Cladding the pier extension with a parging is a utilitarian treatment in keeping with the historic character of the space and differentiates the material from the retained historic brick masonry. - Refer to “New Basement Windows” for related changes.

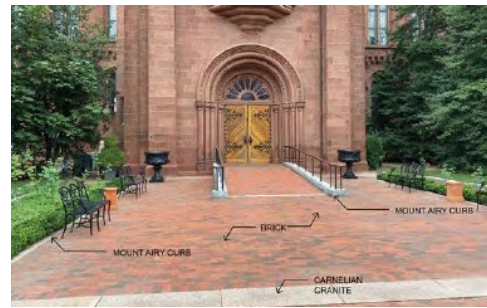
Existing South Entrance condition.

- Universally accessible walkway replaces an existing ramp on axis with the South Tower entrance. Current ramp is not universally accessible.
- Walkway will be paved with salvaged brick and Mount Airy granite curbs in keeping with the Haupt Garden materials palette.
- Historic sandstone steps are retained, with the walkway constructed over the steps flush with the historic landing.
- Low bronze kickrail provides edge protection at the top of the walkway.

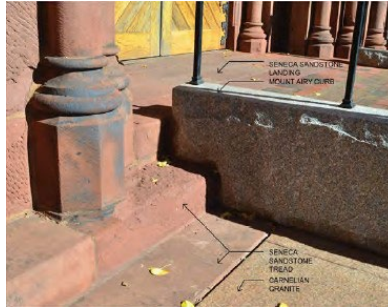
Existing ramp connection to the historic sandstone stair treads.

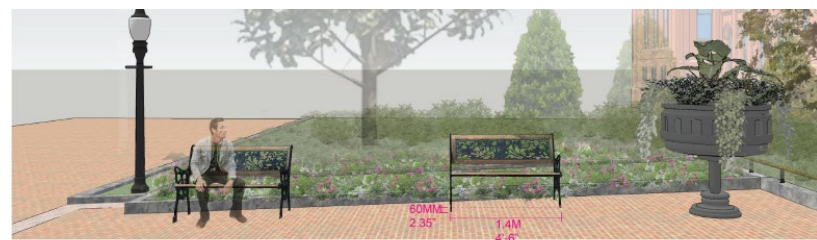
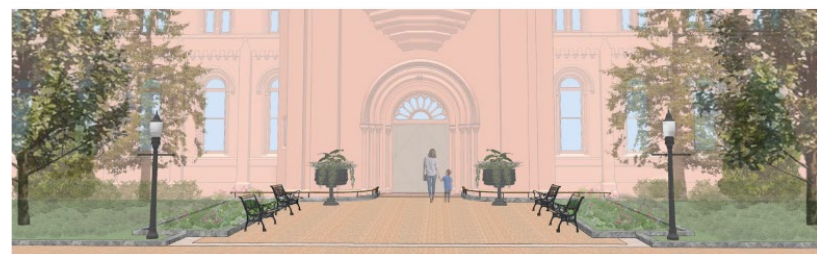
Proposed South Entrance renderings.

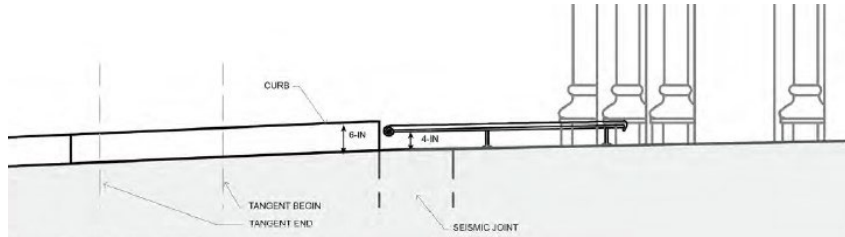
Section from walkway surface look west. Stone curb transitions to a bronze kick rail to maintain visibility of the South Entrance stone colonettes.

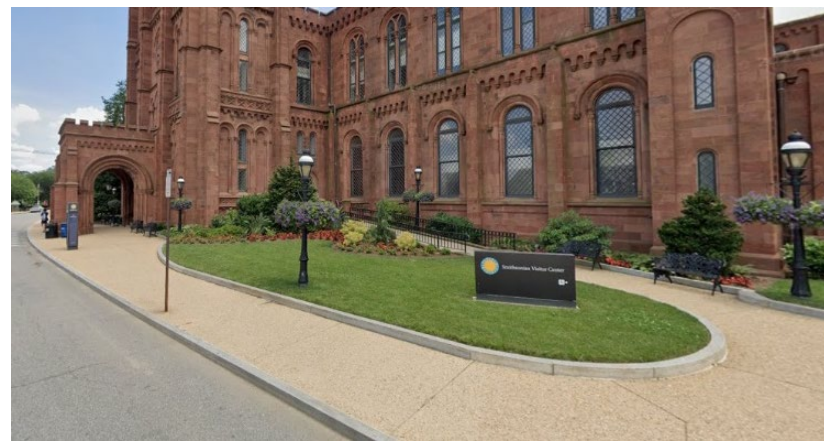
Existing west accessible ramp to the Castle's North Tower.

- Setting is a character defining feature.
- Existing east and west asymmetrical pathways are not historic, installed c. 1987.
- East entrance to the North Tower features stairs and stone newel posts installed c. 1987. West entrance to the North Tower features an access ramp installed c. 1987. These non-historic entry materials will be removed.
- North Tower setting features a semi-symmetrical path arrangement to the east and west entrances around undulating planting beds with lush plantings.
- Historic fabric will not be removed or obscured by the construction of the walkways.
- Proposed guardrail design is in keeping with the Haupt Garden fence and gate design.
- Adverse effect is avoided through maintaining the existing landscape character and setting through the proposed curvilinear paths, planting beds, and planting diversity.

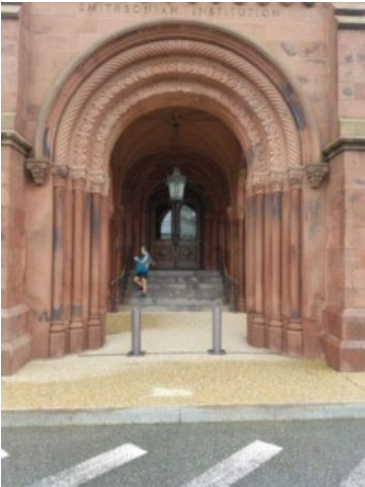
<p>Mock-up of bollards inside the porte cochere.</p>	<ul style="list-style-type: none"> - Haupt Garden, Folger Rose Garden, and landscape building settings will be restored in all disturbed areas related to construction. - Cumulative adverse effects from excavation work, construction fencing, and alternate pedestrian routes are temporary, provided the site is restored after construction is complete, including reinstallation of salvaged hardscape pavers and plantings. - Perimeter Security has a cumulative adverse effect on the Castle’s Setting, a character defining feature. - Consensus on material and metal finishes for the Seismic Control Joint cover plate minimizes adverse effects on the Castle and National Mall settings. - Consensus on utilitarian finishes for the areaways does not call undue attention and will not intensify the adverse effects from these installations on the Castle and National Mall settings. - New Basement Windows, Egress Doors, Replacement and Restoration of Windows, Installation of Rooftop Fall Protection, 4th Floor Egress, and Rooftop Mechanical Penthouses, result in a cumulative adverse effect on the Castle exterior, affecting character defining features and overall exterior appearance: Building Massing, Roof Profile, North and South Towers, and façade configurations. - Interior effects from the South Tower Elevators alter historic fabric in significant interior spaces including the Children’s Room, Great Hall, and on upper floors. Interior effects at the Basement Level alter the space’s volume and character. Cumulative effects of interior alterations are adverse on the Castle’s historic interiors.

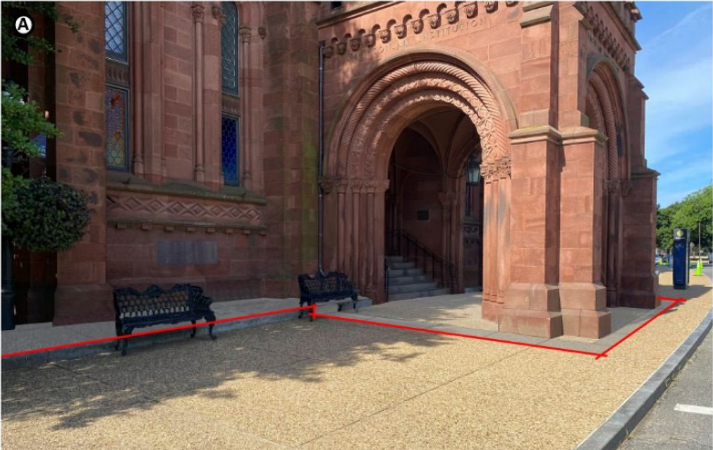
<p>Visualization of proposed seismic joint cover at the porte cochere.</p>	<p>- Castle is a contributing element to the National Mall Historic District, prominently sited in the Mall.</p> <p>- Haupt Garden, Folger Rose Garden, landscape building setting, and the Jefferson Drive roadbed and sidewalk will be restored in all disturbed areas related to construction.</p> <p>- The Andrew Jackson Downing Urn, a memorial and public artwork located in the Haupt Garden, will be temporarily relocated to a SI storage facility.</p> <p>- Cumulative adverse effects from excavation work, construction fencing, and alternate pedestrian routes are temporary, provided the site is restored after construction is complete, including reinstallation of salvaged hardscape pavers and plantings.</p> <p>- Seismic control joint and perimeter security will be visible immediately adjacent to the base of the Castle at-grade, and visible around the porte cochere in the sidewalk. This has a cumulative adverse effect on the Castle and National Mall Settings.</p> <p>- Consensus on material and metal finishes for the Seismic Control Joint cover plate minimizes adverse effects on the Castle and National Mall settings.</p> <p>- New Basement Windows, Egress Doors, Replacement and Restoration of Windows, Installation of Rooftop Fall Protection, 4th Floor Egress, and Rooftop Mechanical Penthouses, result in a cumulative adverse effect on the Castle exterior which changes how the Castle presents within the Historic District context.</p>
