Project Background and Section 106 Compliance

This project provides a comprehensive rehabilitation of the Smithsonian Institution Building (Castle) to address physical deterioration, obsolete infrastructure and systems, non-compliance with building codes, and provide below-grade mechanical and building support space connected to the adjacent Quadrangle Building loading dock.

RoHC Revitalize Castle Assessment of Effects on Historic Resources

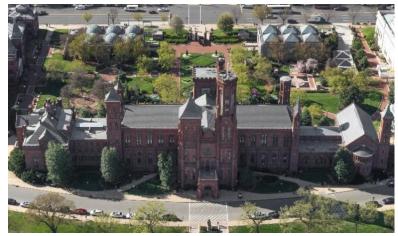
Smithsonian Institution Building, South Elevation.

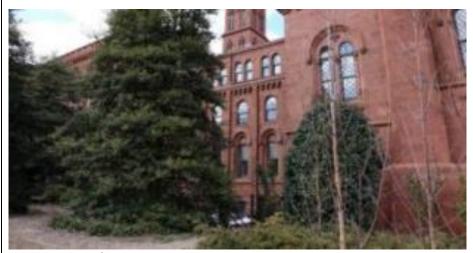
Existing southeast façade.

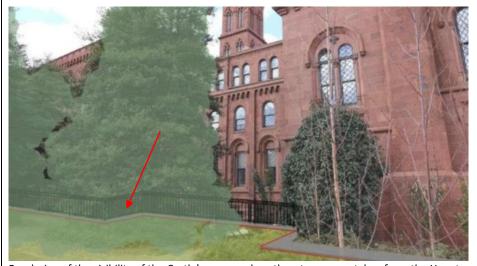
Rendering of the visibility of the Castle's proposed southeast areaway, taken from the Haupt Garden hardscape path. The fall protection railing and plantings will be finalized in Phase 2 of Section 106 consultation. Egress stair gate location is noted with a red arrow.

- Options for exposed foundation surface treatments and materials to minimize adverse effect, are pending mock-ups and further development in Phase 2 of 106 consultation.

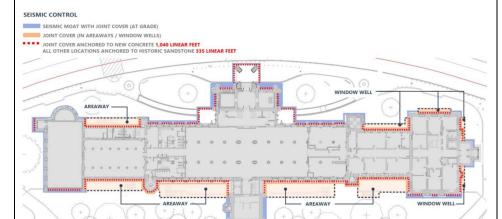
Installation of Seismic Control Joints Around the Castle Perimeter (Location and Width)

Proposed Castle site plan. Blue shading notes at-grade seismic joint cover; orange shading notes below-grade seismic joint cover in areaways or window wells.

- Seismic base isolation joint is required around the entire Castle perimeter.
- Seismic control joint must be as regular as possible around the Castle's unique footprint.
- Seismic control joint will have an at-grade cover plate to prevent water infiltration into the joint.
- Seismic control joint moat cover is 1'2" in width, but the overall visual assembly width varies to account for buttresses or other architectural features.
- Seismic control joint cover plate overall assembly width will be the minimum dimension possible.

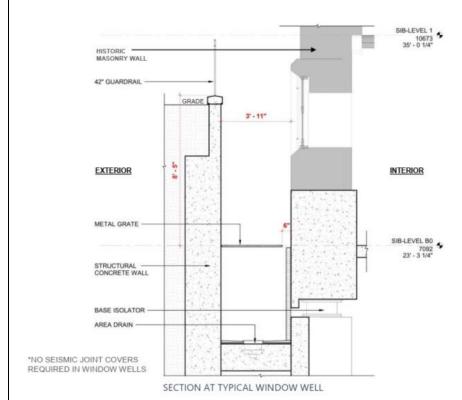
Section of a typical window well. Note that a seismic control joint cover is not required in window wells.

- Setting is a character defining feature.
- Castle is an unreinforced masonry structure with complex building massing. Castle experienced significant damage from the 2011 Mineral, VA earthquake.
- Seismic base isolation provides protection for the Castle with minimal visual impact. Seismic base isolation avoids the installation of visually intrusive steel and cable supports.
- Seismic control joint is associated with base isolation, which separates the building from the ground motion. Base isolation is achieved by creating a plane of separation between the superstructure and the foundations.
- Seismic control joint covers the seismic moat to prevent water infiltration.
- Seismic control joint cover is not required in the proposed window wells because water infiltration is handled through floor drains.

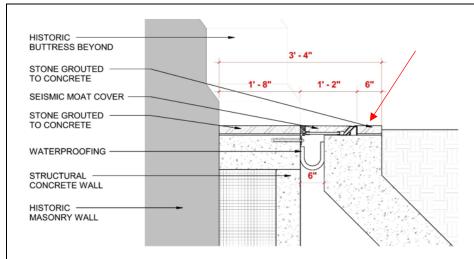
SEISMIC JOINT COVER WITH STONE EDGING

Note the dimension of the seismic moat cover width of 1'2". This option includes a 6" stone edge finish treatment, noted with a red arrow.

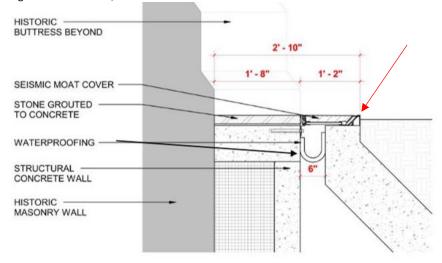
SEISMIC JOINT COVER WITH FINSHED METAL EDGE

Note the dimension of the seismic moat cover width of 1'2". This option lacks a stone edge, with the finished metal of the cover plate terminating the above-grade assembly, noted with a red arrow.

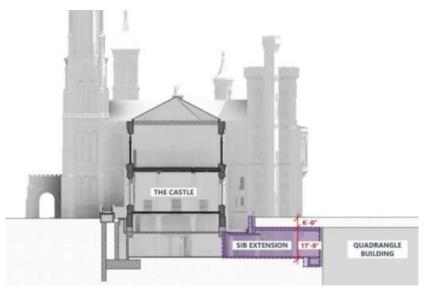
Extent of Excavation Adjacent to Castle – SIB Extension (B1 Level), B2 Level Cistern*

Proposed transverse section through the Castle showing the depths of excavation. SIB Extension is shaded purple.

- SIB Extension will allow for the majority of service functions and infrastructure to be placed outside the Castle footprint, prioritizing the historic interiors for public programming and use.
- There is the potential for construction related adverse effects from excavation or building vibration.
- Excavation for this project is connected to Stipulation 7.C (Monitoring of Adjacent Historic Properties) of the South Mall Master Plan Programmatic Agreement which requires monitoring adjacent to historic properties.
- Adverse effects of excavation adjacent to the Castle will be mitigated and remedied provided the following conditions are met:
- 1. Pre-construction monitoring is carried out to establish a baseline for movement

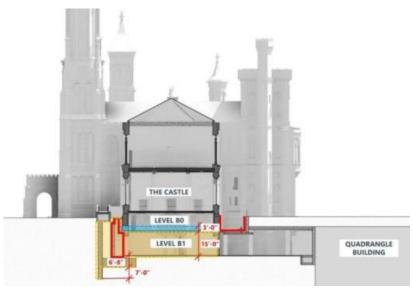
Proposed transverse section through the Castle showing the depths of excavation. Lowered basement is shaded blue. Mechanical distribution level is shaded yellow.

- Basement floor level (B0) will be lowered 3' to accommodate public use and programming.
- Seismic base isolation will be inserted.
- New mechanical distribution level (B1) with a 15' floor to ceiling height is proposed below the Castle basement for building specific mechanical equipment.
- Mechanical distribution level is aligned with the existing Quadrangle loading dock, Quadrangle B1 level, and the SIB Extension.
- B2 level will contain an excavated but not enabled future connection to the Quadrangle Building B2 level.

- Castle is an unreinforced masonry building, with a long and narrow profile, and complex building massing.
- Castle is at risk for significant seismic related damage, experienced during the 2011 earthquake.

- Base isolation separates the building from the ground motion, achieved by creating a plane of separation between the superstructure and the foundations.

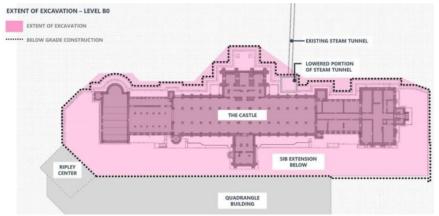
Extent of excavation at the BO level (current Castle basement).

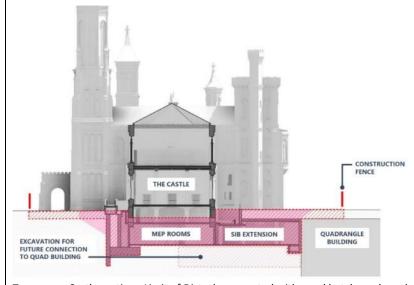
Transverse Castle section. Limit of Disturbance noted with a red hatch mark, and construction fencing with red.

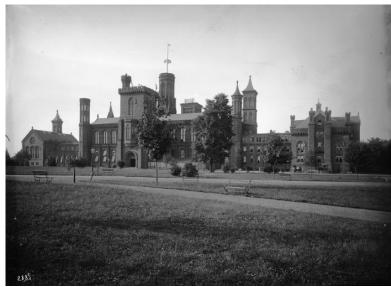
Castle South Elevation and South Yard, 1880.

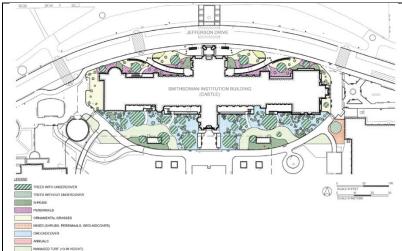
Final landscape planting plan. Trees are placed around the Castle perimeter, with shrubs, perennials, and turf comprising the ground cover.

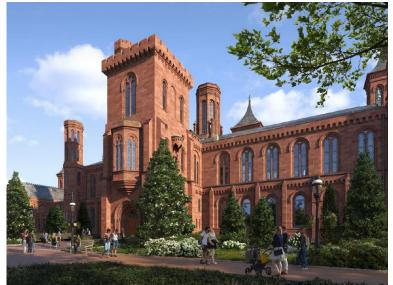
Rendering of the proposed planting plan.

- Existing landscape setting features a mix of large structural trees (evergreen and deciduous), large shrubs/small trees, low shrubs, perennials, and turf. Diversity, type, and hierarchy of plantings will be maintained.
- Proposed trees and plantings are in keeping with the existing landscape variety but use native and sustainable plantings.
- Refer to "Accessible Walkways at the North Entrance" and "Alterations at the South Entrance to Improve Accessibility" for related changes.
- Changes to the landscape and replacement of hardscape will not alter the character of the Castle's setting.

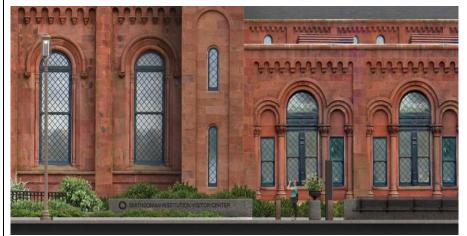
Rendering of the approach to the west accessible walkway at the North Entry.

- Existing large SI pylon sign west of the porte cochere will be removed.
- Two (2) existing Smithsonian Visitor Center metal signs will be replaced in the same location with stone walls with engraved signage. These signs are hardened walls and part of perimeter security.
- Two (2) new directional signage pylons are proposed in the landscape at the transition between the sidewalk and the North Entry accessible walkways.

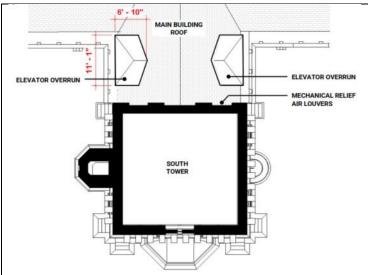
Proposed roof plan noting locations of the elevator overruns and through wall louvers.

- Phase 1 of 106 consultation included a significantly taller mechanical relief bulkhead than the existing condition, found to have significant visual impact and adverse effect. Phase 1 of 106 consultation produced a through wall louver design, with consensus that this solution minimized adverse effect by eliminating visibility of the mechanical relief bulkhead.

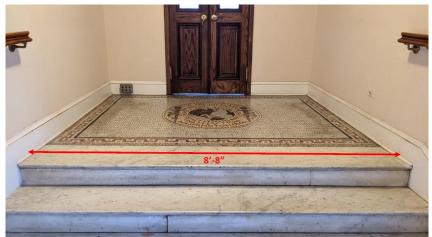
Existing upper mosaic at corridor of third level Regent's Room.

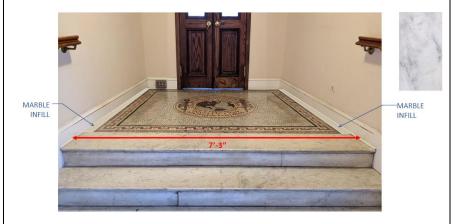
Proposed modification to the mosaics from narrowing the corridor $1^\prime 5^{\prime\prime}$ to accommodate the elevator shafts.

- Interior alterations associated with the elevators have an adverse effect on historic fabric and interiors.
- New elevator openings in the south side of the Great Hall remove historic plaster.
- Design originally proposed two openings at the Children's Room to access each elevator vestibule. This was revised in consultation to one opening to preserve the historic stairs and minimize adverse effect.
- Two mosaic floor panels at the third floor will be narrowed through excising the center solid color tesserae and portions of the fretwork border. Mosaics will be relaid with the fretwork border pattern intact aside from the dimensional change. Infill is required at the east and west edges, proposed in marble in keeping with the adjacent historic stairs. This treatment minimizes adverse effect through preservation of the central decorative medallion and majority of the mosaics.

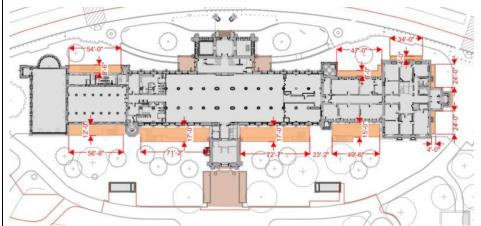
Areaways and Window Wells - Finishes

Castle site plan, with proposed below-grade areaways and window wells noted with orange shading.

- Recessed areaways and window wells are proposed at locations around the Castle perimeter.
- Recessed areaways expose up to 4 feet of the Castle's foundations.
- Castle's foundation wall consist of rubble stone with unknown exact depths.
- Within the areaways, rubble stone will be left intact, with applied waterproofing and a redtinted parge coat on the exterior.
- Other materials include neutral gray pavers and ultra-high performance concrete on the new areaway walls.

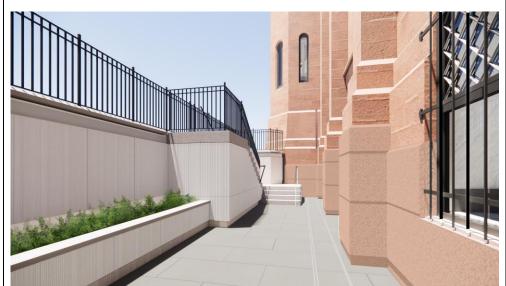
Rendering of finishes at the southwest areaway. Parging is shown on the Castle's base, gray porcelain pavers, and a neutral gray ultra-high performance concrete on the new retaining wall.

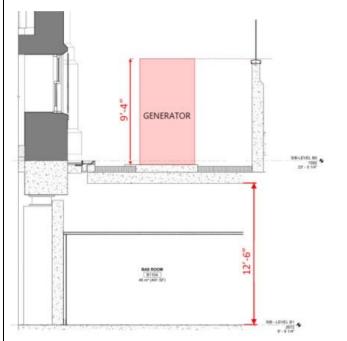
Section of southeast areaway above the SIB Extension. Generators do not exceed the height of the areaway wall.

- Removal of the Central Utility Plant from the project required alternate placement for the emergency generator.
- Emergency generators replace two existing pieces of mechanical equipment, one of which is visible above-grade.
- Generators will not be visible within the Haupt Garden and setting, except within the immediate vicinity of the southeast areaway. The southeast areaways are for staff use or building operations and will not have any public function.
- Presence of the largely non-visible generators and associated equipment will not intensify the adverse effect from the areaways.

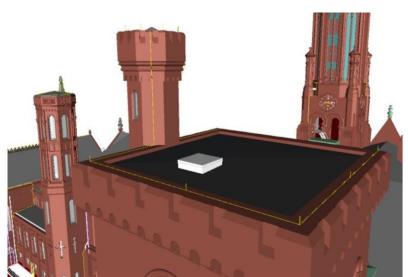
Axonometric view over the South Tower roof looking west.

- Lighting protection system will be installed on the perimeter of the Castle roof.
- Air terminals (metal rod) project 10" above rooftop features, placed at the perimeter of the Towers and peak of the East Wing roof.
- Air terminals will be clamped to existing features, with grounding cables held in place using metal brackets attached at mortar joints. Some cables will require adhesive mounting at the roof edges.

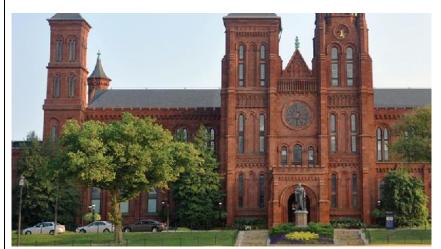
Installation of Rooftop Fall Protection

Rendered view of the fall protection system looking south to the Castle.

- Life safety fall protection system will be installed at the Castle roof to allow maintenance.
- Fall protection system consists of low metal cables and stanchions at the roof ridges.
- Low metal stanchion redirects in select locations off the ridges connect different sections of fall protection system.

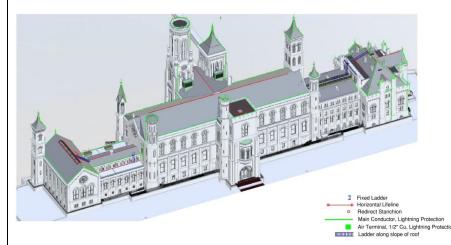
Axonometric drawing of the Castle. Red lines indicate the horizontal cable lifelines. Green lines indicate the lighting protection system.

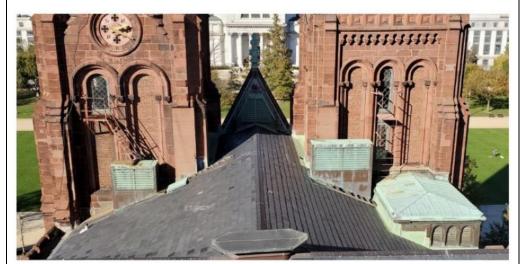
Installation of Roof Access

Existing conditions of roof access ladder and stairs at the south elevations of the Flag and North Towers.

- Roof access hatch proposed on the peaked roof between the Flag and North Towers.
- Access hatch provides direct access to the cable fall protection system.
- Permits the removal of unsightly non-historic access stairs at the south sides of the Flag and North Towers.

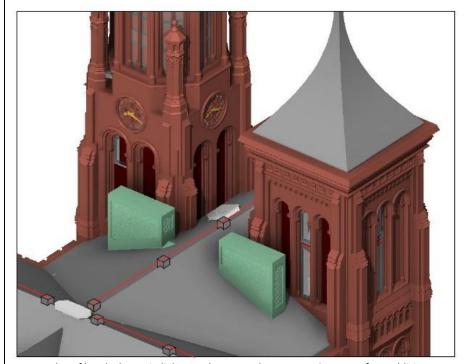
Proposed roof hatch shown in light gray between the towers. Green rooftop additions represent mechanical penthouses. Red lines represent the fall protection system.

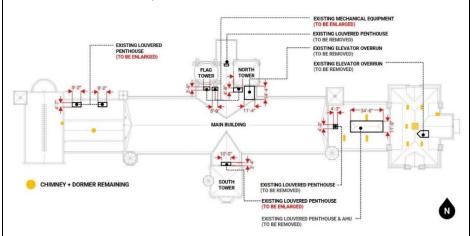
Modifications to Rooftop Mechanical Penthouses

Existing roof plan. Existing rooftop features with all black text in the tags will be removed.

- West Range has two (2) visible mechanical penthouses that will be expanded. Location and height remain the same, and only the width expands.
- One (1) visible elevator mechanical penthouse and two (2) mechanical penthouses will be removed from the North Entry Hyphen.
- One (1) visible non-historic mechanical penthouse on the East Wing will be removed for the 4th Floor Egress Path.
- Two (2) visible mechanical penthouses are proposed behind the Flag and North Towers at the North Entry Hyphen.

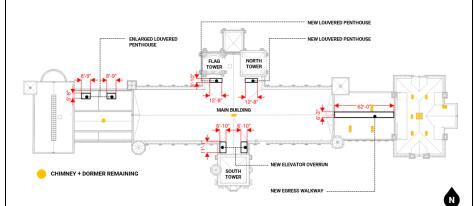
Proposed roof plan. Historic chimneys and dormers that will be retained are noted in yellow.

- Roof Profile and Building Massing are character defining features.
- Historic visible chimneys, dormers, and historic ventilators will be retained, noted with yellow on the plans at left.

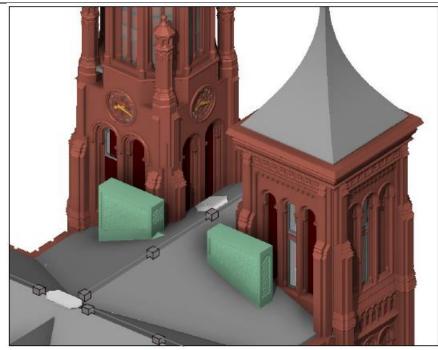
Axon view of the proposed North Entry Hyphen mechanical penthouses.

- The preferred option is the narrowest width and as close to the ridge as possible to reduce visibility and minimize adverse effect. The penthouses will be clad in copper and feature an arched louver at the east and west sides in keeping with detailing found on the Castle's stone and other rooftop additions.

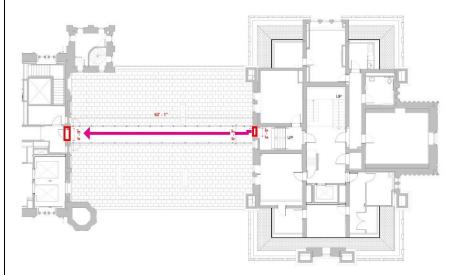
Installation of East Wing 4th Floor Egress

Plan of the proposed egress path from the East Wing across the East Range roof to the Main Building.

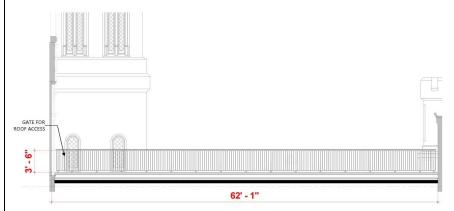
Elevation of the egress walkway and fall protection railing design.

- Roof Profile is a character defining feature.
- Secondary means of egress from the fourth floor of the East Wing is currently across the East Range roof, through windows and without fall protection. A second means is required for occupancy.
- Proposed egress walkway replaces an existing visible mechanical penthouse added in 1973. Egress pathway fall protection railings and the existing mechanical penthouse are comparable in height.
- Adjacent historic brick chimneys on the East Wing roof installed c. 1900 will be retained and restored.
- Egress path fall protection railings will be visible from various locations within the National Mall and to the south.
- Fall protection railings will have a lit handrail, only activated during emergencies.
- Installation of egress doors will not require alterations to the existing

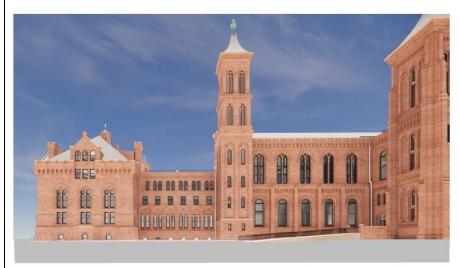
Walkway railing visibility from the middle of the National Mall.

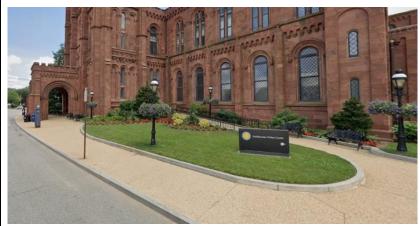
Existing west accessible ramp to the Castle's North Tower.

Accessible Walkways at the North Entrance

Landings at the east and west doors will be granite.
- Adjacent landscape beds will be adjusted to a symmetrical configuration.
- Non-historic east and west doors to the North Tower will be replaced with wood and glass paired doors.

- Setting is a character defining feature.
- Existing east and west asymmetrical pathways are not historic, installed c. 1987.
- East entrance to the North Tower features stairs and stone newel posts installed c. 1987. West entrance to the North Tower features an access ramp installed c. 1987. These non-historic entry materials will be removed.
- North Tower setting features a semisymmetrical path arrangement to the east and west entrances around undulating planting beds with lush plantings.
- Historic fabric will not be removed or obscured by the construction of the walkways.
- Proposed guardrail design is in keeping with the Haupt Garden fence and gate design.
- Adverse effect is avoided through maintaining the existing landscape character and setting through the proposed curvilinear paths, planting beds, and planting diversity.

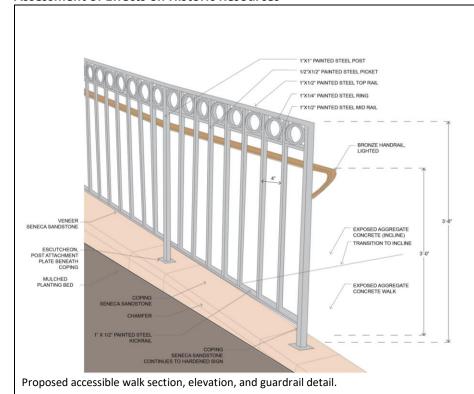
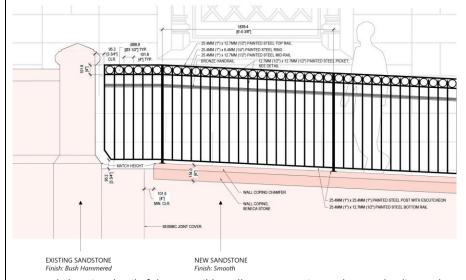
Proposed elevation detail of the accessible walkway connection to the west landing at the North Entry.

- Adverse effect is avoided through use of sandstone, granite, and aggregate concrete paving to construct the walkways, consistent with materials present in the setting.
- Use of a smooth finish on the vertical walls and coping stones for the walkways differentiates the new construction from the adjacent bush hammered sandstone on the c. 1970s landings.

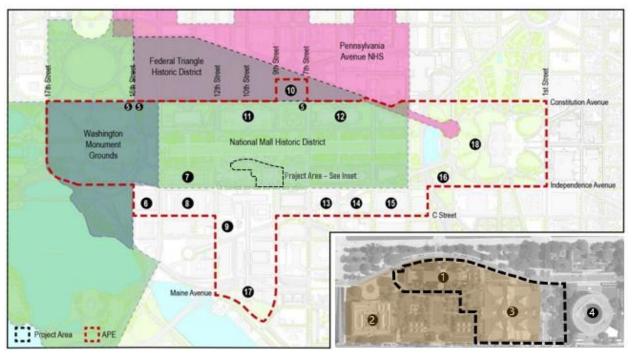
Area of potential effects map, noted with the red dotted line. The RoHC project area is noted with the black dotted line on the overall and inset maps.

The area of potential effects is defined as the geographic area within which an undertaking may directly or indirectly cause alterations in the character or use of historic properties. This Assessment of Effects on Historic Resources considered the effects of the Revitalization of the Historic Core project within the below mapped area. This area of potential effects was set by the Programmatic Agreement for the South Mall Campus Master Plan.
