# A GRAND ENTRANCE

## RESTORING THE COOPER HEWITT CANOPY

Carly Bond | OPDC

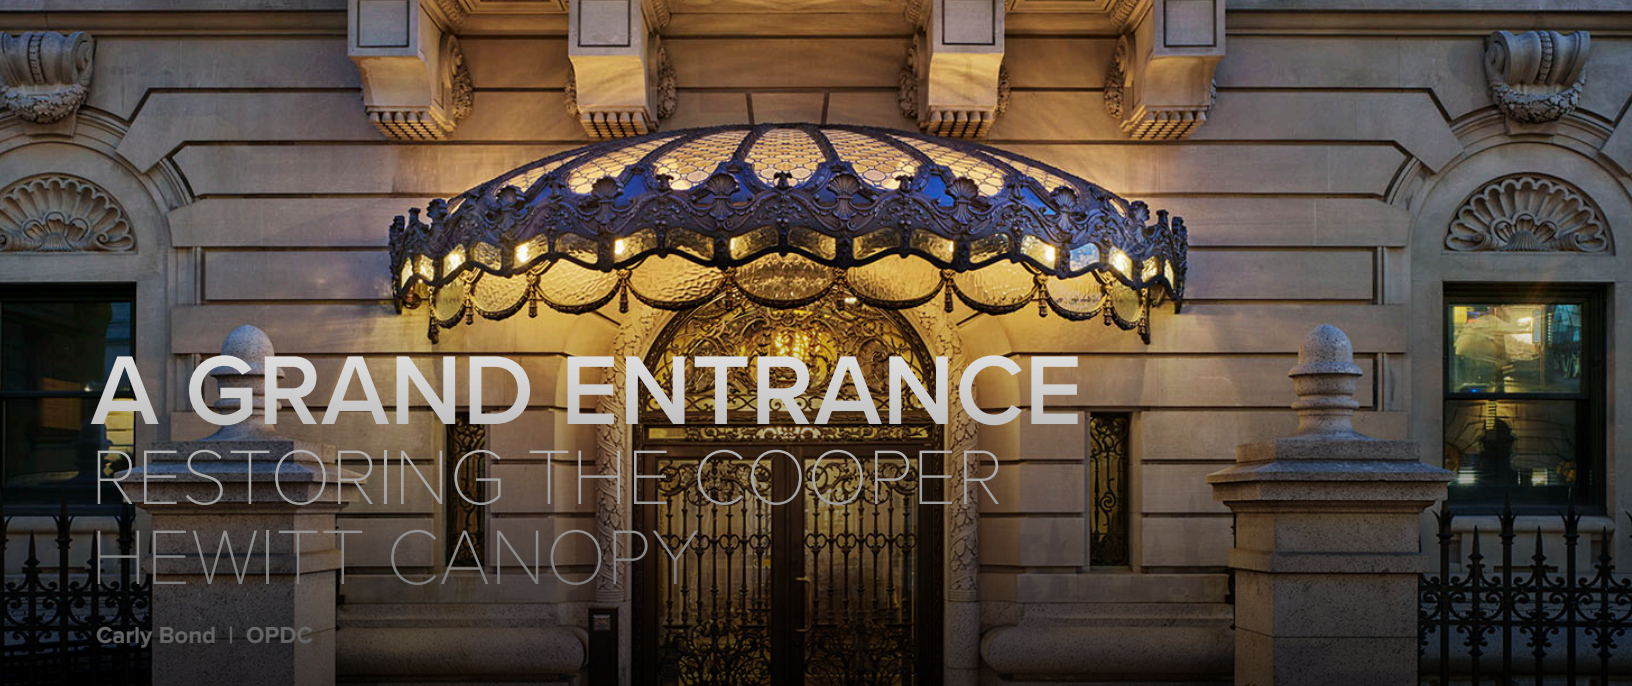
The Smithsonian Institution and the Cooper Hewitt, Smithsonian Design Museum completed a significant restoration of the bronze and leaded glass canopy over the building's main entrance on East 91st Street in New York City in September 2017. The canopy has been welcoming visitors and announcing the building's presence in the streetscape since its completion in 1902. Restoration work has once again returned this significant feature to its original splendor and serves as a beacon for museum patrons, surrounding neighborhood, and the Carnegie Hill Historic District.

Prior to dismantling this intricate puzzle, the existing conditions of the canopy were laser scanned which produced a three dimensional highly detailed model. This laser scan documentation provided sufficient detail for recreation of metal elements as required and also informed the contours for the reconstructed leaded glass panels to fit back into the curved roof structure. The canopy components were carefully numbered and disassembled for conservation work off-site.

The majority of the historic bronzework was retained and required almost 500 individual repairs to address structural integrity and material loss. All of the bronze was cleaned to bare metal and missing or broken pieces were recast. All of the metal was given a statuary bronze finish in keeping with the canopy's original appearance. The eleven leaded glass panels were disassembled and carefully reconstructed with new metal coming. The majority of the original glazing was reinstalled. Any replacement of broken glazing was carefully replicated to maintain the historic tint and texture of the original glass.

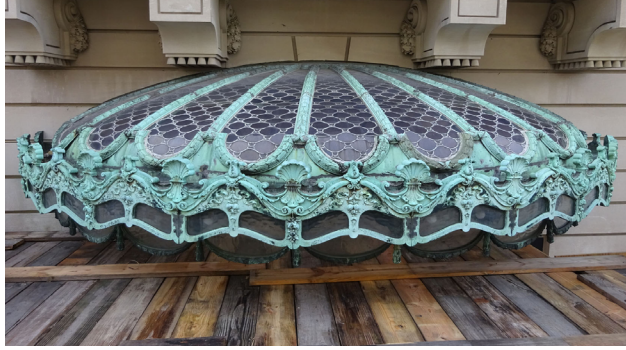
◀ Clockwise: The **Cooper Hewitt canopy** prior to restoration. / The canopy during the **reassembly portion** of the restoration process. / The **underside of the canopy** during the condition assessment before restoration.
